High-Temperature Tensile Behaviour of GTAW Joints of P92 Steel and Alloy 617 for Two Different Fillers

Abstract: This study explores the high-temperature (HT) tensile rupture characteristics of a dissimilar gas-tungsten-arc-welded (GTAW) joint between P92 steel and Alloy 617, fabricated using ER62S-B9 and ERNiCrCoMo-1 fillers. The high-temperature tensile tests were performed at elevated temperatures of 550 °C and 650 °C. An optical microscope (OM) and a field emission scanning electron microscope (FESEM) were utilized to characterize the joint. The high-temperature test results indicated that the specimen failed at the P92 base metal/intercritical heat-affected zone (ICHAZ) rather than the weld metal for the ERNiCrCoMo-1(IN617) filler. This finding confirmed the suitability of the joint for use in the Indian advanced ultra-supercritical (A-USC) program. The fracture surface morphology and presence of precipitates were analysed using an SEM equipped with energy dispersive spectroscopy (EDS). The appearance of the dimples and voids confirmed that both welded fillers underwent ductile–dominant fracture. EDS analysis revealed the presence of Cr-rich $M_{23}C_6$ phases, which was conf

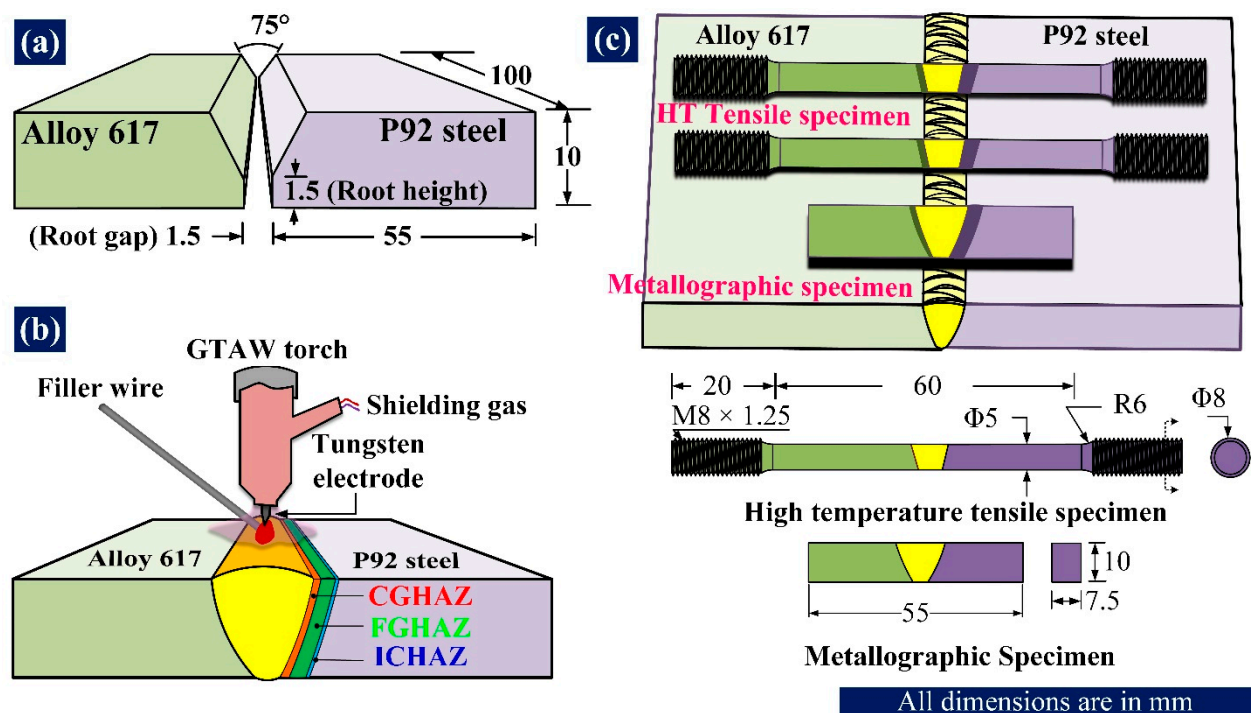
Figure 1. Schematic of (a) V-groove, (b) GTAW joint, (c) Welded plate and extracted samples with dimensions.

For this study, two 10 mm thick plates of P92 steel and Alloy 617 were welded together using the multi-pass gas tungsten arc welding (GTAW) process. The plates were cut and machined into dimensions of 100 mm \times 55 mm \times 10 mm. One side of the plates was machined as per the conventional V-groove of bevel angle 37.5° with a root face of 1.5 mm. All required dimensions related to the groove are illustrated in Figure 1a. Two joints were made: one joint with the P92 filler (ER62S-B9), and the other joint with the

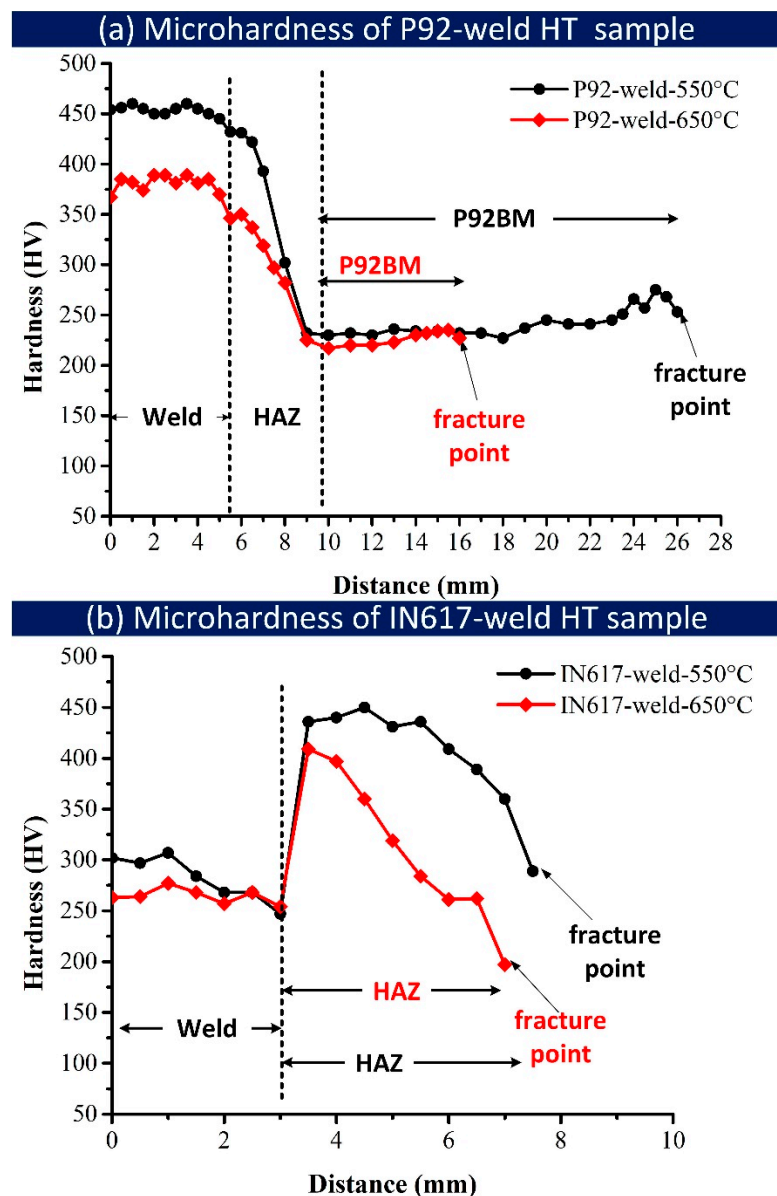
Figure 13. Hardness variation along the longitudinal section from weld centre to near-fracture location HT tensile sample of (a) P92-weld and (b) IN617-weld.

Based on the as-welded sample hardness profile for both welded plates (P92-weld and IN617-weld), the highest hardness was noticed in the position just near the fusion interface, i.e., CGHAZ, while the lower value of hardness was observed in ICHAZ. It can be seen that ICHAZ was the weakest region of the weldments (Figure 3a). However, the P92-weld sample failed from P92 BM instead of the ICHAZ, whereas in the IN617-weld sample, failure was observed at ICHAZ. The macrograph of the longitudinal section of the tested sample of the P92-weld indicates (Figure 8a,g) that the location of HAZ is very far from the fracture location, whereas the macrograph of the longitudinal section of the tested sample of the IN617-weld indicates (Figure 11a,f) that the fracture location is ICHAZ of P92. The hardness variation along the longitudinal section of the tested samples (P92-weld and IN617-weld) from the weld centre to the near-fracture location is depicted in Figure 13a,b. The sample of P92-weld tested at 550 °C indicates comparatively more hardness values of respective zones (weld, HAZ, 92BM) than the sample tested at 650 °C. The P92-weld displayed the highest hardness in the weld and the lowest at the outer edge of the HAZ and fracture location. The hardness of weld metal in P92-weld-550 °C and P92-weld-650 °C was 454 ± 4 HV and 382 ± 7 HV, respectively. The reduction in hardness of other regions of the weldments was also observed. The reduction in hardness might be due to the tempering reaction, which is a function of the operating temperature and time. For the IN-617 weld,

a lower hardness was measured for the weld metal tested at 650 °C as compared to the sample tested at 550 °C, but the difference was low as compared to the P92-weld. This may be due to the difference in microstructure of the weld metal, i.e., martensitic in the P92-weld and austenitic in the IN617-weld. The weld metal exhibited hardness values of 287 ± 17 HV and 266 ± 7 HV for IN617-weld-550 °C and IN617-weld-650 °C, respectively. For the region of P92 HAZs, a similar trend is observed in the IN617-weld as noticed in the P92-weld.
