High-Temperature Tensile Behaviour of GTAW Joints of P92 Steel and Alloy 617 for Two Different Fillers

Abstract: This study explores the high-temperature (HT) tensile rupture characteristics of a dissimilar gas-tungsten-arc-welded (GTAW) joint between P92 steel and Alloy 617, fabricated using ER62S-B9 and ERNiCrCoMo-1 fillers. The high-temperature tensile tests were performed at elevated temperatures of 550 °C and 650 °C. An optical microscope (OM) and a field emission scanning electron microscope (FESEM) were utilized to characterize the joint. The high-temperature test results indicated that the specimen failed at the P92 base metal/intercritical heat-affected zone (ICHAZ) rather than the weld metal for the ERNiCrCoMo-1(IN617) filler. This finding confirmed the suitability of the joint for use in the Indian advanced ultra-supercritical (A-USC) program. The fracture surface morphology and presence of precipitates were analysed using an SEM equipped with energy dispersive spectroscopy (EDS). The appearance of the dimples and voids confirmed that both welded fillers underwent ductile–dominant fracture. EDS analysis revealed the presence of Cr-rich $M_{23}C_6$ phases, which was conf

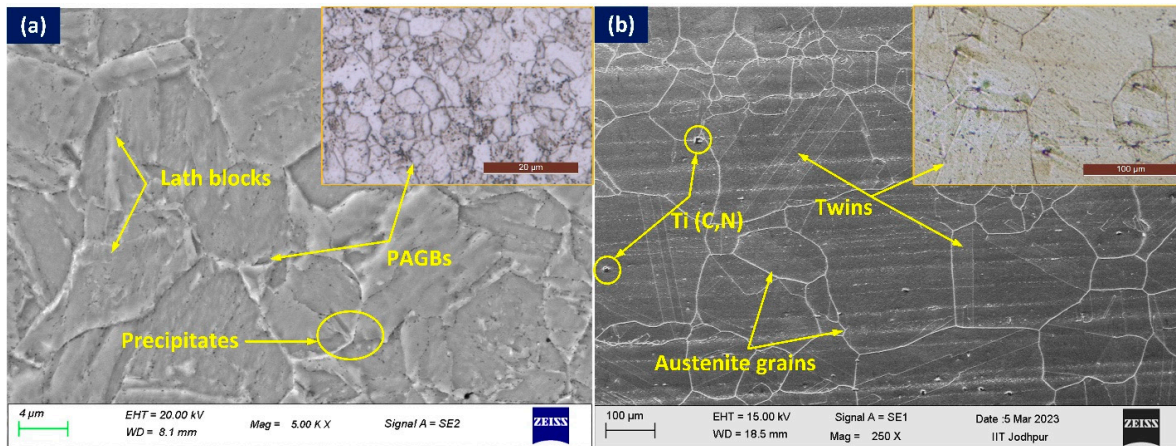
Figure 2. SEM and optical microstructure of (a) P92 steel BM and (b) Alloy 617 BM.

The microstructure of P92 steel BM is depicted in Figure 2a. The tempered martensitic microstructure consists of lath blocks, lath packets, packet boundaries, and prior austenite grain boundaries (PAGBs). The microstructure is strengthened through the presence of Cr, Mo, and W-rich coarse $M_{23}C_6$ precipitates, as well as V and Nb-rich fine MX (X: C, N) precipitates [24,25]. The microstructure of Alloy 617 BM consists of a solid solution that strengthens the matrix of austenite grain (Figure 2b) along with twins and carbides of Cr and Mo (M_6C), Mo-rich (M_6C), and Ti-rich (MX (X: C, N)) [24,25].
