The role of isolated farmsteads in the open landscape protection on the example of Kashubia

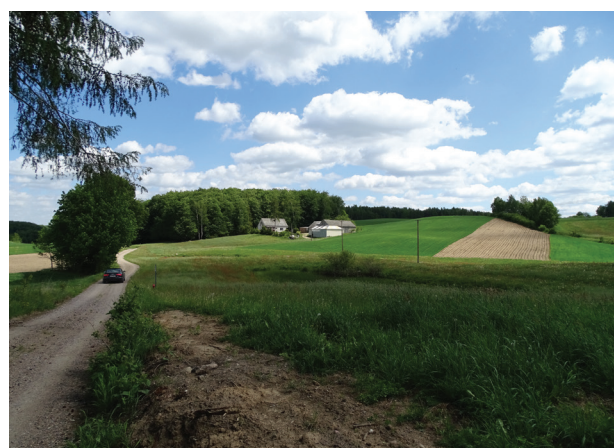
Fig. 1. An isolated farmstead in Kashubia (photo by A. Górk)

The study was conducted on the border of three communes in the Pomeranian Voivodeship, i.e., the communes of Somonino, Nowa Karczma and Przywidz. The research area centres around Pojezierze Kaszubskie [the Kashubian Lake District], whose landscape is characterised by young glacial relief with numerous hills, ravines, lakes and post-glacier depressions. The region is very attractive in terms of the views it offers, which stems from the diverse terrain and picturesque, small settlements against a background of forests or meadows and greenery-covered fields. Often, scattered farmsteads or hamlets are characterised by an outstanding landscape exposure. Due to the attractiveness of the landscape, the proximity of a large urban centre and the availability of construction land, this area has become a site of expansion of single-family residential and tourist construction. The study is focused on the development of old isolated farmsteads (Fig. 1). In the conditions of energy

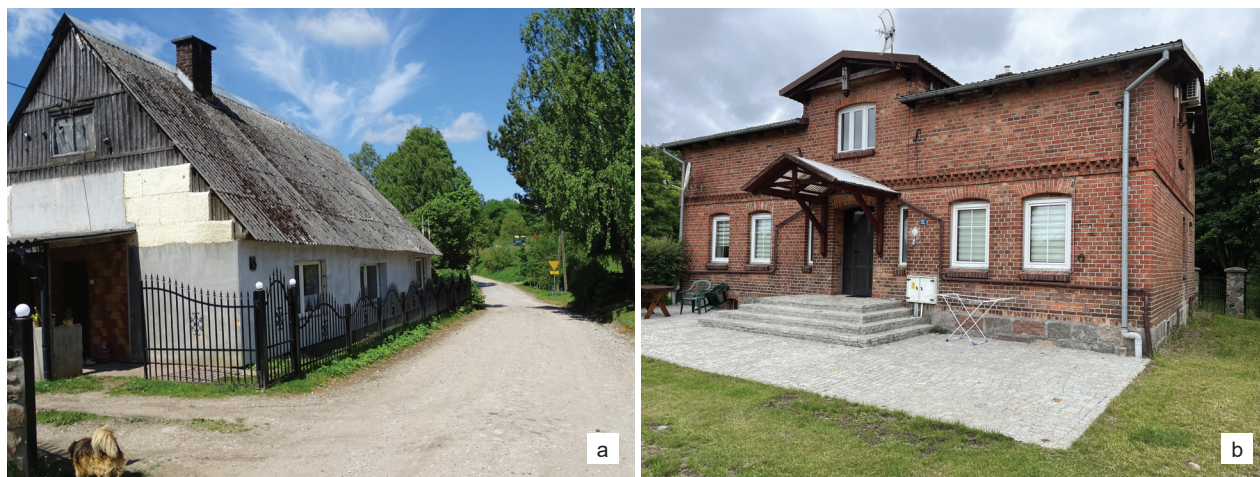
Fig. 2. Two types of farmstead houses in Kashubia:
a) a building with a high roof, b) a building with a semi-flat roof (photo by A. Górka)

well as large farmer farmsteads. Even though the Prussian administration standardised the number and functions of buildings on the farm, as well as their construction, a lot of freedom was enjoyed in Kashubia in this matter. Sometimes, farmsteads had multiple buildings, while farm buildings were still built of wood at the turn of the 19th and 20th centuries. Barns were built in a half-timbered structure, but only the most recent ones have survived to this day. These barns have a pole structure boarded with wooden material.

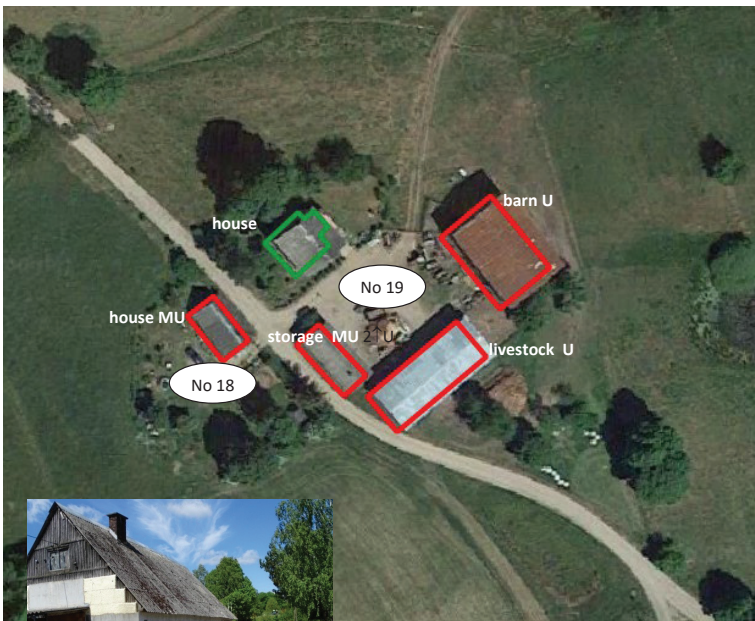
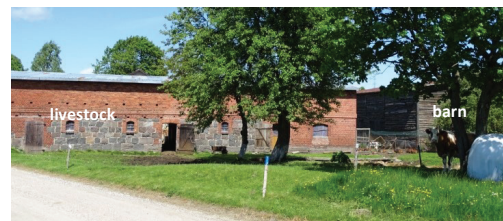
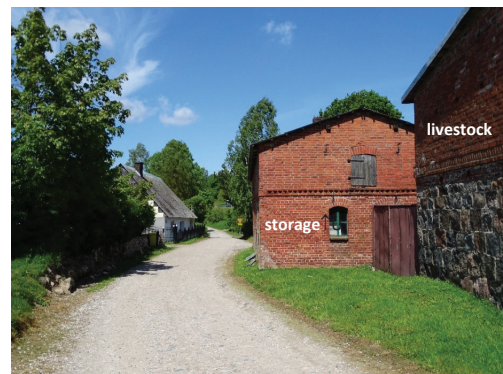
No 18: Grabowska Huta 38, 83-403

No 19: Grabowska Huta 39, 83-403

■ before 1937 r., ■ after 1937 r.

M – a modified building body or facade; U-used; D - degrading; R- in ruins

map from 1937 with building data from 2020

orthophotomap and building data from 2020

Fig. 4. An example of a farmstead inventory card (elaborated by A. Górka)

Along the scenic routes, 26 historic farmsteads were identified (Fig. 3). Each of them was described on an inventory card, in accordance with the model shown in Figure 4. Based on cartographic research and expert analysis of architectural features, buildings dating back to before 1937 and ones that were erected later were identified. They were documented in photos, their condition was described while modifications to traditional features were noted.

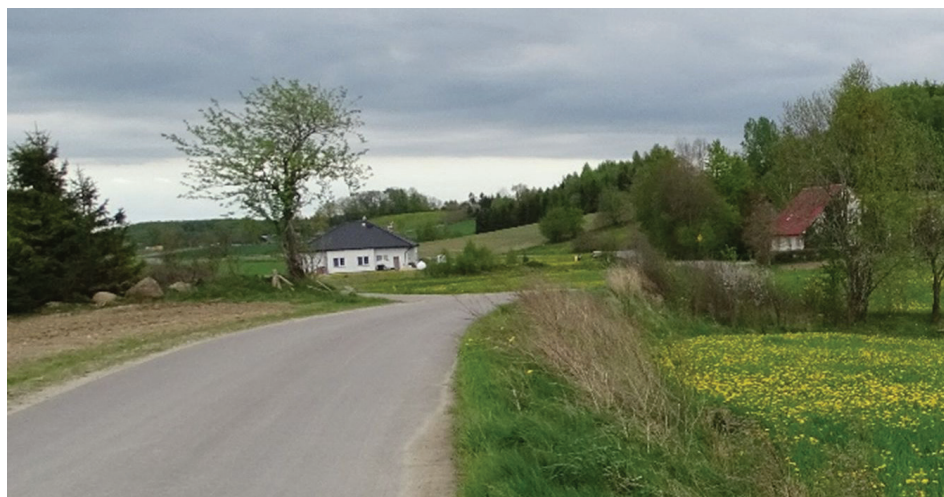
Fig. 5. New building closing the scenic corridor (photo by A. Górka)
