# Characterization of Corrosion-Induced Fracture in Reinforced Concrete Beams Using Electrical Potential, Ultrasound and Low-Frequency Vibration

Tomasz Ferenc<sup>1</sup> · Erwin Wojtczak<sup>1</sup> · Błażej Meronk<sup>1</sup> · Jacek Ryl<sup>2</sup> · Krzysztof Wilde<sup>1</sup> · Magdalena Rucka<sup>1</sup>

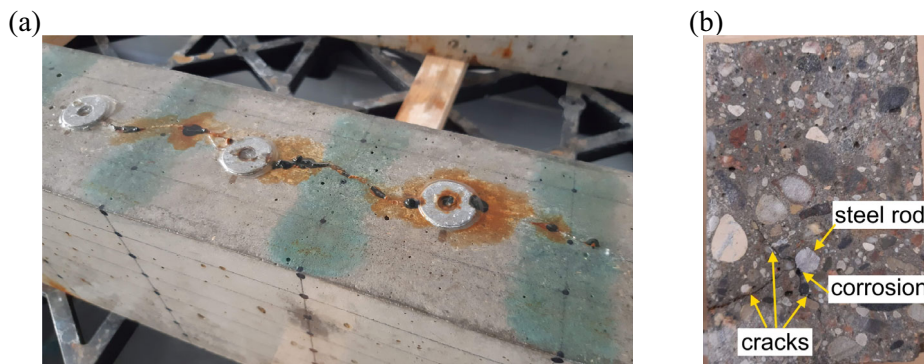
Fig. 9 The specimen during experiments a overall view on the bottom of the specimen after removing from the solution, b cross-section after experiments

the subsequent measurements, around D8–D9 depending on the specimen, cracks began to appear, which became observable visually after 12–13 days (measurements D12–D13) (Fig. 9a).

After the experimental tests were carried out, the selected specimens were cut into pieces so that the corrosion of the steel rod could be seen (Fig. 9b). As can be observed, the corrosion occurred locally, on a specific surface of the steel rod, from where the crack started to spread radially and randomly, omitting large aggregates.

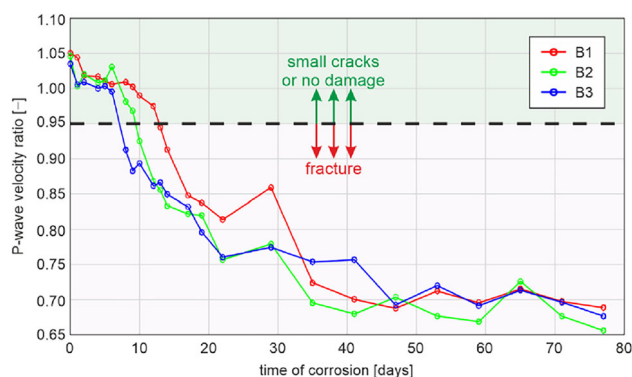
**Fig. 17** The ratio of P-wave velocity at the top and bottom line on the side of each beam

Since the P-wave velocity measurements are time-consuming, it is suggested to reduce the number of measurement points to two lines on the side of the beam, one at the top (near reinforcement) and one at the bottom (far from reinforcement) edges (points 1, 9, ..., 81, 89 and 8, 16, ..., 88, 96, cf. Figure 7). The difference between the mean P-wave velocity values at the top and bottom lines can indicate the developing crack. To verify this recommendation, the ratio of P-wave velocities at the top and bottom lines was calculated (Fig. 17).

It is visible that in the early stages of corrosion, the difference is insignificant and does not exceed 5%. This level of change may not be an indication of damage, it may just be the effect of concrete being a heterogeneous material. However, small internal cracks may occur in this stage. If the velocity difference exceeds 5% (ratio below 0.95), it can be considered as the beginning of fracture. This threshold is associated with the appearance of the first surface cracks in beams (B1—measurement D8, B2—D10, and B3—D13). Based on these observations, a ratio of the P-wave velocity at the top and bottom lines of the beam ( $C_{L,t}$  and  $C_{L,b}$ , respectively) can be considered as a damage index with:

$$DI = \frac{C_{L,t}}{C_{L,b}} \leq 0.95 \quad (2)$$
