Sustainable development requires risky decisions - problematic 300 ton overweight transport passing a bridge

Mikołaj Miśkiewicz, Andrzej Kozakiewicz, Lukasz Pyrzowski, Bartosz Sobczyk

Gdańsk University of Technology, Gdańsk, Poland

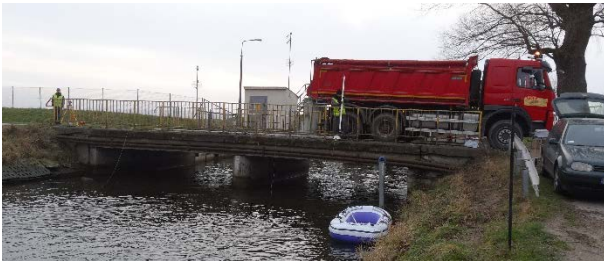
The loading test was carried out using 2 3-axle trucks with a total mass of 33 tonnes each and 2 4-axle trucks each having a mass of 40 tonnes. The trucks were positioned on the bridge according to five different arrangement configurations. These were aimed to induce extreme values of reaction forces over the supports and bending moments at the mid-span and over the support as well. Examples of vehicle alignments are shown in Figure 4.

Figure 4. Test load settings: top - inducing a minimum bending moment over the intermediate support, bottom - inducing a maximum span bending moment

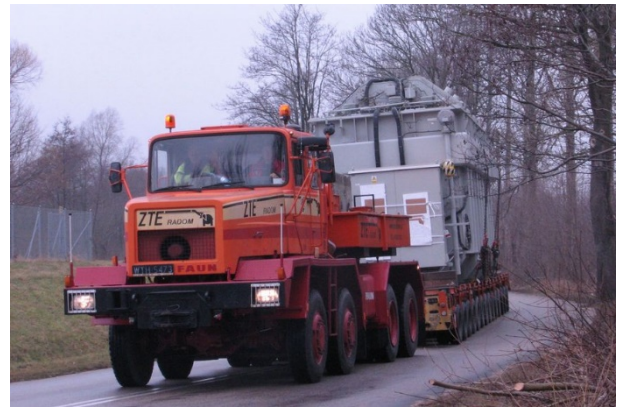
Figure 10. The oversized vehicle before driving onto the bridge

Finally, after a complete set of diagnostic work and computational simulations, permission was given to proceed with the crossing under several conditions. Firstly, it was recommended that the passage must be piloted, take place exactly along the center line of the road and its speed must not exceed 10 km/h. Secondly, it was recommended that the geometry and axle loads of the transport vehicle set should be strictly controlled. Thirdly, it was necessary to remove any obstacles from the bridge that could cause additional and unwanted load increase due to dynamic effects. What is more, due to the condition of the structure, detailed inspections were recommended immediately before and after the crossing. Moreover, since the extreme reaction was exceeded by 11% and the details about foundation method was missing, it was recommended to perform monitoring of the bridge supports during
