## Sustainable development requires risky decisions - problematic 300 ton overweight transport passing a bridge

Mikołaj Miśkiewicz, Andrzej Kozakiewicz, Lukasz Pyrzowski, Bartosz Sobczyk

Gdańsk University of Technology, Gdańsk, Poland

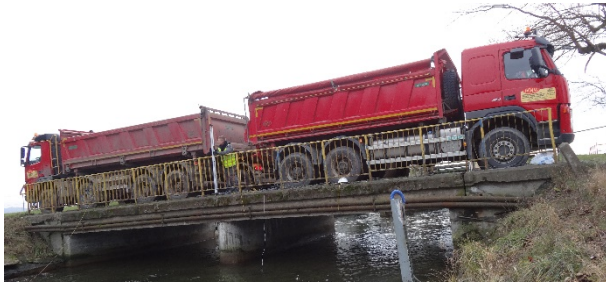
The loading test was carried out using 2 3-axle trucks with a total mass of 33 tonnes each and 2 4-axle trucks each having a mass of 40 tonnes. The trucks were positioned on the bridge according to five different arrangement configurations. These were aimed to induce extreme values of reaction forces over the supports and bending moments at the mid-span and over the support as well. Examples of vehicle alignments are shown in Figure 4.

Figure 4. Test load settings: top - inducing a minimum bending moment over the intermediate support, bottom - inducing a maximum span bending moment
