CAUSES OF DEFECTS AND DAMAGE TO BRICK MASONRY ELEMENTS IN HISTORIC BUILDINGS

Maciej NIEDOSTATKIEWICZ¹, Tomasz MAJEWSKI²

The paper is an engineering review of the causes of damage to masonry structures and indicates the need for cooperation between representatives of various specialties of science and technology, in particular architectural historians, specialists in the field of conservation of monuments, structural engineers and specialists in the field of geotechnics, geology, hydrogeologists and meliorators in order to ensure the protection of masonry structures in historic buildings.

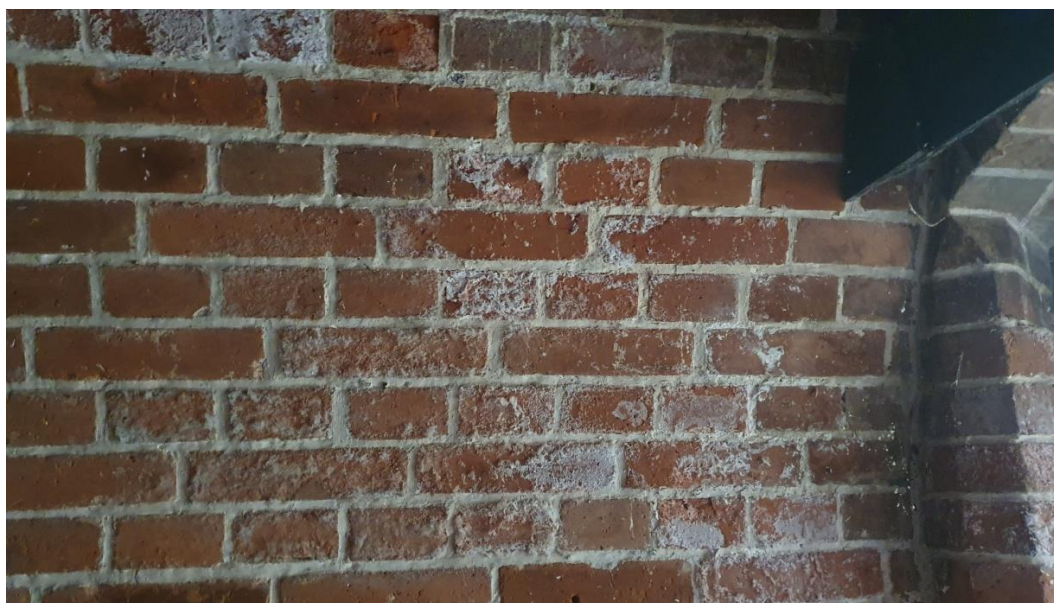
Fig. 4. Development of biological corrosion on the interior surface of the exterior solid ceramic brick masonry, visible cement mortar tight joint improperly executed in the past period during renovation work (photo: Maciej Niedostatkiwicz)

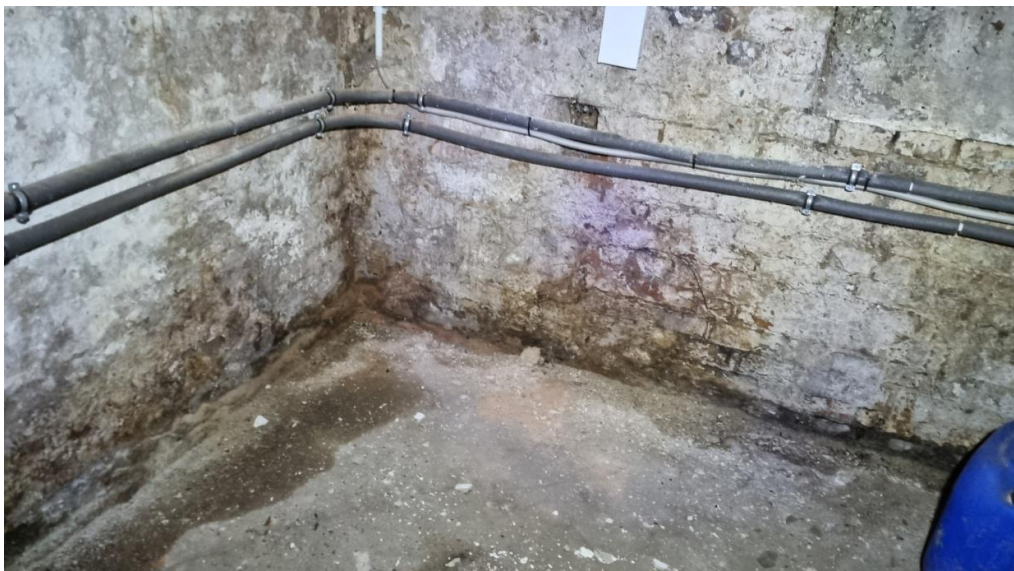
Fig. 8. Dampness of the external masonry of solid ceramic brick caused by the lack of horizontal damp proofing in the part sunk in the ground and the lack of technical efficiency (leakage) of the vertical damp proofing membrane (photo: Maciej Niedostatkiwicz)

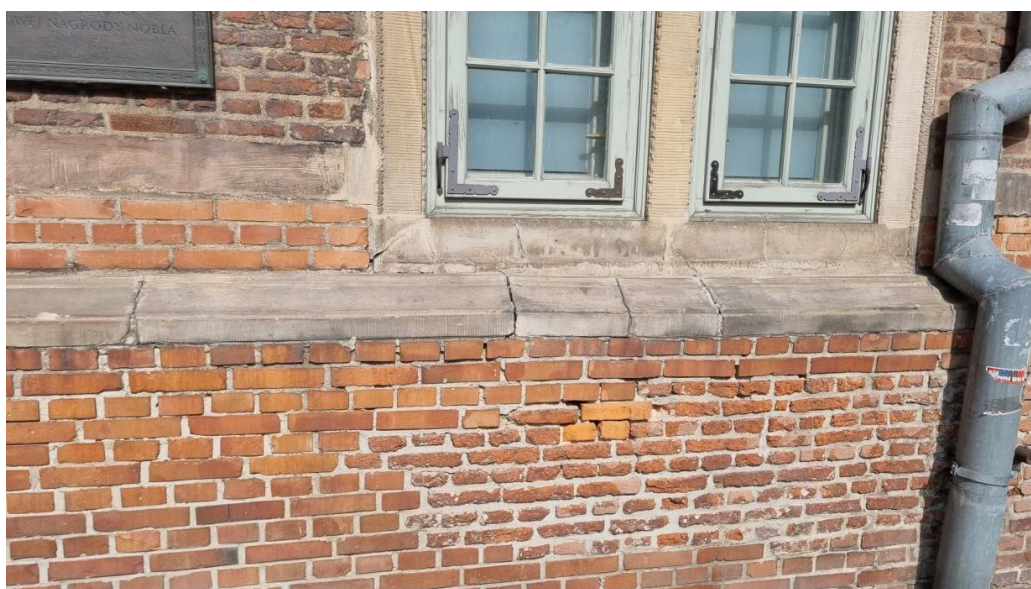
Fig. 9. "Hollow joints" of the exterior masonry of solid ceramic brick, additionally visible frost damage and weathering of the wall (photo: Maciej Niedostatkiwicz)

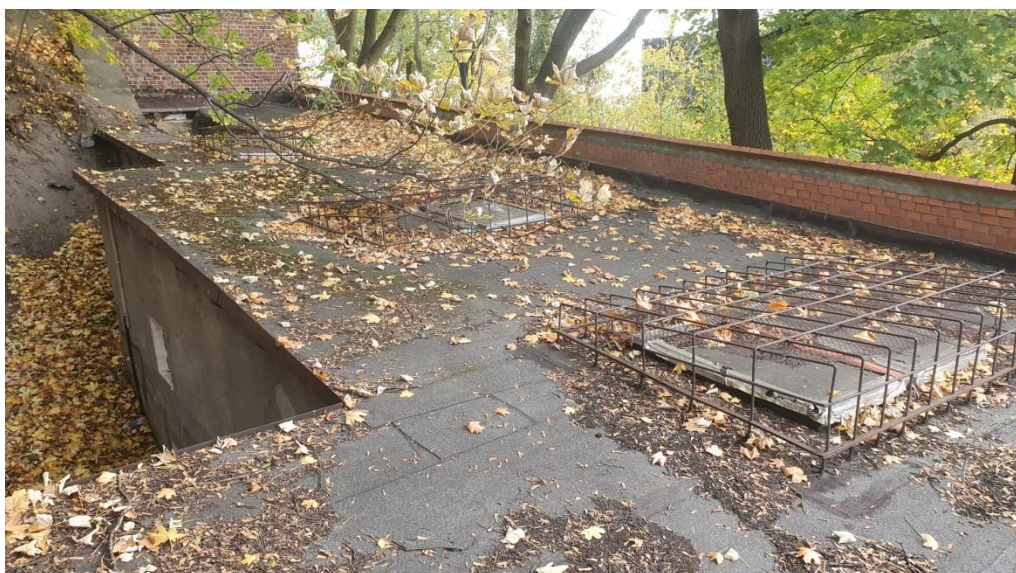
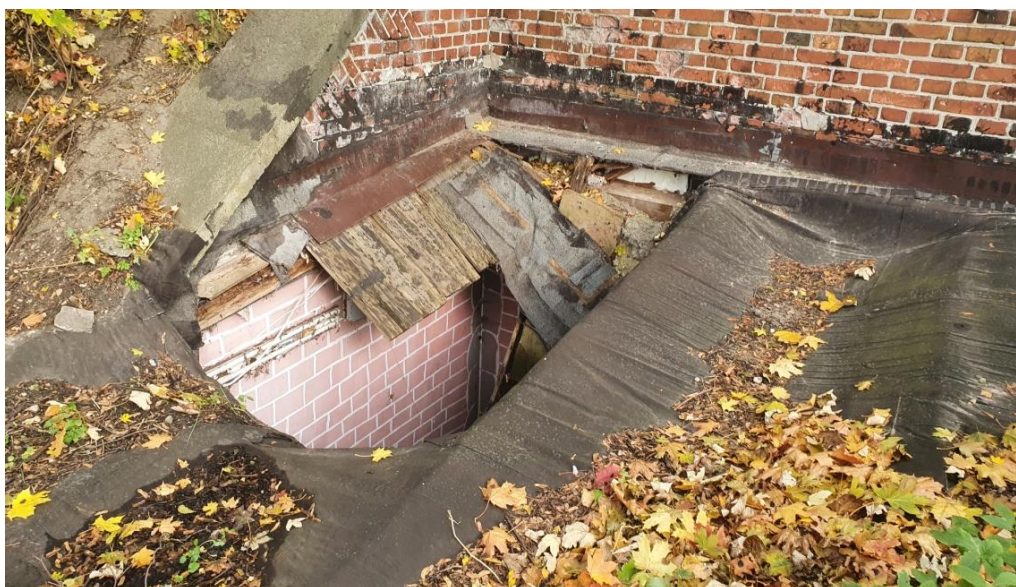
Fig. 15. Moisture damage to ceramic masonry as a result of water flooding caused by the collapse of a moisture-damaged and biologically corroded wood-framed roof: a) view, b) close-up (photo: Maciej Niedostatkiwicz)

A fairly common phenomenon that causes premature loss of technical value of a historic building is failure to maintain it properly or even lack of concern for the object's durability (Fig. 14 and Fig. 15).

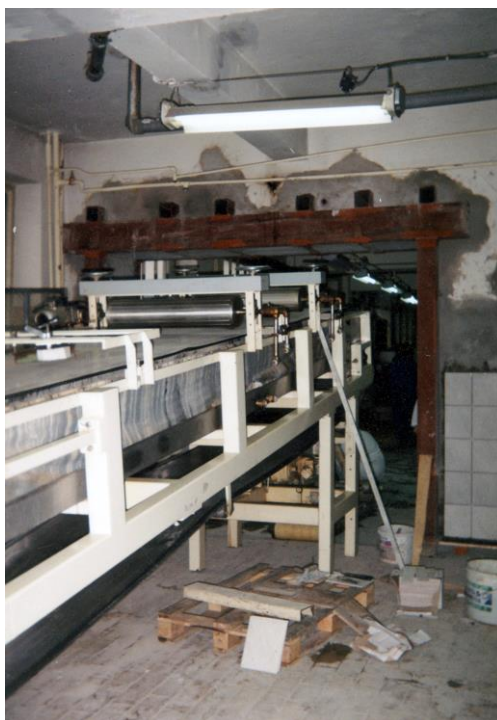
Fig. 18. Widening of the door opening in the inner wall of solid ceramic brick
– view of the steel frame construction
(photo: Maciej Niedostatkiwicz)

The renovation documentation developed in accordance with the recommendations of *Conservation Works Program*, makes it possible to safely carry out works related to the reconstruction and expansion of immovable monuments (Fig. 16), including carrying out works aimed at the ultimate change of use of the historic building (Fig. 17 and Fig. 18).
