CAUSES OF DEFECTS AND DAMAGE TO BRICK MASONRY ELEMENTS IN HISTORIC BUILDINGS

Maciej NIEDOSTATKIEWICZ¹, Tomasz MAJEWSKI²

¹Gdansk University of Technology, Faculty of Civil and Environmental Engineering,
Department of Engineering Structures

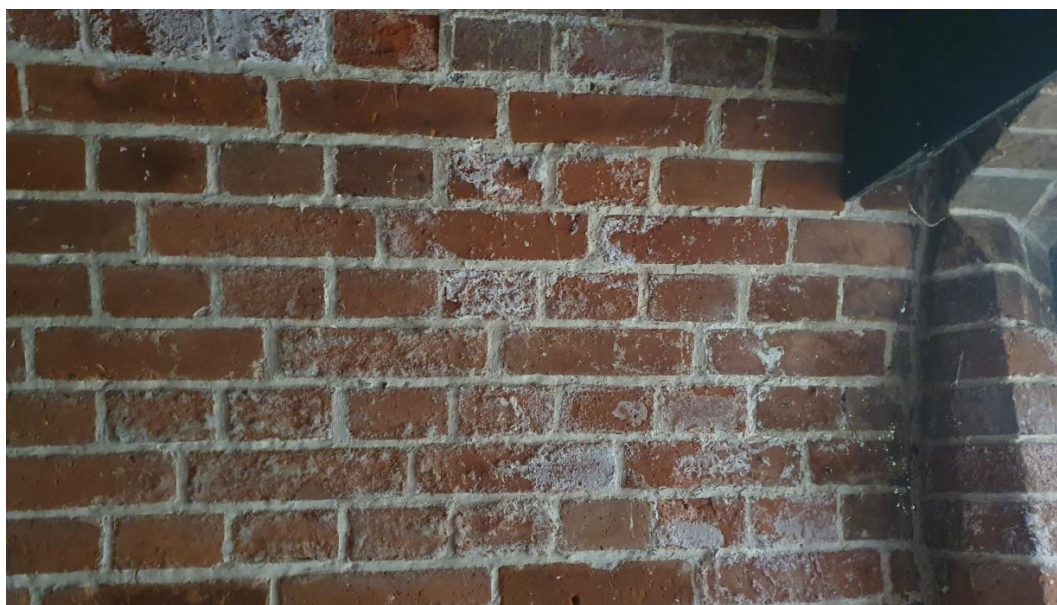
Fig. 4. Development of biological corrosion on the interior surface of the exterior solid ceramic brick masonry, visible cement mortar tight joint improperly executed in the past period during renovation work (photo: Maciej Niedostatkiwicz)
