Influence of Lubrication Water Contamination by Solid Particles of Mineral Origin on Marine Strut Propeller Shafts Bearings of Ships

Gdansk University of Technology, Faculty of Mechanical Engineering and Ship Technology, Poland

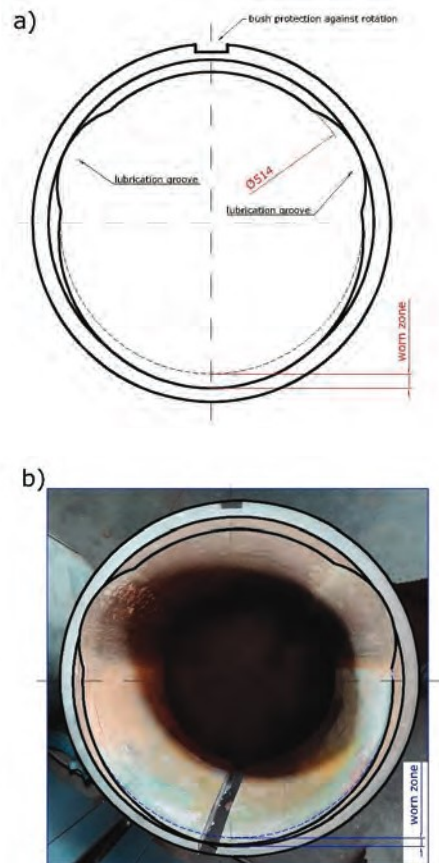
Fig. 2. A ship tail shaft strut bearing bush after dismantling from the passenger and car ferry shown above: (a) simplified drawing of the bushing; (b) photo of a dismantled, worn bushing (the worn area is marked; a slice of the bush was cut and removed by shipyard workers to make disassembly easier)

However, this solution also has some significant disadvantages. An unprotected propeller shaft is exposed to corrosion, and must be carefully protected. The bearing is lubricated with water, which is not filtered, meaning that it may contain various impurities, including hard solid particles of mineral origin, which are particularly dangerous. This was the case for the shaft shown in Fig. 1. After only two years of operation, the wear of the bushings was so deep that it was necessary to replace the bearings and regenerate the journals of both propeller shafts (Fig. 2).

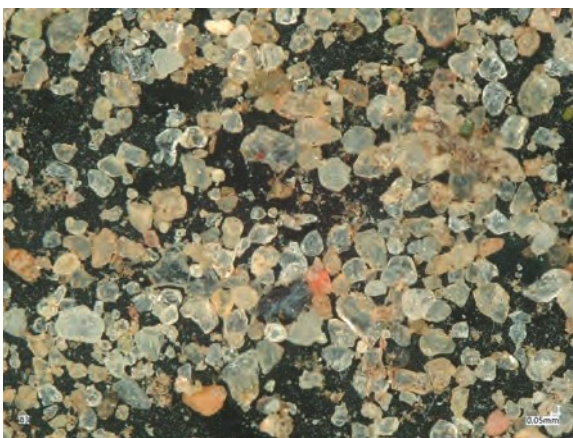
Fig. 5. Microscopic photo of solid particles of mineral origin used during the tests

A mixture of fresh water with particles of mineral origin typical of the Baltic Sea catchment area was used as a lubricant [29][30]. For this purpose, natural sedimentary material was collected from the river. It was cleaned from biological contaminant like leaves parts. The high quality, modern digital microscope was used for making pictures (Fig. 5) The dedicated software provided by manufacturer was used for analysis of the particles size. After conducting a statistical analysis after many measurements of different samples percentages of particles of various sizes figure with particles size distribution was plotted (Fig. 6).

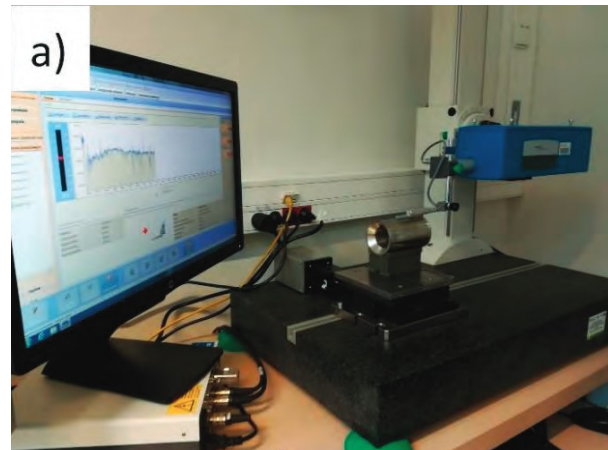
Fig. 7. (a) Profilometer measurements of the shaft journal surface profile; (b) method used to calculate the wear field based on the roughness profile.

In order to investigate the wear of the sliding pair, it was necessary to measure the wear of the shaft journal and bushings. The shaft journal wear was determined by analysing the measurement results with a profilographometer, which allowed us to calculate the consumption area and then the volume (Fig. 7).

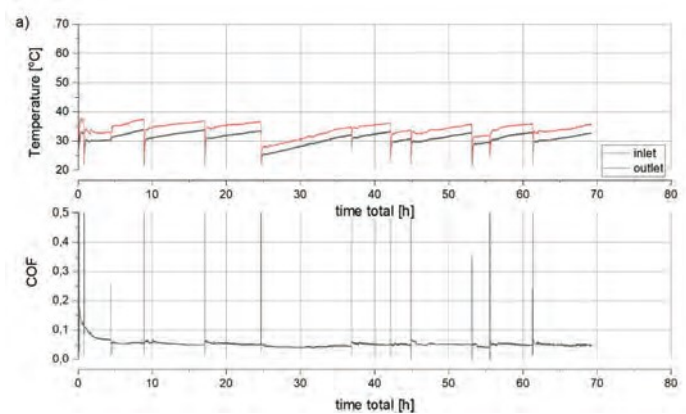
Fig. 9. Temperature of the water at the inlet and outlet sides of the bearing, and coefficient of friction (COF) for a classic bearing with a rubber bush with grooves around the entire circumference, under clean water lubrication (bearing 1a*)

The results of testing 27 different sliding couples are presented below. The testing of each bearing took on average two weeks, and the full series of tests took almost a year. For each material pair, we began by testing the couple under clean water lubrication conditions with a typical geometry for a given solution (Fig. 3). During the bearing operation, which lasted 70 h, the friction force was measured and recalculated to give the coefficient of friction (COF) and the temperature of the water flowing through the bearing on the supply and outlet sides. Lubrication with a liquid containing hard solid particles of mineral origin in the case of a metal sliding pair is accompanied by a very intense process of crushing solid particles, causing a temperature rise [10]. In the case of bearings with non-metal, more flexible bushings, the wear process was different; after adding the contaminants, the resistance to movement in the bearing increased, but the

particle crushing process was not intensive. The wear process was accompanied by a visible increase in temperature over the entire system, which was due, among other things, to the small volume of the lubricant system, which had a volume of only 10 l. The temperature and COF charts presented below were acquired for a classic, popular solution, a rubber bearing with grooves made around the entire circumference (Figs. 9 and 10), and the low intensity of the wear process is visible. A comparison of the temperature measurement results clearly shows an increase in the temperature of the lubricant flowing through the bearing. In the case of clean water, this increase is about 4°C, whereas for contaminated water it is about 6°C. This is undoubtedly due to the greater resistance to movement in the case of lubrication with a liquid containing solid particles compared to pure water.

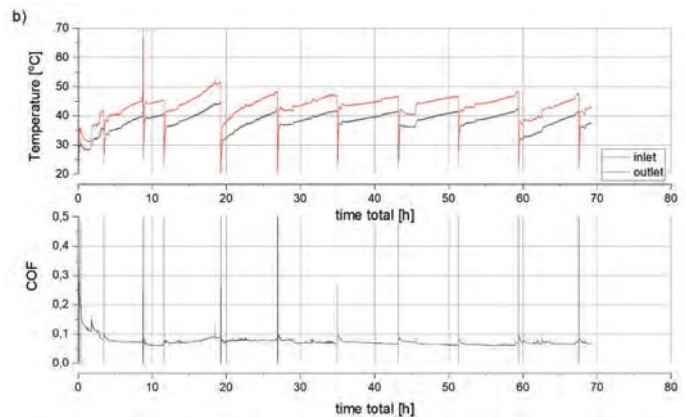
Fig. 10 Temperature of the water at the inlet and outlet sides of the bearing, and coefficient of friction (COF) for a classic bearing with a rubber bush with grooves around the entire circumference, under contaminated water lubrication (bearing 1a)

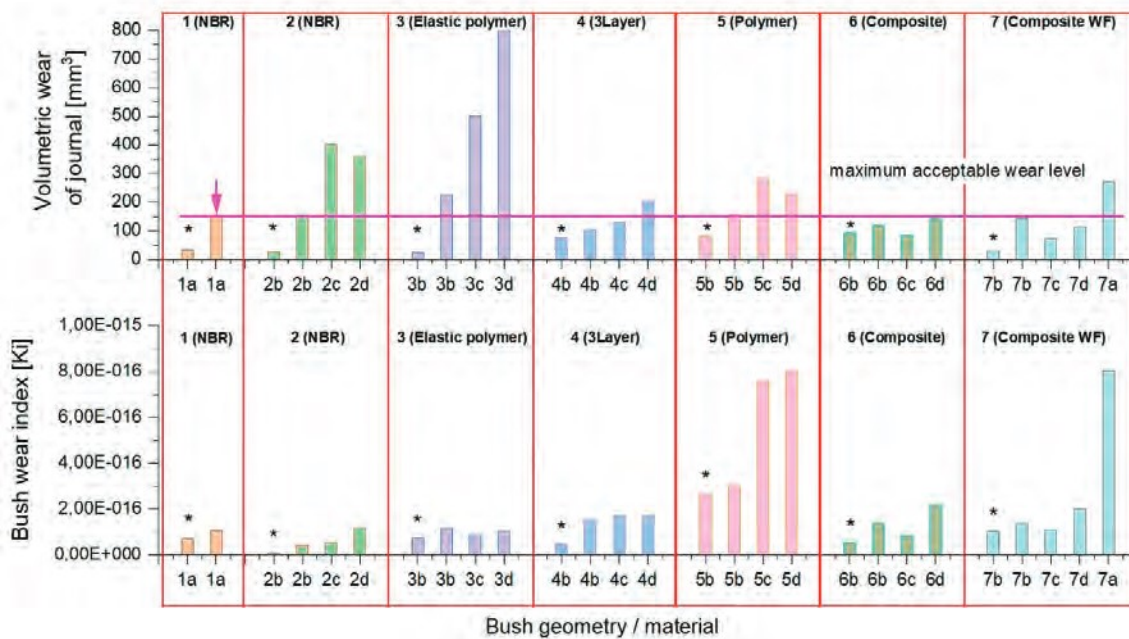
Fig. 11. Summary of wear results for shaft journals and bearing bushes, for varying sliding couples and geometries (* indicates tests performed with clean water)

The reference line showing the maximum acceptable wear level is marked on the volumetric journal wear comparison chart above. This is conventionally used to show the level of wear recorded for the classic solution, i.e. a bearing with a rubber bushing with through lubrication grooves on the

circumference. It is known from experience that in many countries, a five-year service life for this type of bearing is considered satisfactory; after this period of time, the propeller shaft is dismantled and the bearing journals are regenerated by grinding or replaced with new ones. This is time-consuming and expensive, but it ensures reliable operation over the assumed five-year period. The overall cost of such an operational strategy is acceptable for the shipowner because the rubber bushing itself, especially if it is mounted in a composite sleeve, is not much more expensive than bronze or brass.

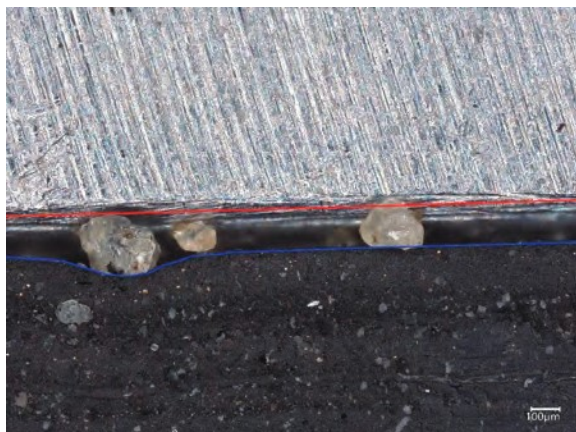
Fig. 12. Contact surface of the steel-NBR pair, with solid particles of mineral origin between them, showing the local deformation of the flexible NBR.

It was found that the forces exerted on the particle were not large enough to crush it, and that it rolled between the shaft journal and the bushing. The local deformation of the bush is shown in the microscopic photo below of a specially prepared model (Fig. 12). This concept helps to explain why on elastic bearing bushes only large scratches probably made by larger hard particle are easy to notice (fig. 13, 2b and 4b). For harder bushes process of crushing a particles results intensive wear especially when hydrodynamic properties are poor because of lubrication grooves located in lower half of the bearing bush (fig. 13, 6d and 7a).

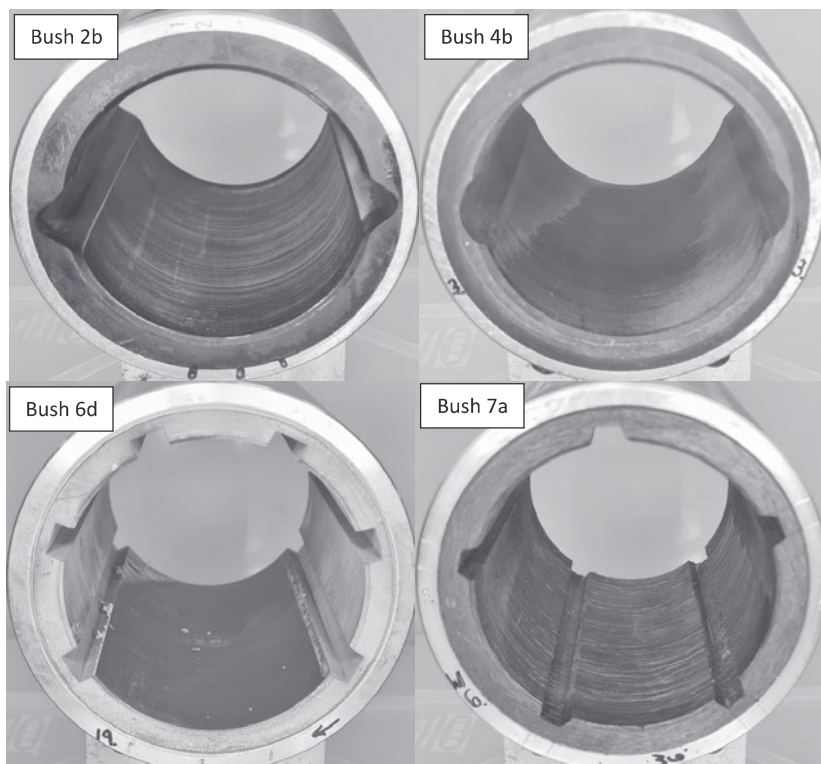
Fig. 13. Selected group of tested bearing bushes; 2b- NBR with scratches on surface, 4b- 3 layer bush with smoothed surface and visible contact zone, 6d - polymer bush with wear zone between grooves, 7a- composite with deep worn zone - visible contact zone (dark)
