# TECHNICAL ASSESSMENT OF 120-YEAR-OLD RAILWAY RIVETED TRUSS BRIDGE

**Abstract.** A 120-year-old railway truss bridge over the Bóbr River, Poland, is investigated in this paper from the mechanical and chemical properties of the materials by testing of old steel samples in a lab – through geodetic measurements, bathymetric measurements of the riverbed and dynamic measurements of bridge spans under service load – to the analysis of structural behaviour by finite-element modelling. The mechanical and chemical properties of the structural old steel are investigated by testing steel elements extracted from the old bridge. Structural analysis shows that the bridge is eligible for renovation or replacement for a new one due to unfulfilled today's load requirements in terms of bearing capacity. The paper begins with a survey of chosen literature carried out on the investigation of the old steel railway bridge's subject matter. This paper can provide scientists, engineers, and designers with an experimental and structural basis in the field of old steel riveted railway truss bridges.

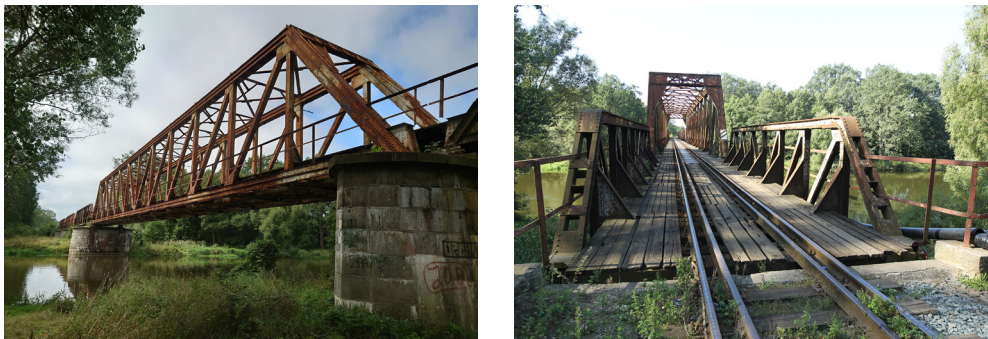
Figure 1. View on railway truss bridge

The railway riveted truss bridge (see Figure 1), which is the subject of this study, is located over the Bóbr River, Poland. The year of construction of the bridge was 1904 (see Figure 2), while in 1957 the bridge was completely renovated. The renovation covered cleaning of corrosion and applying protective paint coatings, as well as replacing the deck sheathing. After nearly 50 years of service, it is necessary to verify that the bridge meets today's load requirements in terms of bearing capacity, and serviceability state and make decisions on a range of reconstruction and repairs.
