Mechanism of hydrogen enhanced-cracking of high-strength steel welded joints

J. Ćwiek*, A. Zieliński

Faculty of Mechanical Engineering, Gdańsk University of Technology,
ul. Narutowicza 11/12, 80-952 Gdańsk, Poland

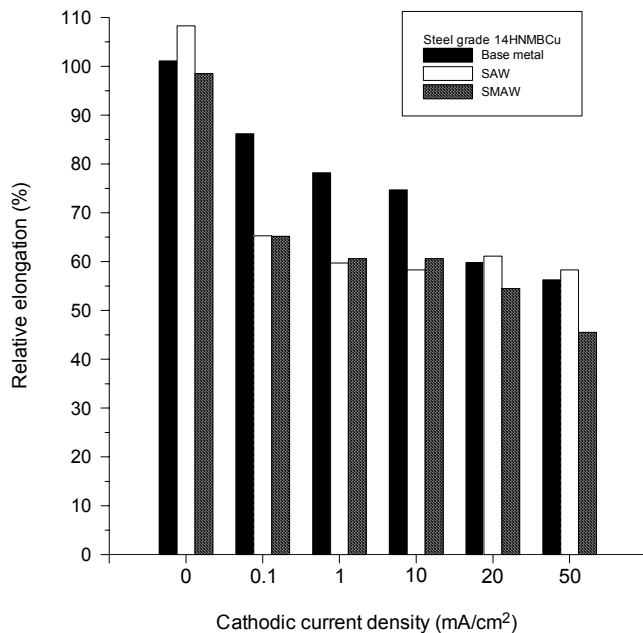
Fig. 1. Relative elongation versus cathodic current density for 14HNMBCu steel and its welded joints

Elongation and reduction in area were chosen as measures of hydrogen embrittlement. Then, relative parameters determined as

the ratio of the appropriate value measured in air to that measured in artificial sea-water were calculated and presented as bar charts (Fig. 1-2).

Observed decrease of relative values of elongation, and reduction in area with the increase of current density exhibits a certain minimum. Further increase of current density does not cause higher degradation. The loss of elongation was as high as 10% for base metal, and 35% for welded joints. Reduction in area decreased of 40% for base metal, and 55-75% in the case of SMAW and SAW welded joints respectively.

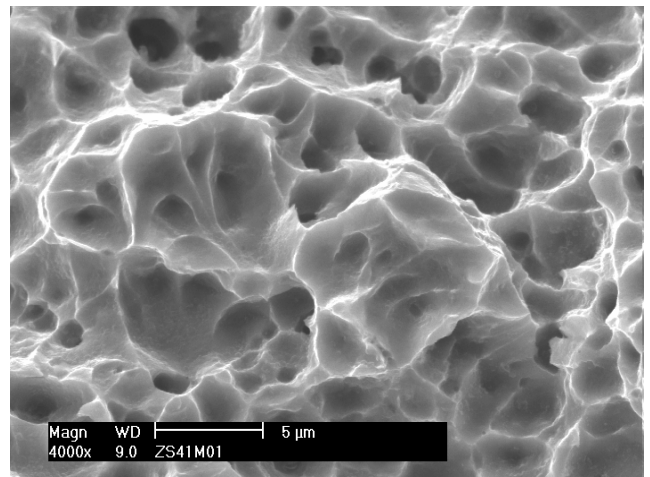
Fig. 3. SEM image of the fracture surfaces of welded joint (SMAW) of 14HNMBCu steel. SSRT test in seawater $i = 0.1 \text{ mA/cm}^2$

Fracture surfaces of failed samples were investigated with the use of the scanning electron microscope (SEM) to determine mode of fracture. Examples of fractographic observations are shown in Fig. 3-4.

Failure of samples with welded joints occurred always in weld metal, where strength was lower comparing to base metal. The reduction of ductility by hydrogen was accompanied by a change in fracture mode. For samples tested in air crack growth occurred in a ductile mode with microvoid coalescence and quasi-cleavage fracture. For samples tested in sea-water transgranular brittle mode with quasi-cleavage and cleavage fracture was observed. At higher cathodic current densities the presence of hydrogen induced microcracks and flakes appeared (Fig. 4).

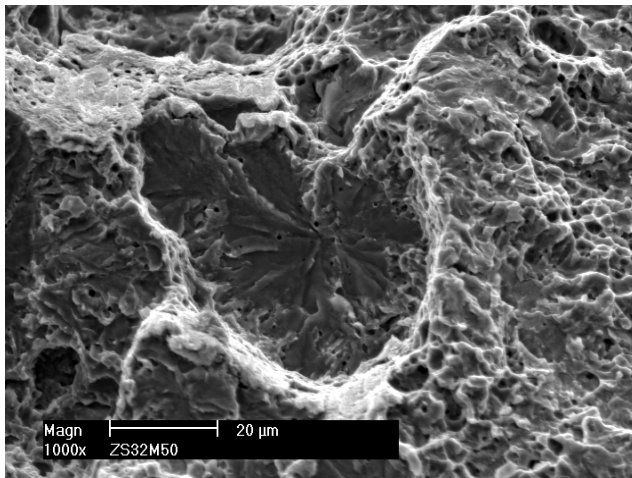
Fig. 4. SEM image of the fracture surfaces of welded joint (SAW) of 14HNMBCu steel. SSRT test in seawater $i = 50 \text{ mA/cm}^2$
