# Mechanism of hydrogen enhanced-cracking of high-strength steel welded joints

J. Ćwiek\*, A. Zieliński

Faculty of Mechanical Engineering, Gdańsk University of Technology,  
ul. Narutowicza 11/12, 80-952 Gdańsk, Poland

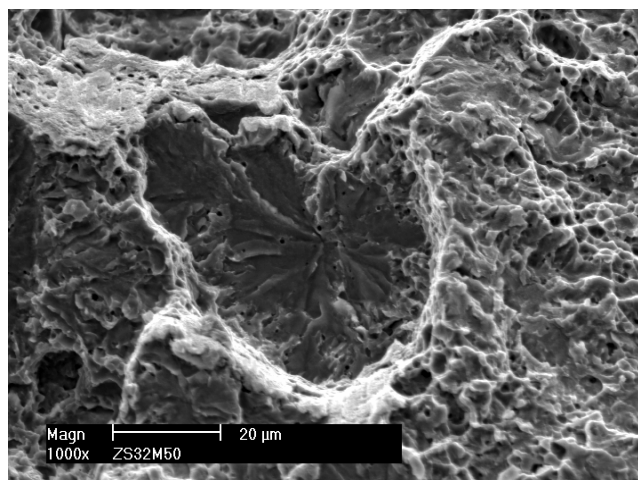
Fig. 4. SEM image of the fracture surfaces of welded joint (SAW) of 14HNMBCu steel. SSRT test in seawater  $i = 50 \text{ mA/cm}^2$

Fracture surfaces of failed samples were investigated with the use of the scanning electron microscope (SEM) to determine mode of fracture. Examples of fractographic observations are shown in Fig. 3-4.

Failure of samples with welded joints occurred always in weld metal, where strength was lower comparing to base metal. The reduction of ductility by hydrogen was accompanied by a change in fracture mode. For samples tested in air crack growth occurred in a ductile mode with microvoid coalescence and quasi-cleavage fracture. For samples tested in sea-water transgranular brittle mode with quasi-cleavage and cleavage fracture was observed. At higher cathodic current densities the presence of hydrogen induced microcracks and flakes appeared (Fig. 4).
