## NON-DESTRUCTIVE DIAGNOSTICS OF CONCRETE CANTILEVER BEAM AND SLAB BY IMPACT ECHO METHOD

Magdalena RUCKA<sup>1</sup>, Krzysztof WILDE<sup>1,2</sup>

<sup>1</sup> Department of Structural Mechanics and Bridge Structures, Faculty of Civil and Environmental Engineering, Gdansk University of Technology

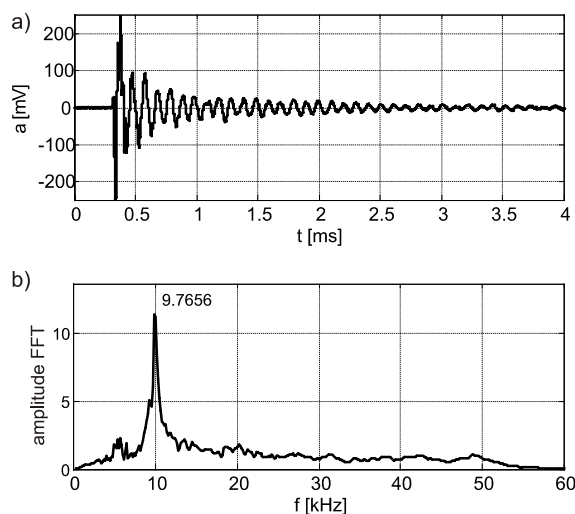
Fig. 9. Acceleration signals measured in point 98: a) in time domain; b) in frequency domain

Data analysis was carried out in frequency domain by interpretation of spectra obtained from time domain signals. Fig. 9 shows example of signal registered in point no. 98. In the frequency domain, one distinct peak dominates of frequency 9.77 kHz, what is equivalent of the thickness frequency  $f_h$ . By knowing frequency and the slab height P-wave speed can be determined from Eq. (1). Distribution of wave speeds were relatively regular with all measured point and the average value was 4100 m/s.
