Operational causes of fatigue failures within passages of gas turbine engines

Zbigniew Korczewski, Assoc. Prof.
Gdansk University of Technology

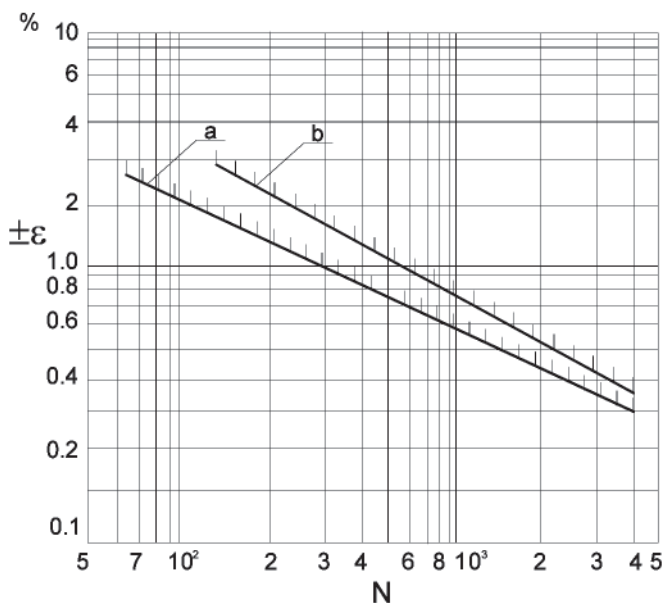
If low-cycle fatigue characteristics of a structural material are known it can be possible to easily determine a number of cycles after which surface cracking may happen, depending on a single amplitude value of the strain ϵ which occurs during one heating-cooling cycle of the material operation, Fig. 8.

Fig. 8. Low-cycle fatigue characteristics: ϵ – strain (single amplitude), N – number of cycles (heating - cooling), **a, b** – fatigue limit (shown for two different materials)
