DYNAMIC STATE ASSESSMENT OF THE WATER TURBINE WITH THE POWER OF 600 kW

Grzegorz ŻYWICA, Paweł BAGIŃSKI, Łukasz BREŃKACZ

Institute of Fluid-Flow Machinery, Polish Academy of Sciences
80-231 Gdansk, Fiszerka 14 str., gzywica@imp.gda.pl

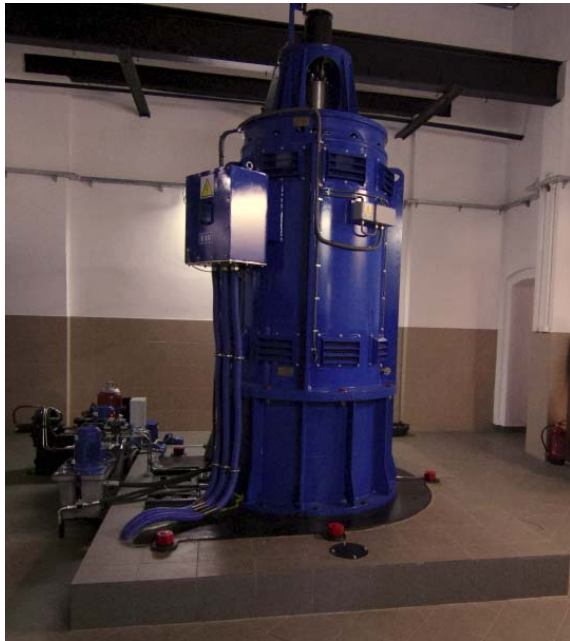
Fig. 2. Tested turbine set in a technical room located in the hydroelectric power plant

power plant. The company has asked the Institute of Fluid-Flow Machinery PAS in Gdansk, expressing doubts about the quality of the machinery's elements and the proper operation of the turbine set in modernized hydroelectric power plant. After upgrading the power plant the exploited Francis turbine was replaced by a modern Kaplan turbine. It turned out that the work of the new turbine set is accompanied by higher noise and vibration levels than before the replacement.

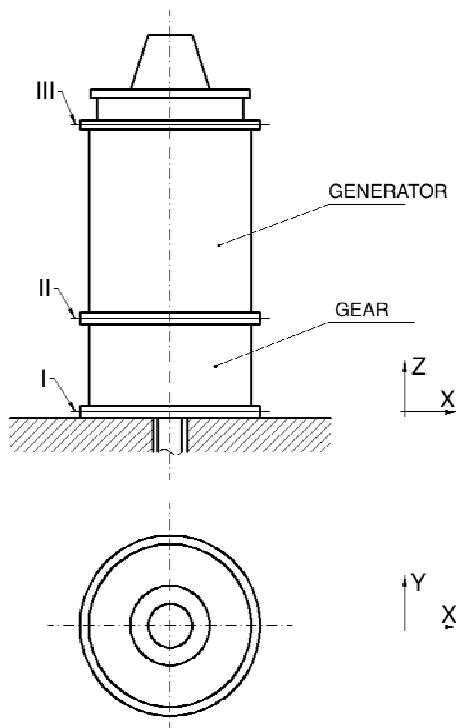
Fig. 3. Scheme of the turbine set with the coordinate system

The measurements were carried out in three measurement nodes, and each of them was measured in three directions consistent with adopted axes (Fig. 3). This represented a total of nine measurement locations (points). Measurement nodes were located within the upper bearing of the turbine shaft (I) and the lower (II) and the upper (III) bearing of the generator's shaft. Closed machine housings prevented a direct measurement of vibrations on the bearings, and therefore according to the standards, the measurement points were located on steel flanges connected to the bearing support housings. Due to the construction of turbine set, it was

impossible to perform measurements within the lower bearing of the turbine shaft.
