DYNAMIC STATE ASSESSMENT OF THE WATER TURBINE WITH THE POWER OF 600 kW

Grzegorz ŻYWICA, Paweł BAGIŃSKI, Łukasz BREŃKACZ

Institute of Fluid-Flow Machinery, Polish Academy of Sciences
80-231 Gdansk, Fiszerka 14 str., gzywica@imp.gda.pl

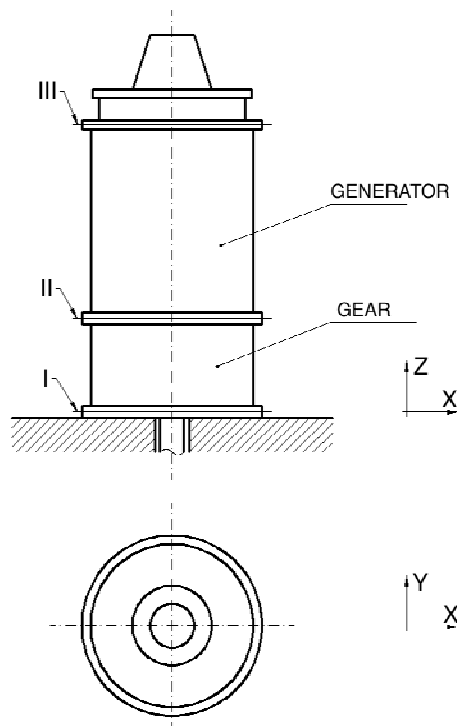
The measurements were carried out in three measurement nodes, and each of them was measured in three directions consistent with adopted axes (Fig. 3). This represented a total of nine measurement locations (points). Measurement nodes were located within the upper bearing of the turbine shaft (I) and the lower (II) and the upper (III) bearing of the generator's shaft. Closed machine housings prevented a direct measurement of vibrations on the bearings, and therefore according to the standards, the measurement points were located on steel flanges connected to the bearing support housings. Due to the construction of turbine set, it was

impossible to perform measurements within the lower bearing of the turbine shaft.

Fig. 3. Scheme of the turbine set with the coordinate system
