## Studies of the mechanism of metal dusting of 10CrMo9-10 steel after 10 years of operation in the semi-regenerative catalytic reformer

The purpose of this paper is to present a metal dusting mechanism for 10CrMo9-10 steel operated for 10 years in the semi-regenerative catalytic reformer.

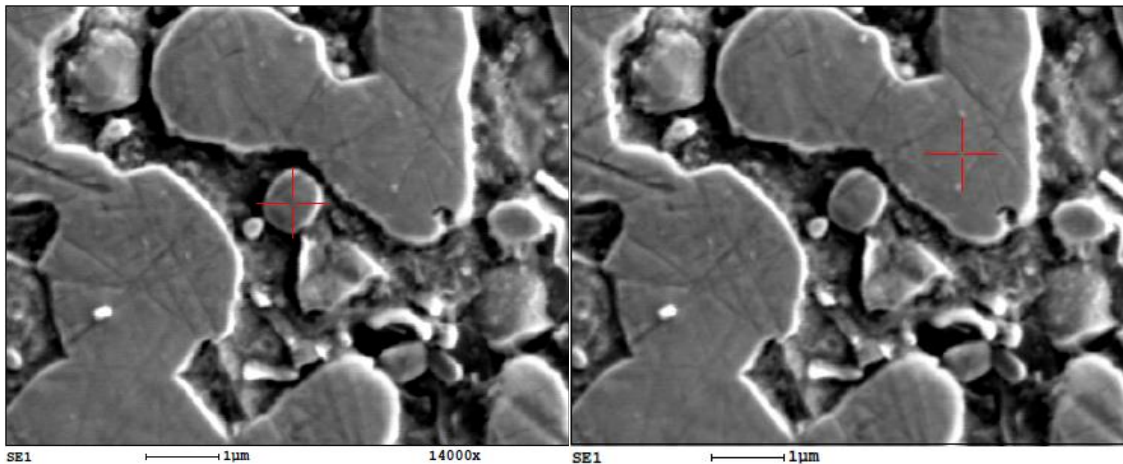
tube are shown in Fig. 12. As is apparent from Fig. 12, the content of chromium and molybdenum in precipitates increases with increasing distance from the inner surface of the tube.

Fig. 12. Content of the chromium, molybdenum and iron in the carbides as a function of distance from the inside surface (IS) of the tube

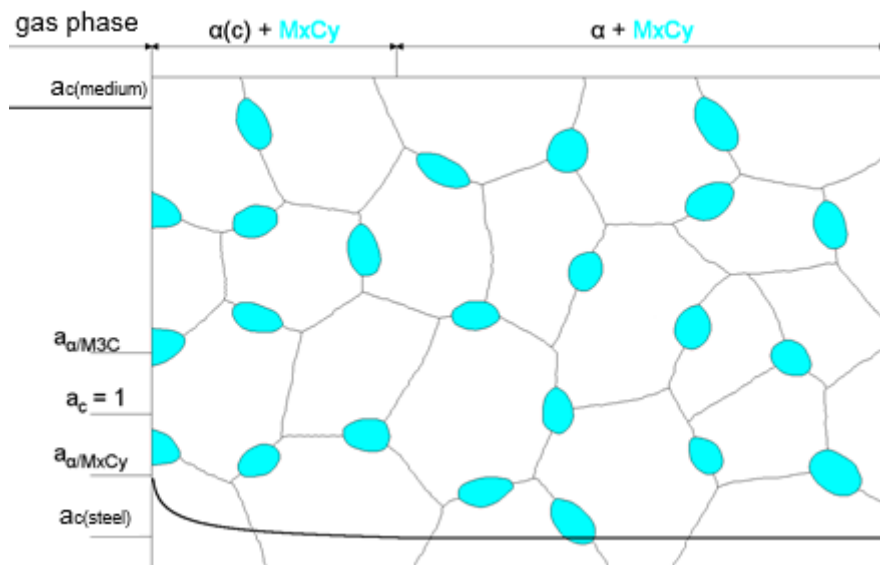
1. 10CrMo9-10 steel in the initial state i.e. after normalizing and high tempering, has a microstructure composed of ferrite  $\alpha$  and alloy carbide  $M_xC_y$  ( $M_2C$ ,  $M_6C$ ,  $M_7C_3$ ). As a result of thermal decomposition of hydrocarbons in the gaseous phase, the free carbon atoms create, which leads to increased carbon activity  $a_c$  at this phase. Free carbon atoms are adsorbed on the surface of the metallic phase, then they are absorbed and diffuse into the steel. The carbon activity in the surface layer of steel increases and ferrite alloy supersaturated by carbon  $\alpha$  (C) is formed, as schematically shown in Fig. 9.

Fig. 9. Stage I - increase the carbon activity in the surface layer and the creation of ferrite alloy supersaturated by carbon (color: online only)

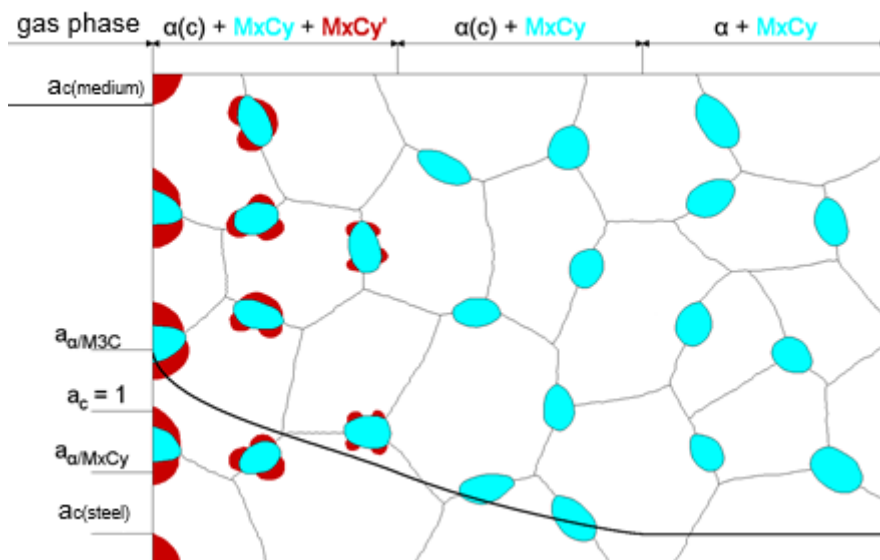
2. The increase in carbon activity greater than the activity of the equilibrium of  $MxCy$  carbide formation ( $a_{\alpha(c)}/MxCy$ ) causes that at  $\alpha$ /primary carbides  $MxCy$  interfaces, new carbides  $MxCy'$  evolve and grow, which leads to an increase in the particle size of carbide. The content of alloying elements - chromium and molybdenum in the ferrite decreases, resulting in their presence in the newly established carbides is dropping, and type of formed precipitates changes (see Fig. 10).

Fig. 10. Stage II - nucleation and growth of new carbide  $MxCy'$  at ferrite/primary carbides  $MxCy$  interfaces (color: online only)

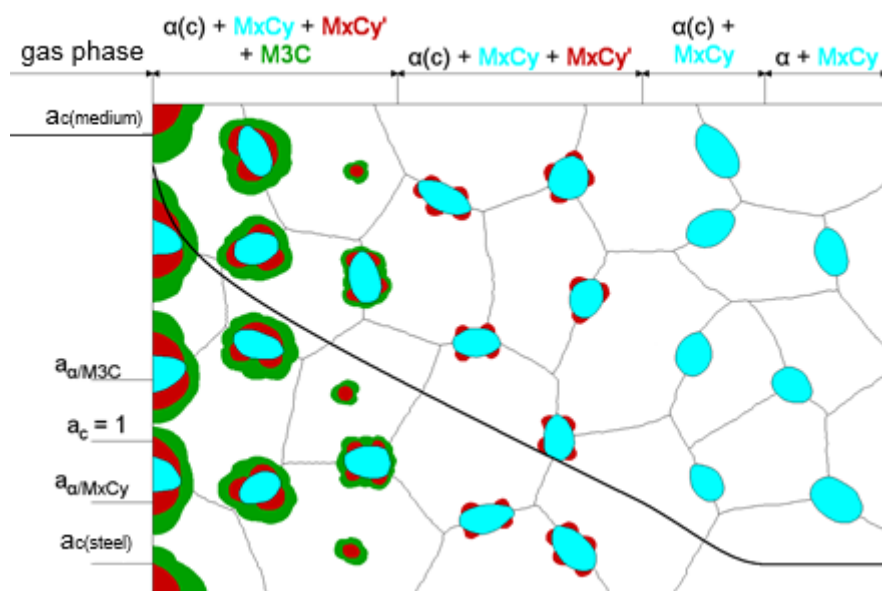
3. The process of carbides precipitation decreases the carbon activity, however, continuous, intensive transport of carbon to the steel causes a further increase in carbon activity in the surface layer. The carbon precipitation process also causes continuous reduction of the content of chromium and molybdenum in the ferrite. After a decrease in the content of alloying elements in the ferrite, and after exceeding carbon activity corresponding formation of  $M_3C$  carbides ( $a_C > a_{\alpha(C)/M_3C}$ ), process of nucleation and growth of low-alloy, metastable  $M_3C$  carbides progresses at ferrite/carbide interfaces (Fig. 11).

Fig. 11. Stage III - nucleation and growth of  $M_3C$  carbides at ferrite/carbides interfaces (color: online only)

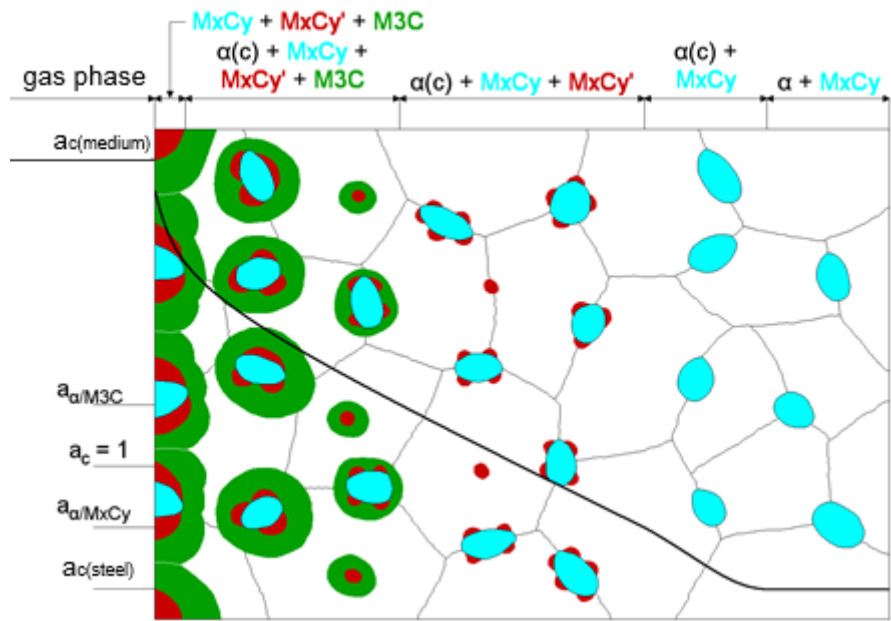
4. Lowering the content of alloying elements in the ferrite and the processes of formation subsequent carbides on the primary carbides, coagulation, spheroidization and diffusion of elements within the carbide phases cause the formation of large spheroidal particles with a complex structure, containing the less alloying elements, the closer the metal surface they are located. Directly below the surface, where the carbon activity is the highest, the process of nucleation and growth of carbides occurs most intensely. This results in a formation of thin zone consisting solely of connected to each other carbide precipitates of a complex structure ( $M_{23}C_6$ ,  $M_7C_3$ ,  $M_3C$ ), and the average chemical composition similar to that of the nominal steel. The predominant type of carbide in these precipitations is low-alloyed, metastable carbide  $M_3C$  type (Fig. 12).

Fig. 12. Stage IV - producing a thin layer consisting of connected to each other carbide precipitates (color: online only)

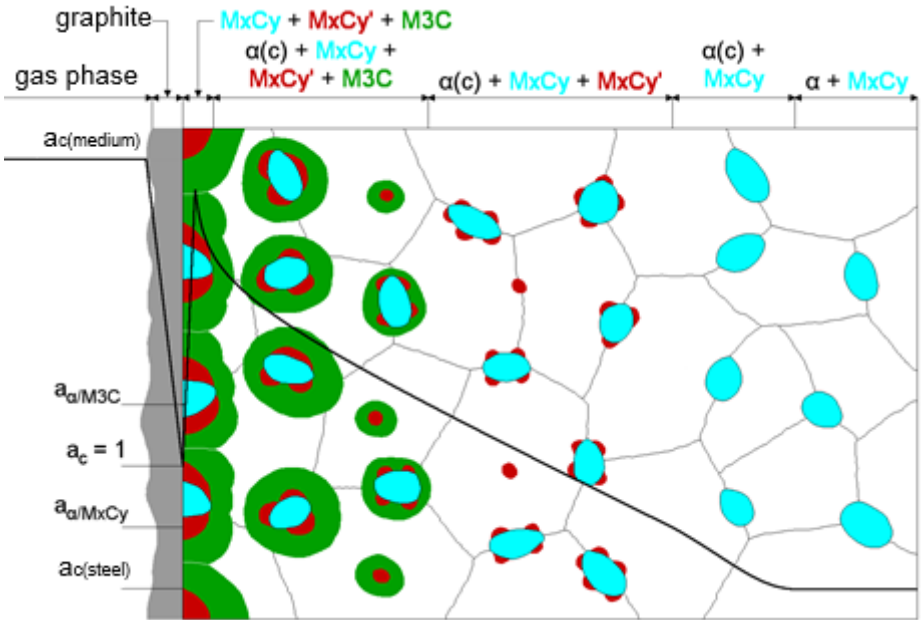
5. In a steel operating in temperature of about 600 °C, transport of carbon from a vapor phase to steel is restricted due to the limited diffusion of carbon in the carbide phase [20-23]. Carbon is deposited on the surface of steel in the form of graphite, and its activity at the graphite/carbides interface is reduced to  $a_c = 1$  (Fig. 13).

Fig. 13. Stage V - nucleation and growth of the graphite layer on the steel surface; lowering the carbon activity of the material located under a layer of graphite (color: online only)

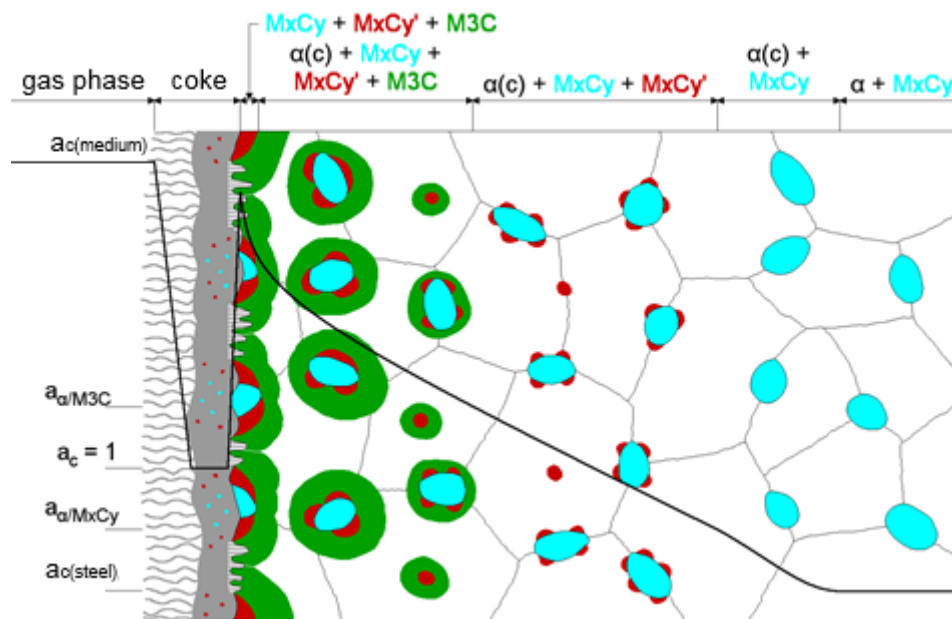
6. Present in surface layer, low-alloyed metastable  $M_3C$  carbide, where M is mainly Fe (meaning that it is approximately cementite) becomes unstable and it starts to disintegrate in accordance with the reaction:  $Fe_3C \rightarrow 3Fe + C$ . The released carbon atoms attach to graphite layer ingrowing into cementite and iron atoms diffuse through the graphite layer on the outside, in accordance with the decreasing concentration gradient, where they combine into molecules capable of catalyzing further deposition of carbon from the gas phase in the form of fibers (Fig. 14).

Fig. 14. Stage VI - destabilization and disintegration of low-alloy, metastable  $M_3C$  type carbides (color: online only)
