X-RAY COMPUTER TOMOGRAPHY STUDY OF DEGRADATION OF THE ZIRCALOY-2 TUBES OXIDIZED AT HIGH TEMPERATURES

The investigations of high-temperature oxidation of zirconium alloys, applied for fuel pellets in nuclear power plants, are usually limited to oxidation kinetics, phase transformations and microstructural characterization. The purpose of this research was to characterize the degradation phenomena occurring within oxide layer and at the interface oxide/metal, on internal and external Zircaloy-2 tube surfaces, below and over crystalline transformation temperature of zirconium oxides. The commercial tubes were oxidized at 1273 K and 1373 K in calm air for 30 min and then examined with a technique novel for such purpose, namely a high-resolution X-ray computer tomography. The light microscopy was used to examine the cross-surfaces. The obtained results show that the form and intensity of oxide damage is significant and it is in a complicated way related to oxidation temperature and on whether external or internal tube surface is studied. The found oxide layer damage forms include surface cracks, the detachment of oxide layers, the appearance of voids, and nodular corrosion. The oxidati

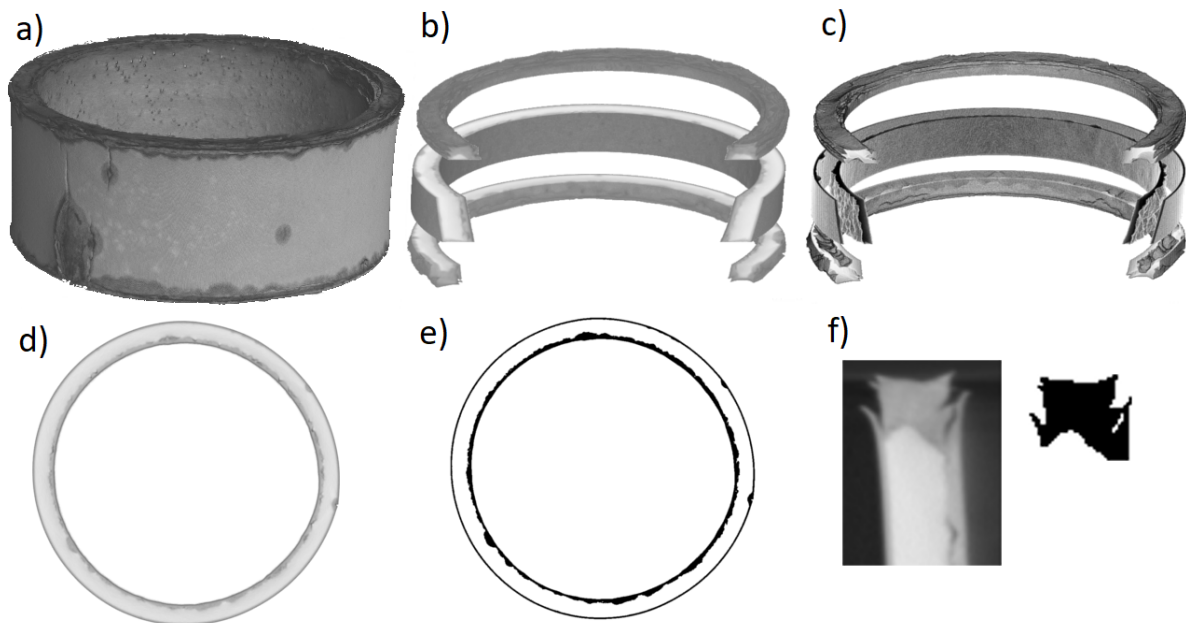
Fig. 1. a) X-ray tomography made the 3D view of sample oxidized at 1373 K and cooled in air, b) separated zones of an oxidized metal, c) separated zones of an oxide layer, d) view of the single slice of the transverse cross-section of the tube; e) binary image of the transverse cross-section of the tube, outer and inner oxide layers can be recognized, f) longitudinal cross-section of the tube and its binary image, the oxide layer at the top edge can be seen.

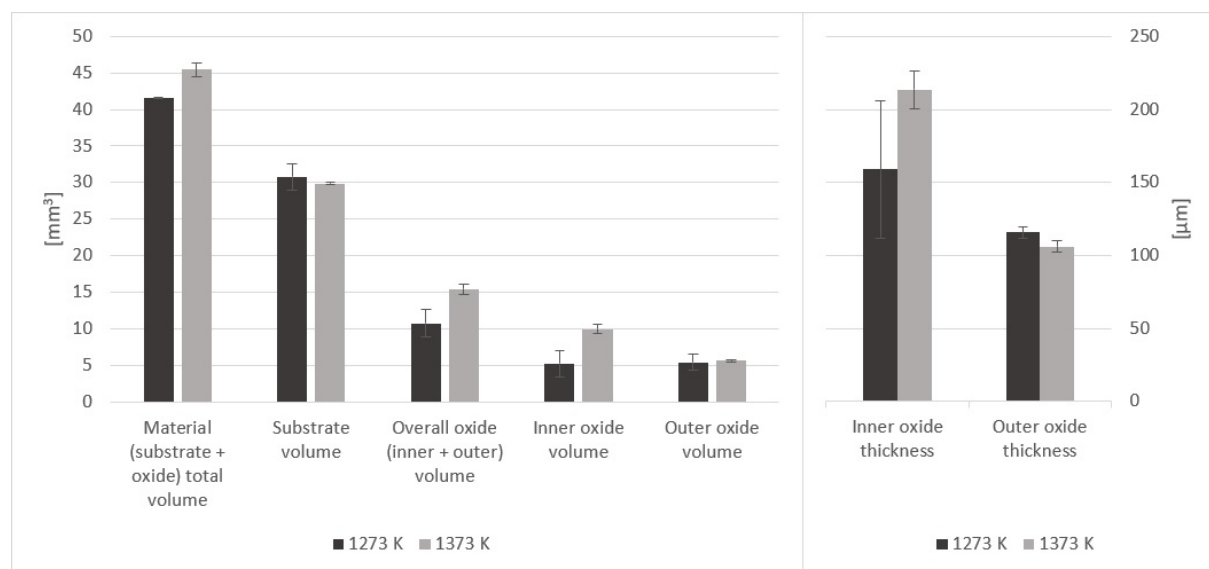
Relationships between the volumes and thickness of the oxide layers, and oxidation temperature and a place of oxidation (oxides grown on the internal or external surface of the tube, called later inner and outer oxides) are presented in Fig. 2. The increasing temperature resulted in an increasing oxide volume and thickness. Both surfaces revealed similar thickness of oxide layer after oxidation at lower temperature, and higher on internal surface after oxidation at 1373 K.

Fig. 2. Relation of the oxide layer volume and thickness on oxidation temperature and oxide layer placement (outside or inside the tube)

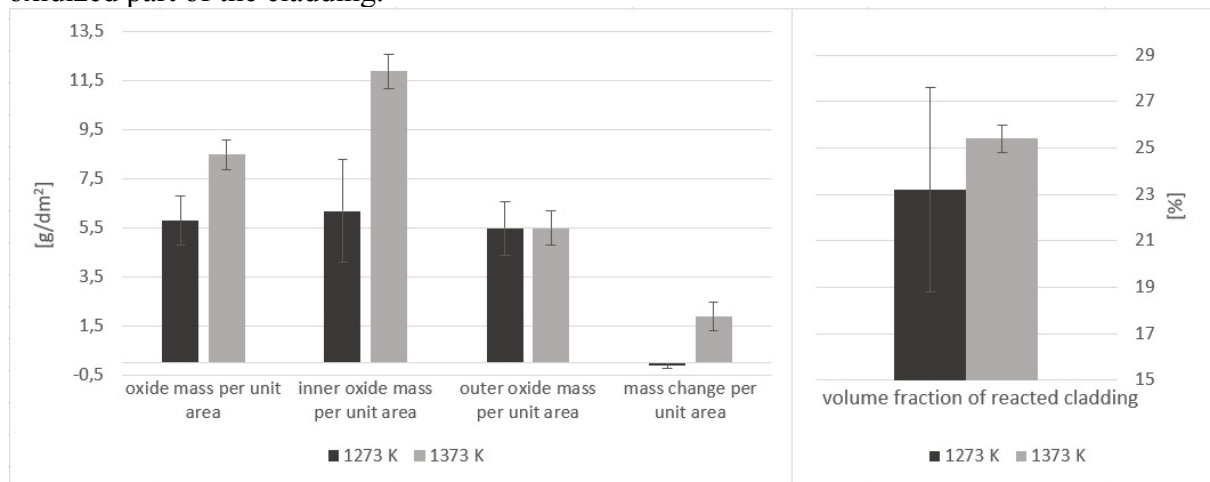
Based on the estimated number and volume of cracks in the oxide layer, the volume of oxide layer was arbitrarily reduced for each temperature and the place of layer, internal or external, e.g. about 20% for specimens oxidized at 1273 K. Figure 4 presents a change in mass per unit area in the middle section of the oxidized tube in comparison to the non-oxidized sample. The presented values were calculated based on the previously measured volumes of the middle section and volumes of oxide, and densities of the substrate alloy and the zirconium dioxide. The volume of reacted zirconium cladding determines previously oxidized part of the cladding.

Fig. 4. Oxide mass per unit area and volume fraction of reacted cladding obtained at different oxidation

The weight gains are consistent with the reference values for oxidation temperature of 1273 K, but after oxidation at 1373 K, they are slightly lower than reported so far [4,5,25]. This discrepancy is negligible and may be attributed to the specimen's geometry, different microstructure, difference between flat and curved surfaces, different environment (air instead of steam) and, in consequence, different oxide growth. The higher inner oxide thickness
