Assessment of technical condition and repair of steel structure elements on the example of fire damage in a warehouse building

Abstract. The paper analyses a case study on the structural assessment of warehouse building partially damaged by fire caused by external source (fire of lorries close to the building). The authors focus on the site investigations and laboratory test results prior to assessing actual condition of the structural elements. Both strengthening concept and repair procedure of a steel column are addressed here. A short literature survey in the paper regards fire damages and its impact on the entire structural systems and its members.

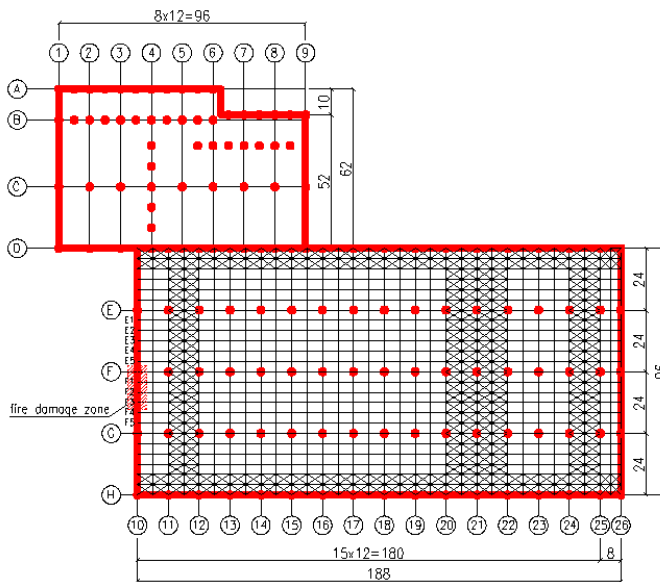
Fig. 3. Floor projection of warehouse building.

Geodetic measurement was aimed at displacement values and deformation of two selected I-section steel columns (denoted Sc1 and Sc2, see Fig. 3) affected visibly by fire. The measured displacements were analysed and compared to the allowable erection tolerances specified by EN 1090-2 [22]. Four types of erection tolerances were taken into

Based on geodetic measurements and determined deviations (see Table 1) it was generally found that the I-beam fire-impaired steel columns detect the allowable deviations contained in specified tolerances. It should be noted, that only for Sc1 column located in cross axis F1/10, the web undulation deviation Δ^4 insignificantly exceed standard manufacturing tolerances. It has been assumed that the indicated deviations are not significant, thus allow to apply standard procedures to determine the column's bearing capacity.
