On the current state of dovetail wall-corner joints in wooden Greek Catholic churches in Polish Subcarpathia with structural and sensitivity analyses

Izabela Lubowiecka¹, Tomasz Zybała¹, Grzegorz Bukal², Marcin Krajewski¹, Marcin Kujawa¹, Paweł Kłosowski¹

1) Department of Structural Mechanics, Faculty of Civil and Environmental Engineering, Gdańsk University of Technology, Gdańsk, Poland

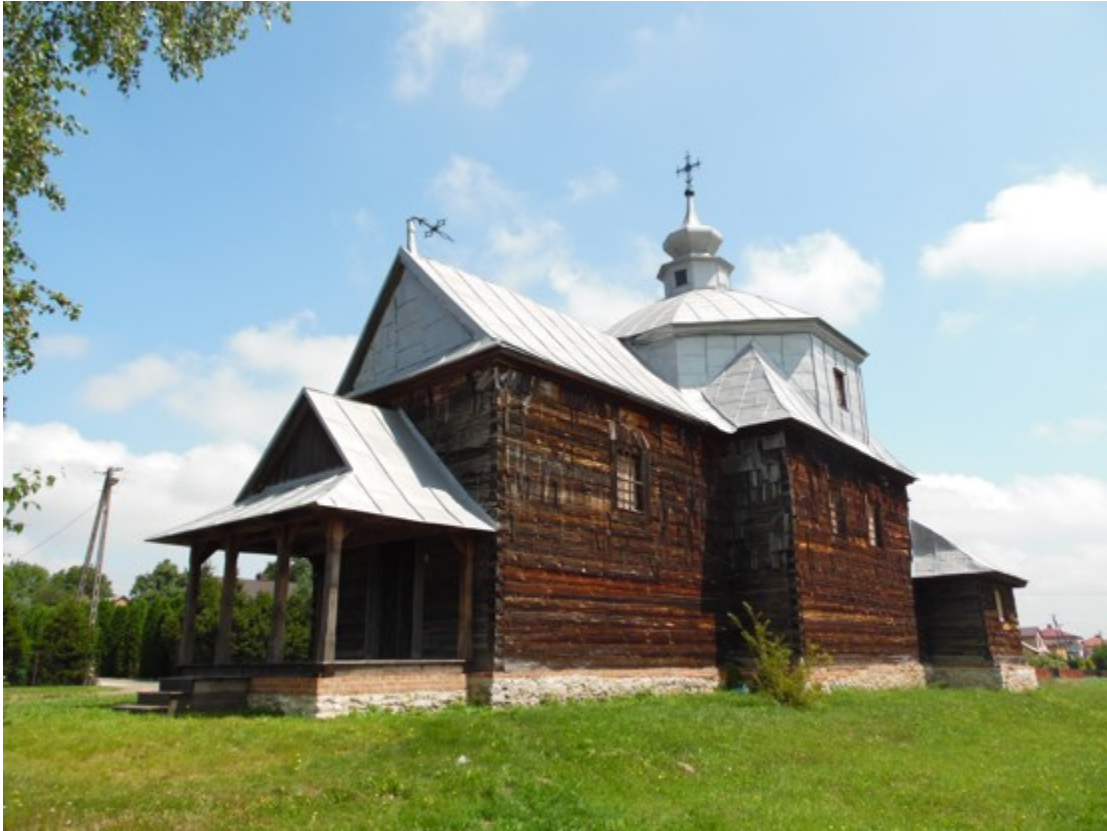
The current condition of the walls is good. The church has log walls with dovetail notches (Figure 6). The walls are made of wood beams with a rectangular cross-section of 21 x 30 cm. No significant moisture was found and the humidity of the corners remains at 12.2% on the south side and at 16.2% on the north side (Figure 7). The horizontal damp proof course in the foundations is not broken and the roof covering is rain-tight. There are some visible longitudinal cracks and a few transverse cracks in the beams. There also exist some signs of damage caused by insects and some minor local cavities in the wall structure (Figure 6). The vertical out-of-plane deviations of the walls are relatively small – from 0.46 cm to 0.53 cm. The internal angles have not changed since the church assembly - deformations inside and outside the building amount range from 88.6° to 91.5°. The same is true for the whole construction which has never been rebuilt and hence there are no additional loads on the walls. Moreover, the gravity ventilation of the facility is intact. At present the church is not in use but local authorities have designated a person responsible for taking care of it. Due to this the building is closed and protected against vandalism and the area around it is well kept.

Figure 2. The Church in Cewków.

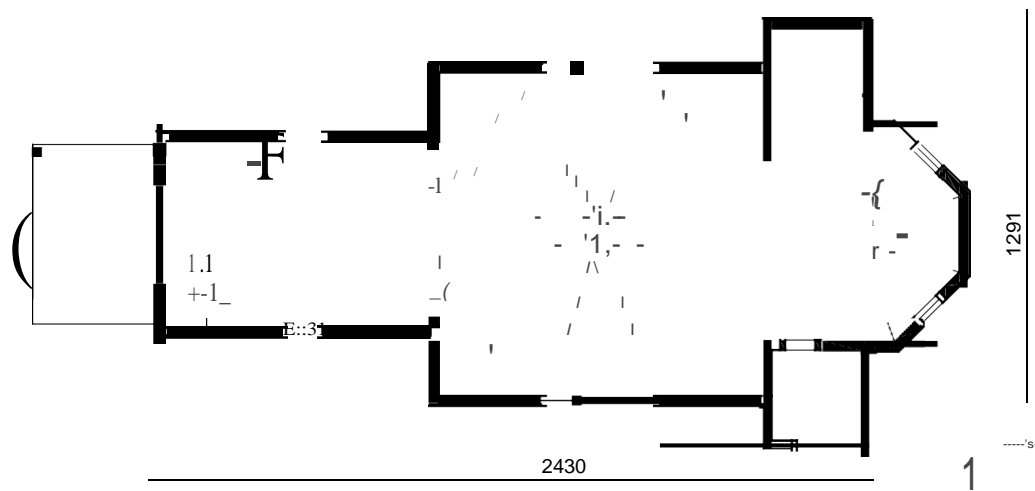
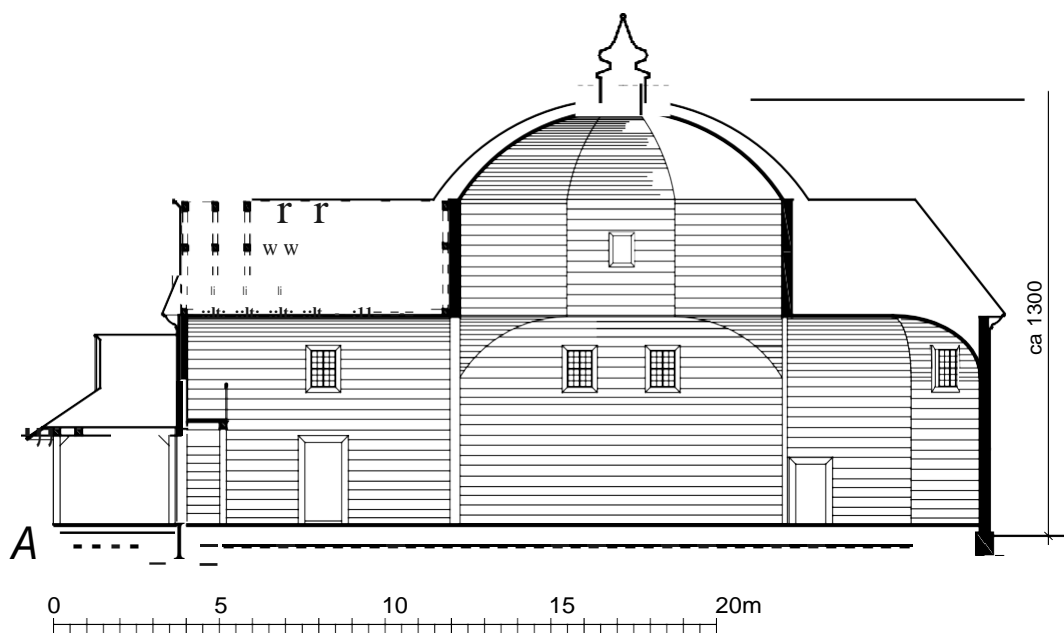
CEWKÓW

Figure 5. Longitudinal cross-section and plan of the church in Cewków.

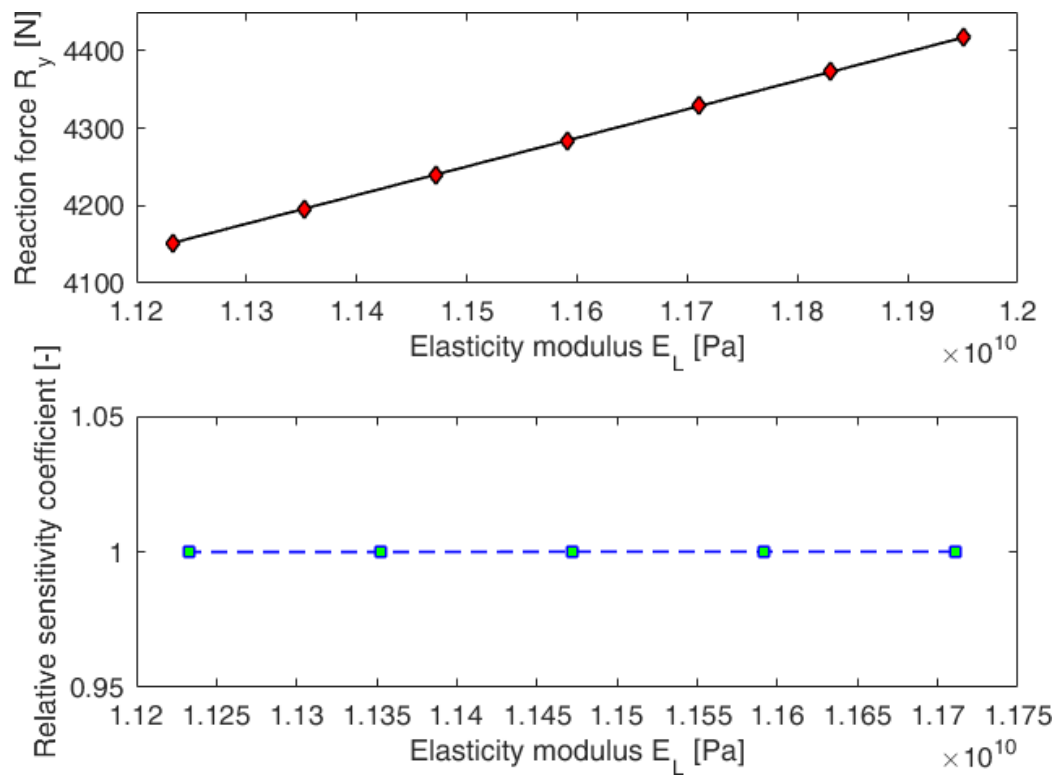
Two types of joint were considered in the study. First it was assumed that the joint is made of dry wood. In this case the Young's modulus does not differ much between old and new wood according to laboratory tests (internal report of Grant No. 2015/17/B/ST8/03260). The Young's modulus in the analysis varies from 11.233 GPa to 11.95 GPa. In the case of a parametric change of the material properties of the whole joint, the change of the reaction force is almost linear so the sensitivity is represented by a constant function (Figure 15). Here it will be represented by the relative sensitivity coefficient which is close to 1. In the second variant, the joint was built of old, damp wood but one of the five logs had been replaced with a new one. The elasticity moduli of

Figure 15. Sensitivity of reaction force due to variation of the modulus of elasticity in dovetail joint where all five logs have the same variable stiffness.
