# Causes of damage and methods of repairing floor made on polystyrene concrete

**Abstract.** The paper describes damages, tests and repair of the floor made on existing ceiling and expanded polystyrene concrete underlay. The floor was built on a reinforced concrete ceiling with an area of about 1050 m<sup>2</sup>. Significant damage in the form of cracks, detachments and unevenness was found in the floor. In order to determine the causes of damage, in situ tests and laboratory tests were carried out. It was found that the damage was caused by numerous performance errors. A test repair of the damage (4.7x6.0 m) was carried out, and then the repair method was applied on the entire floor surface.

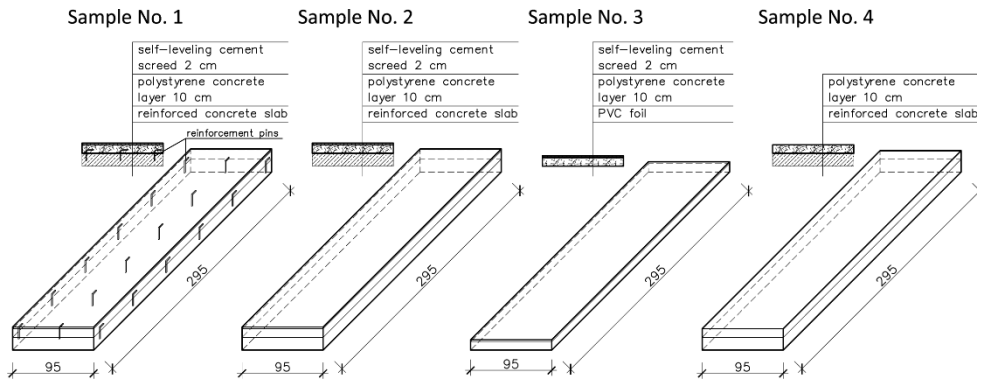
**Fig. 7.** Comparative test samples.

In order to determine the possible interaction between individual layers of the floor, four test specimen were prepared. Three of them were made on a 95x295 cm reinforced concrete slab, the last one on a PVC foil (Fig. 7). The first sample was reinforced with steel 12 mm pins, with 10 cm of a 30/50 EPSC overlay and 2 cm of self-leveling screed. The model reflected the existing floor. Sample no. 2, was identical to the first one with exclusion of reinforcement pins which were not installed. The model, in comparison to the first one, was used to determine the effect of the pins. In sample no. 3, a 30/50 EPSC was cast on a PVC foil and finished with a 2 cm layer of self-levelling screed. The model was used to determine the possible influence of slip membrane laid under the EPSC. The last sample, a 10 cm layer of 30/50 EPSC cast over a reinforced concrete slab. was made in order to determine the possible shrinkage. The specimen was left uncured and uncovered, untypically to standard practices. The samples are shown in Fig. 8 and Fig. 9.

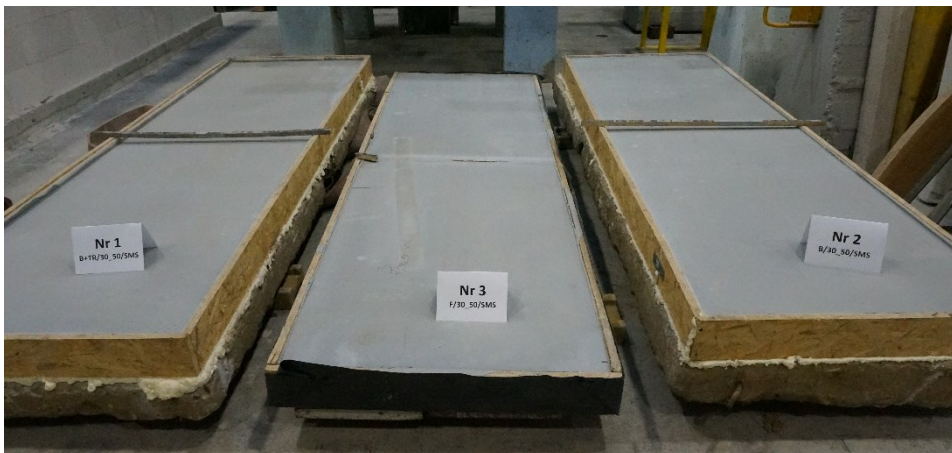
**Fig. 8.** Samples no. 1, 2 and 3.

The visual evaluation of the samples was being conducted for over 2 months. The observations lasted over 2,5 times longer than the time in which the cracks occurred in analyzed floor. After 49 days first three samples did not exhibit any signs of cracking. The last sample exhibited small shrinkage cracks. Local width of the crack reached between  $0.1 \div 0.5$  mm. The cracks on the surface of the EPSC occurred after two weeks due to lack of curing. The cracks are shown in Fig. 10.

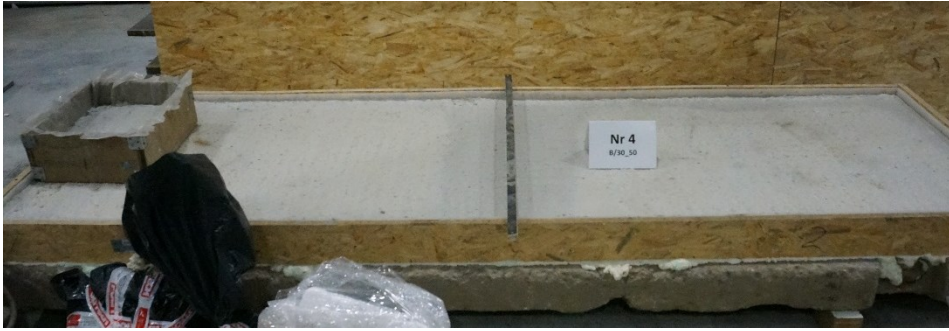
**Fig. 9.** Sample no. 4.

Comparative tests have shown that it is possible to make a self-levelling screed for the designed floor. Lack of curing resulted in the occurrence of cracks in the EPS concrete.

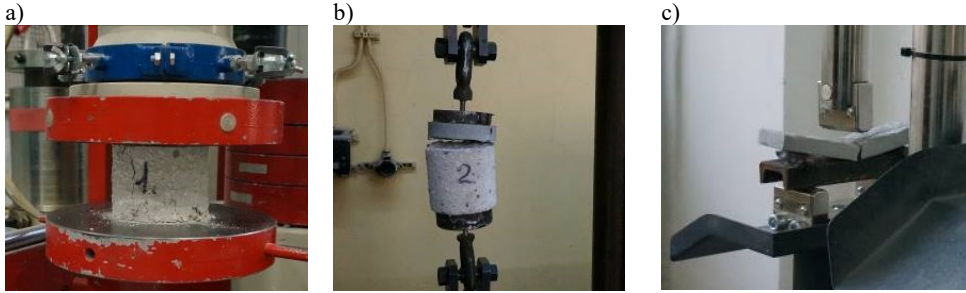
Conducted tests have determined that the materials used (p. 4.1) in the comparative laboratory tests meet the manufacturers recommendations in terms of compressive and flexural strength. Core samples from the damaged floor in majority also exhibited required

compressive and tensile strength. A single sample exhibited significantly lower flexural strength, while the other did not meet the tensile strength requirements.

**Fig. 12.** Laboratory tests: a) compressive strength test of the EPS concrete, b) tensile strength test of the EPSC+screed samples, c) flexural strength test of the screed.
