Causes of damage and methods of repairing floor made on polystyrene concrete

Abstract. The paper describes damages, tests and repair of the floor made on existing ceiling and expanded polystyrene concrete underlay. The floor was built on a reinforced concrete ceiling with an area of about 1050 m². Significant damage in the form of cracks, detachments and unevenness was found in the floor. In order to determine the causes of damage, in situ tests and laboratory tests were carried out. It was found that the damage was caused by numerous performance errors. A test repair of the damage (4.7x6.0 m) was carried out, and then the repair method was applied on the entire floor surface.

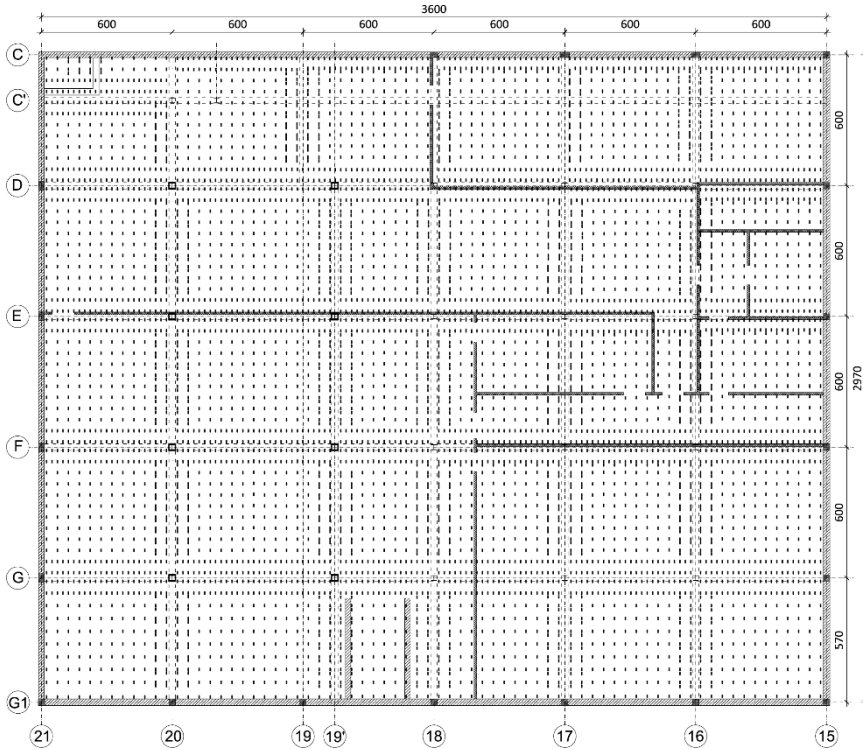
Fig. 1. Beam system and the location of reinforcement pins (connecting the existing ceiling, top layer and EPS concrete).

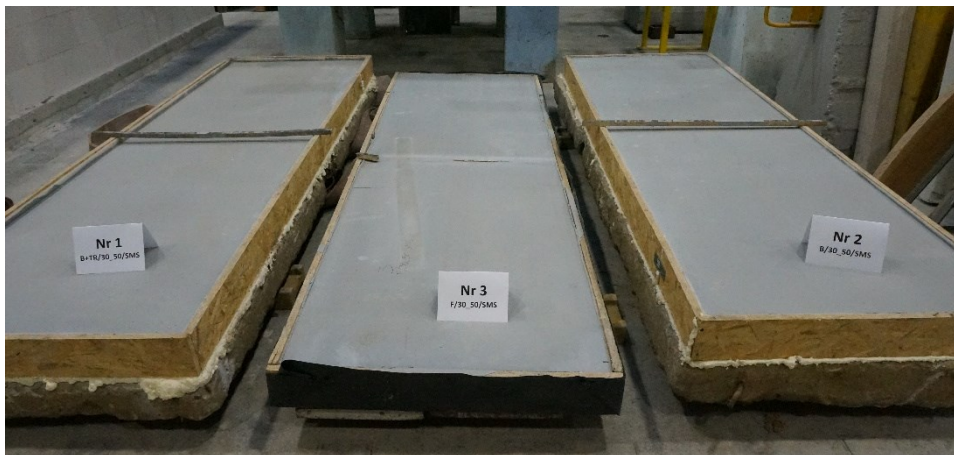
Fig. 8. Samples no. 1, 2 and 3.

The visual evaluation of the samples was being conducted for over 2 months. The observations lasted over 2,5 times longer than the time in which the cracks occurred in analyzed floor. After 49 days first three samples did not exhibit any signs of cracking. The last sample exhibited small shrinkage cracks. Local width of the crack reached between $0.1 \div 0.5$ mm. The cracks on the surface of the EPSC occurred after two weeks due to lack of curing. The cracks are shown in Fig. 10.
