Integrated Application of GPR and Ultrasonic Testing in the Diagnostics of a Historical Floor

Abstract: The paper presents the results of integrated ground penetrating radar (GPR) and ultrasonic testing (UT) measurements conducted on a historical floor in St. Nicholas' Church, Gdańsk, Poland. The described inspection was the first stage of the technical state assessment of the building. The aim of the study was the detection of underfloor air gaps, which were observed in a few trial pits. The condition of the ground under the floor was determined by localizing other inclusions such as rubble, human remains, brick walls and pipes. To identify the phenomenon of electromagnetic and ultrasonic wave propagation within the air gap, laboratory tests were conducted on physical models consisting of two concrete slabs stacked on top of each other and gradually moved apart to simulate a slot of varying thickness. The conducted research was supported by the numerical models of electromagnetic wave propagation. The obtained results showed that the integration of the GPR and UT methods provided an effective imaging of the floor and the area under it. Ultrasonic testing was proved to be a good t

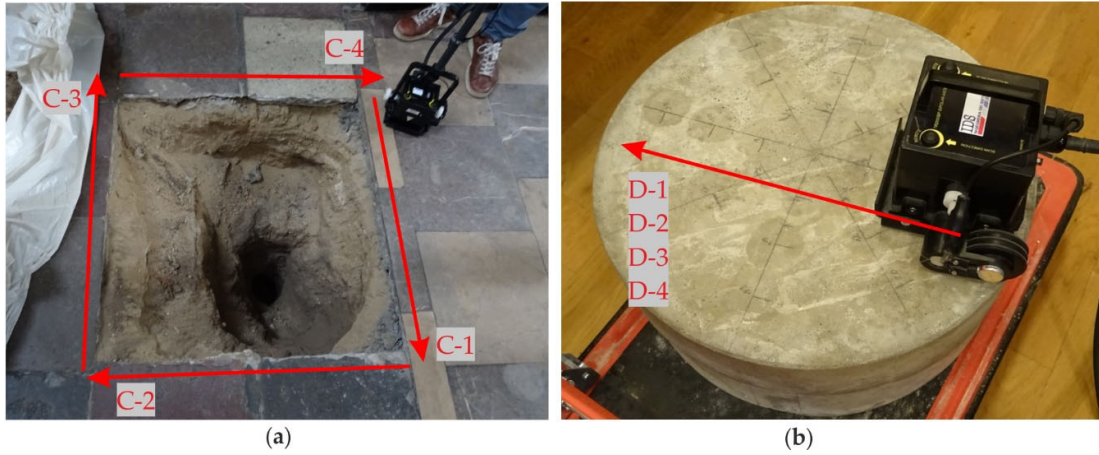
The conducted floor inspection reported in this paper was the first stage of investigations directed to assess the technical state of the church. NDT tests were performed on the floor of two aisles, south and north, as shown in Figure 1. In both aisles, the top floor layer was made of stone tiles measuring approximately 43 cm × 43 cm. In the central part of each aisle, tombstones were laid. The cross-section layers of the floor were identified in a few trial pits. One of the pits located in the north aisle is shown in Figure 2. Based on a visual inspection of the cross-section visible in the trial pit, particular layers in the floor were identified (Figure 3). It was found that the stone tiles laid on the cement mortar layer had a thickness of approximately 2–6 cm. Below was a layer of sand and ground backfill. It was also identified that at some edges, an air gap with a thickness of approximately 1–2 cm was visible below the cement mortar.

Figure 7. GPR traces registered along (a) edges of the trial pit (traces C-1 to C-4) and (b) the circular slabs with air gaps of varying thickness (traces D-1 to D-4).

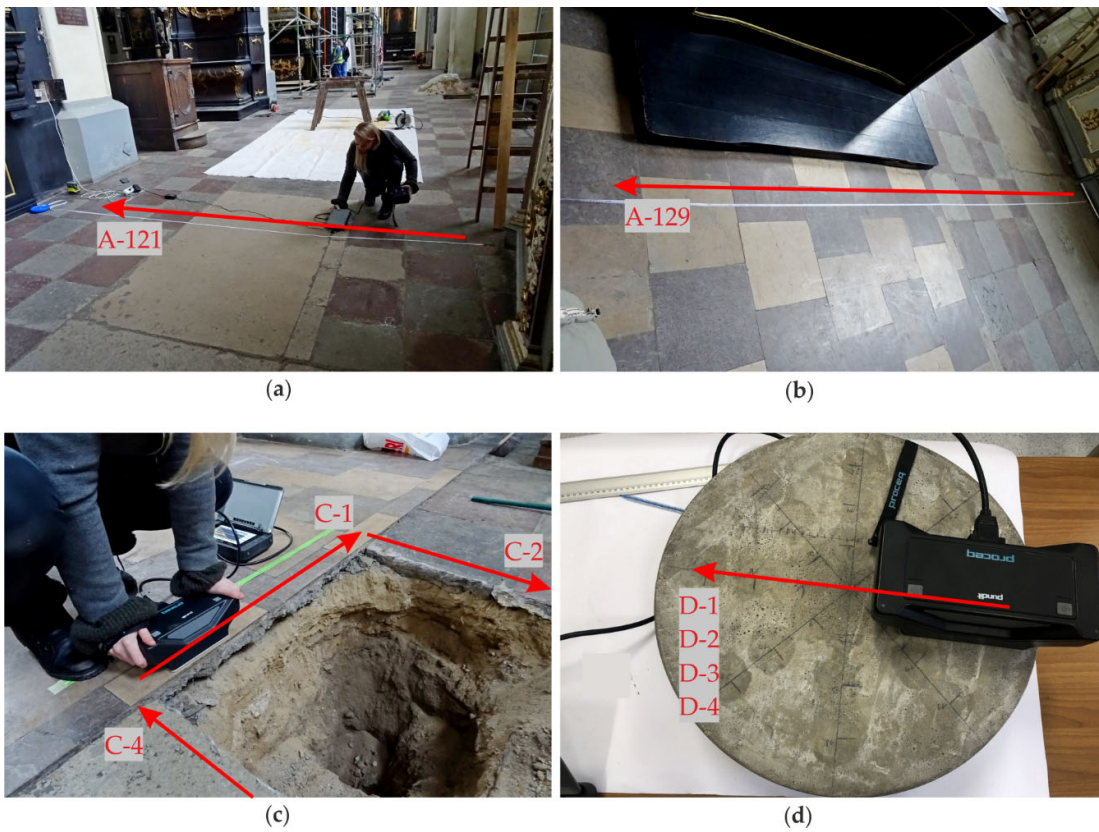
Figure 8. Ultrasonic measurements: (a,b) along traces A-121 and A-129 in the south aisle; (c) along edges of the trial pit; (d) along circular slabs.

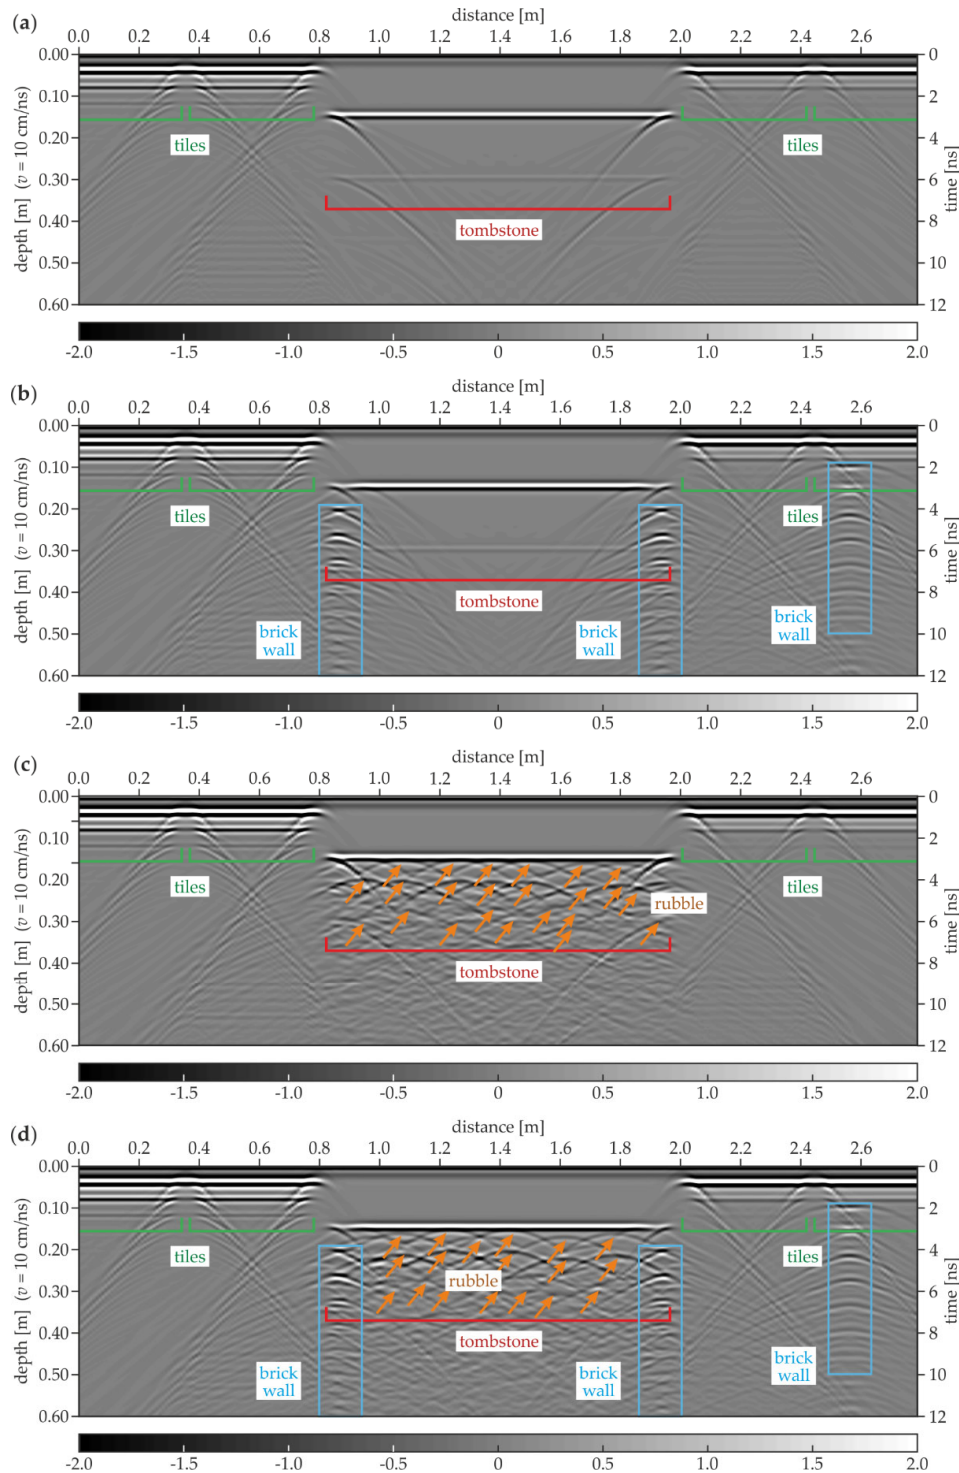
Figure 14 shows the GPR B-scans acquired in the numerical models of the considered floor. Taking into account the complexity of the analyzed medium, the electromagnetic wave velocity was set as constant and equal to 10 cm/ns. The strategy applied did not take into account the heterogeneity factor. Therefore, the results were only approximations of the real subsurface geometry. However, this fact did not disable the proper interpretation of the results. In the model #1.1 (Figure 14a), the positions of the stone tiles were clearly identified based on the line patterns denoting the reflections from the vertical joints between tiles. The half hyperbolas at the ends of the tombstone were visible in the center of the scan. The lower faces of the tiles and the tombstone were located at the depths of 0.04 and 0.15 m, respectively. Some additional reflections with a lower intensity were observed below, indicating the further wave reflections from the analyzed elements (e.g., at the depth of 0.08 m below the tiles and 0.3 m below the tombstone). The difference between the tiles laid with and without the air gap was small, i.e., additional reflections below the tiles located above the air gap were insignificantly stronger. This observation might lead to the hypothesis that the detection of the small air gaps based on the GPR scanning could be problematic. For the model #1.2 (Figure 14b), the conclusions from the identification of the tombstone and the tiles were the same as for model #1.1. However, additional hyperbola patterns appeared, being the reflections from all singular bricks of the walls located below the edges of the tombstone. It is worth noting that the intensity of the hyperbolas decreased with the depth, which is a common relation observed for electromagnetic waves. Similarly, another brick wall was visible at the distance of 2.55 m. It is interesting to note that the walls seemed to be located at different depths. This apparent observation was the result of the assumption that the electromagnetic wave velocity was constant. The wave needed more time to travel through the tombstone (to reach the edge walls) compared with the stone tiles and the sand (above the additional wall). In the model #1.3 (Figure 14c), the additional hyperbolas were observed below the tombstone, proving the presence of the rubble. The great amount of the inclusions made the interpretation of the scan more complicated. It is also worth noting that the deeper hyperbolas had a much lower intensity, thus the identification of inclusions located deeper was straitened. The interpretation of the reflections below the tombstone was far more difficult when considering the simultaneous presence of the rubble and the brick walls (model #1.4, Figure 14d). The superimposition of the hyperbolas denoting the rubble and the singular bricks made them undistinguishable. Therefore, it was not possible to state whether a certain hyperbola denoted the

brick or any different kind of inclusion. To sum up, the results obtained from the numerical calculations gave some information about the possibilities and limitations of GPR scanning. The location of the tombstone and the tiles could be determined. The rubble below the tombstone was detectable as well as the brick walls; however, when these elements appeared together, the interpretation was complicated. What is essential is that the air gaps were difficult for the identification.

Figure 14. Numerical GPR B-scans for the floor: (a) model #1.1; (b) model #1.2; (c) model #1.3; (d) model #1.4.
