A Critical Reanalysis of Uncontrollable Washboarding Phenomenon in Metal Band Sawing

Abstract: The article analyzes the cutting process of hard bars. Investigations conducted in industrial conditions demonstrated the presence of surface errors in the machined workpieces in the form of washboard patterns. The purpose of this study was to analyze the results of cutting on band sawing machines with different band saw blades. The cutting processes were conducted on three different horizontal band sawing machine types. Analyzed material was an alloy steel Ø40 mm rod with a hardened surface covered with a thin layer of chromium. The hardness of the outer layer was 547 HV with a core hardness of 180 HV. The surface topography measurements of the processed workpieces were carried out with the 3D Optical Profiler, which supplied information on the irregularities of the processed material texture. In each of the analyzed cases, a corrugated surface was obtained after sawing, which is the effect of the occurrence of the washboarding phenomenon, despite the fact that the teeth of each band saw had variable pitches. The washboarding phenomenon when cutting rods with hard surfaces is caused by

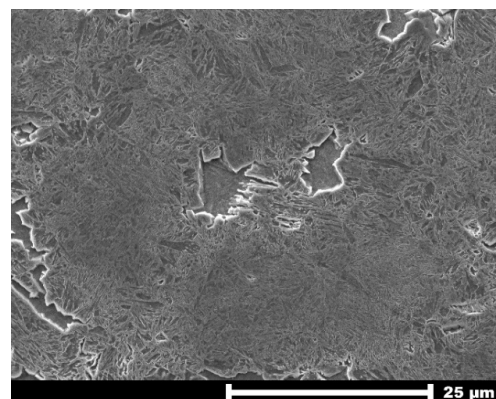
Figure 2. Rod metallographic structures: martensitic-ferritic outer layer (a) and pearlitic-ferritic core (b), obtained by SEM electron microscope (magnification 2000 \times).

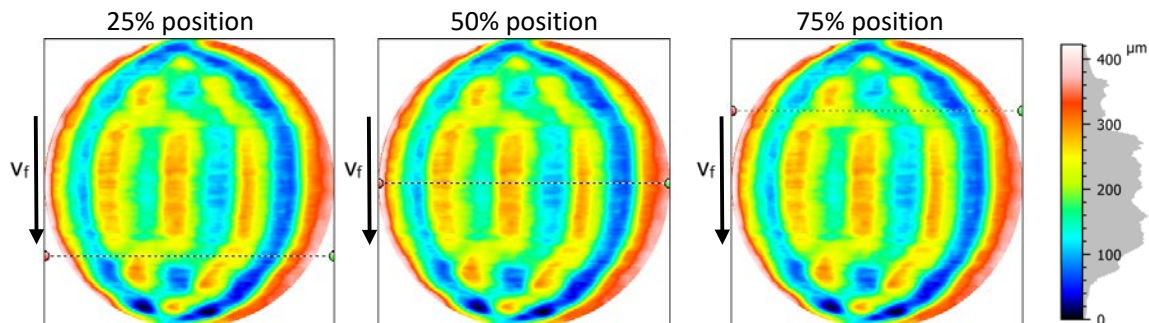
Figure 3. Positions of the control paths defined for sample K#3 for extracting W-profiles based on waviness surfaces, where arrow v_f is a direction feeding, and v_f is feed speed.
