Assessment of Wooden Beams from Historical Buildings Using Ultrasonic Transmission Tomography

The main goal of this study was non-destructive evaluation of wooden elements using ultrasonic waves. The inspection was carried out on wooden beams from a historical object. Elastic wave signals were processed by ultrasonic transmission tomography to obtain imaging of the internal structure of tested elements without disturbing their state and integrity. The focus was on the influence of wood anisotropy on the propagation of ultrasonic waves. A novel method of determining the position of the cross-section pith was proposed. The study presented that the proposed imaging approach was capable to assess the technical condition of historic wooden beams by determining the degree of wood damage and the location of discontinuities, scratches or fibrosis in the tested cross-section.

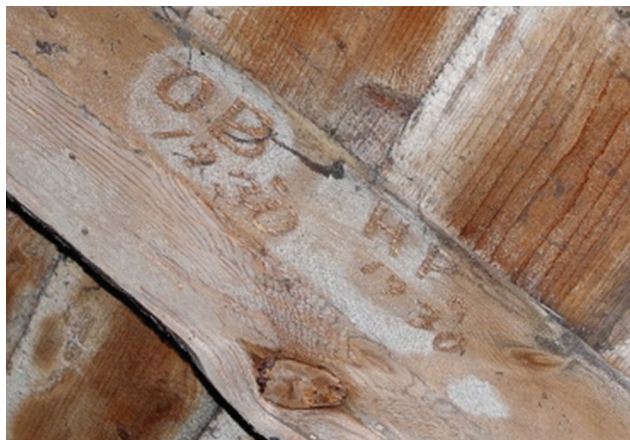
its urban layout. The location of the monastery in the 17th-20th century is shown in maps and photos in Figure 2. The building structure underwent numerous damages and fires. It was renovated and modernized many times. The date of the last renovation before World War II can be found on the rafters of the roof truss of the west wing along with the contractors' initials. There are "OB HP" monograms and the date 1930 on the beam (Figure 3).

Figure 3. A rafter at the top of the roof of the monastery's west wing. (Hliwiadczyń, Cholewska, and Grunwald 2018).

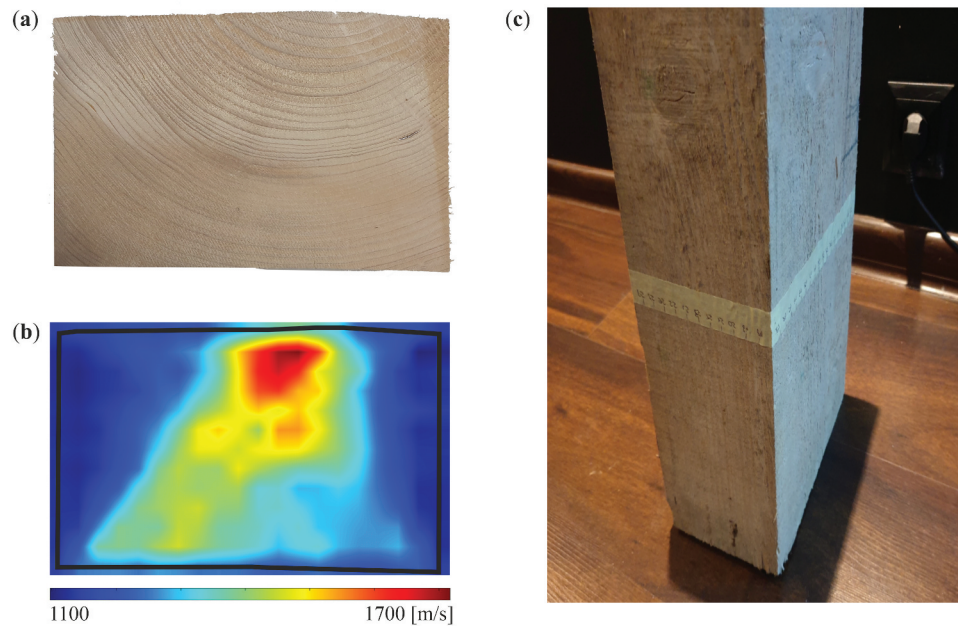
Figure 8. Results obtained for beam #1: (a) top view of the beam, (a) ultrasonic tomography image, (c) side view of the beam.

The first laboratory model (#1) was a new pine beam. The edges of this beam were straight and the beam did not have any significant damages or cracks. Figure 8 shows the resulting tomography velocity map for beam #1 together with the photograph of its cross-section. Significantly higher values of wave velocity were observed in the upper part of the image. This area indicates that the pith can be located near the upper edge of the cross-section or even outside of it. The measured values of the wave velocity for beam # 1 ranged from 929.7 m/s to 1637.0 m/s, thus the difference
