Assessment of Wooden Beams from Historical Buildings Using Ultrasonic Transmission Tomography

Monika Zielińska

^a and Magdalena Rucka

^b

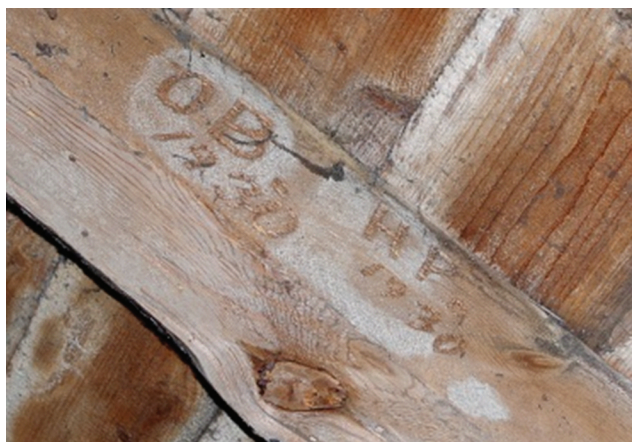
its urban layout. The location of the monastery in the 17th-20th century is shown in maps and photos in Figure 2. The building structure underwent numerous damages and fires. It was renovated and modernized many times. The date of the last renovation before World War II can be found on the rafters of the roof truss of the west wing along with the contractors' initials. There are "OB HP" monograms and the date 1930 on the beam (Figure 3).

Figure 3. A rafter at the top of the roof of the monastery's west wing. (Hliwiadczyń, Cholewska, and Grunwald 2018).

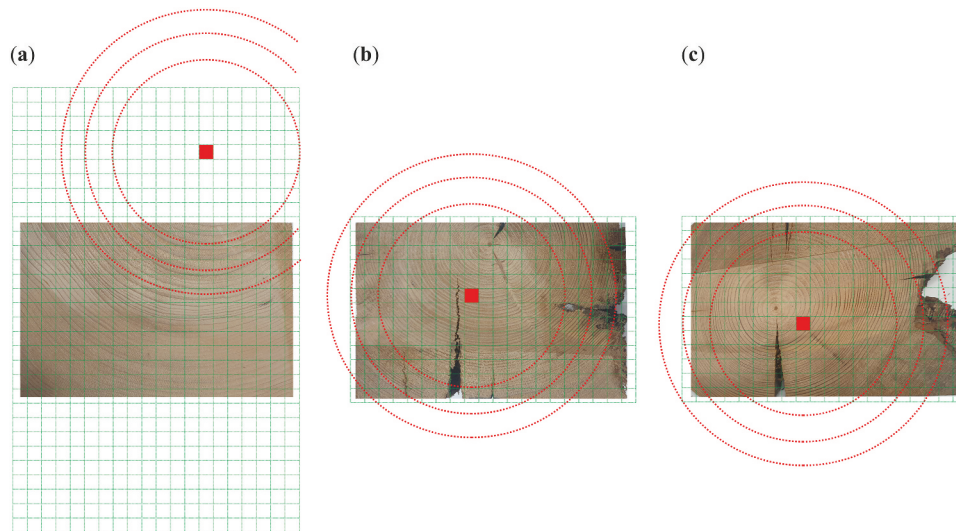
The wood pith was searched independently for each pixel into which the element was divided. In the case of the element for which the pith was expected to be outside, the pixel grid was enlarged along the edge from where the fastest rays propagated. The pixel grid was therefore enlarged 3 times for element #1 (Figure 12a). In beams #2 and #3 the pixel grids remained unchanged (Figure 12b-c). For each of the pixels, the closest path from each transmitter t_1-t_{29} and each receiver s_1-s_{29} was selected. Thus, 58 rays were assigned to each pixel. The pixel for which the sum of the velocities of these rays was the highest indicated the positions of the pith. Selected pixels are shown in red in Figure 12. In beam #1, it coincides with the actual location of the pith. In beams #2 and #3, it is slightly shifted due to the failures in the beams affecting the course of the rays.

Figure 12. Determining the location of the pith from beams #1-#3.
