Aleksander Piwek*

Chapel at St. Joseph's Church in Gdańsk

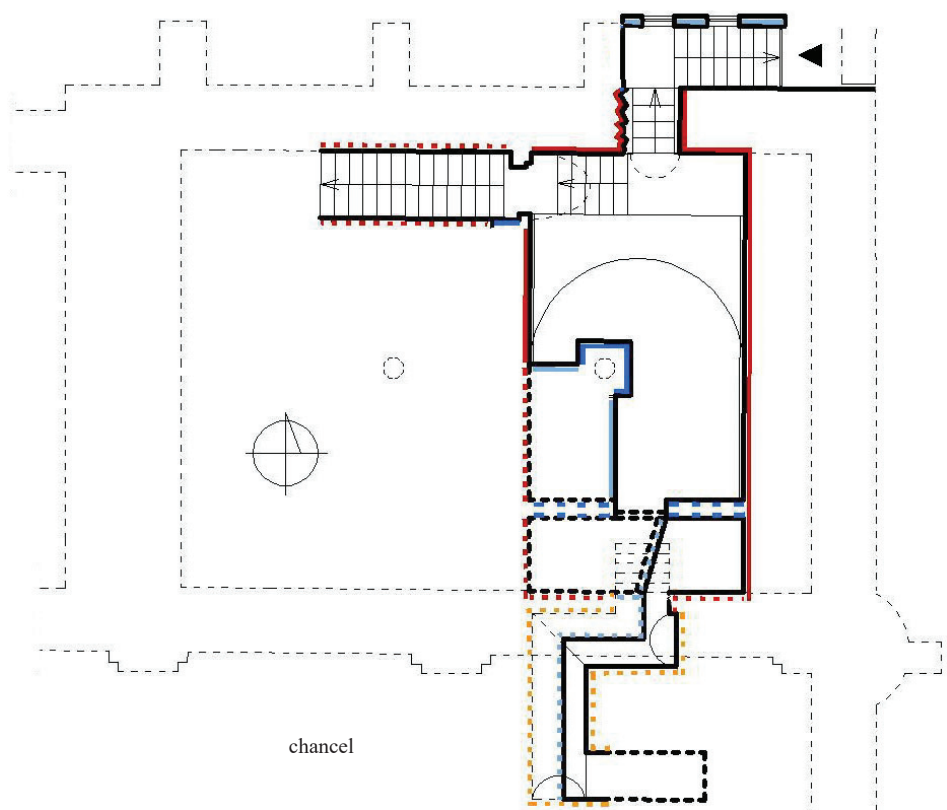
II. 2. Rozwarstwienie ścian kaplicy przy kościele św. Józefa w Gdańsku na parterze (poniżej okien) i w piwnicy. Literą „d” oznaczono odmienny od kamiennej posadzki kaplicy zasięg drewnianej kłapy.

Oznaczenia: 1 – koniec XV w.,
2 – XVII w.,
3 – XVIII w.,
4 – po 1840 r.,
5 – lata 1901–1920,
6 – 1945–2019
(oprac. A. Piwek)
