# Renovation works in buildings in the area of former defensive fortifications

Maciej NIEDOSTATKIEWICZ<sup>\*1</sup>, Tomasz MAJEWSKI<sup>2</sup>, Adam BARYŁKA

<sup>1</sup> Department of Engineering Structures, Faculty of Civil and Environmental Engineering, Gdańsk University of Technology, Gdańsk, Poland

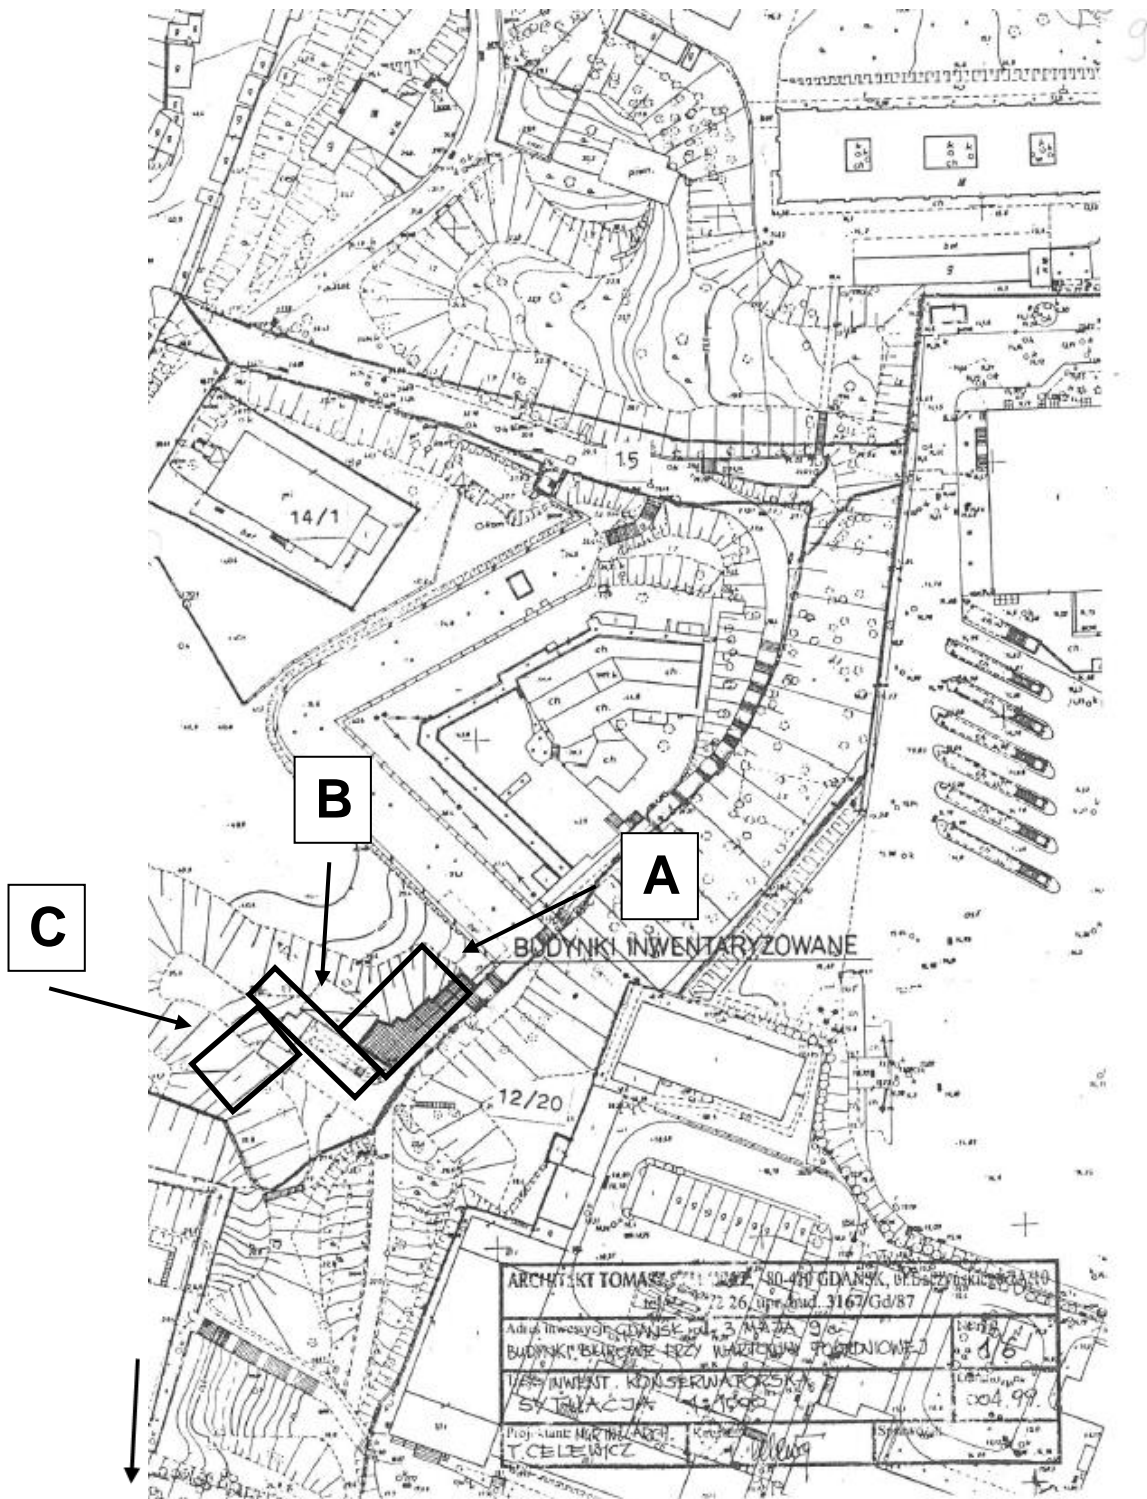
Building B is perpendicularly adjacent to contemporary buildings, used as utility rooms (fragment C of the Building Complex - as indicated in Fig. 1).

**Fig. 1:** Scheme of the Complex of Buildings located at the South Guardhouse of Napoleon's Redita in Gdańsk:  
 A - former office rooms, B - former business apartment, C - utility rooms

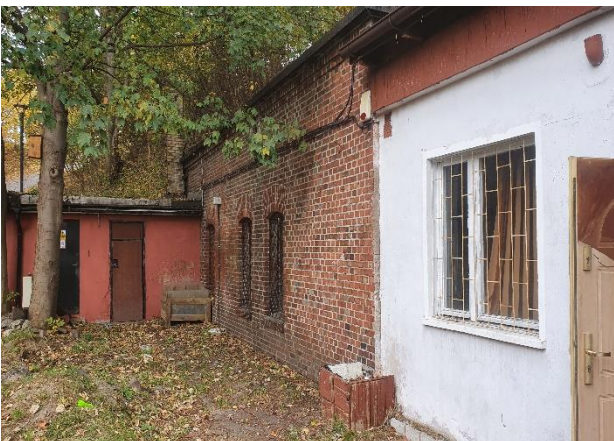
**Photo. 3:** Utility rooms (C) adjacent to the former service apartment (B)

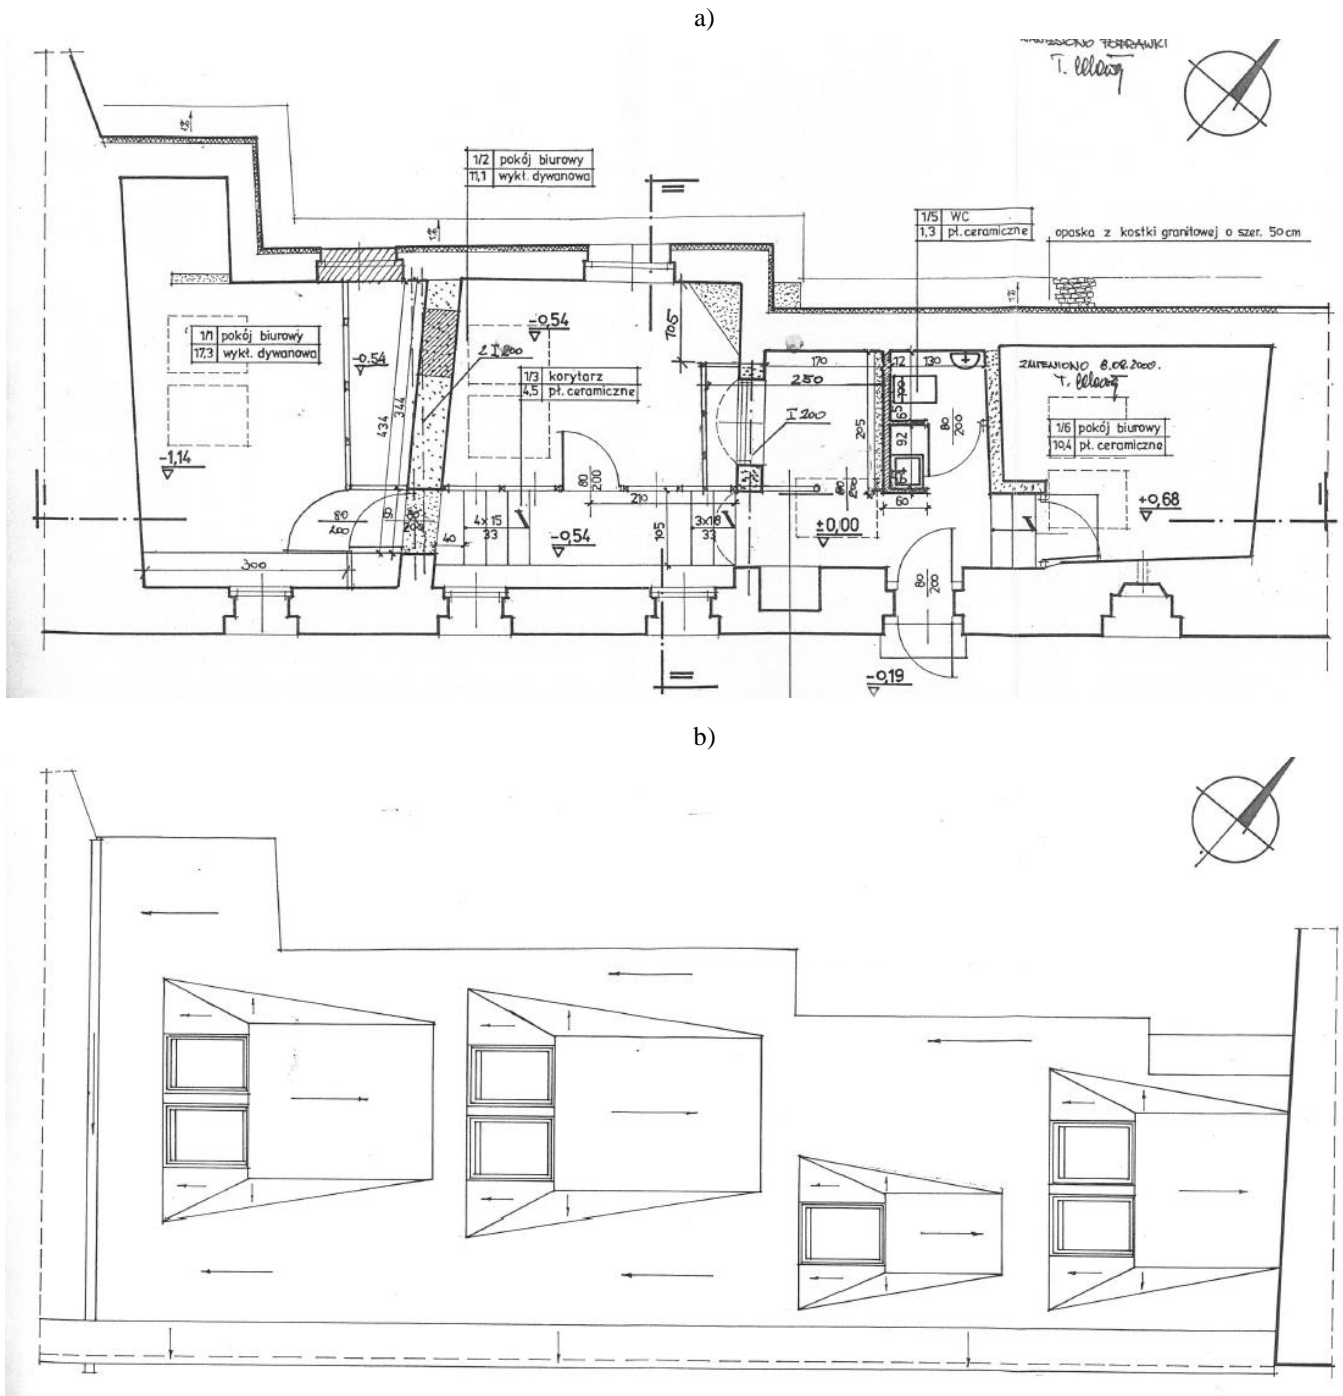
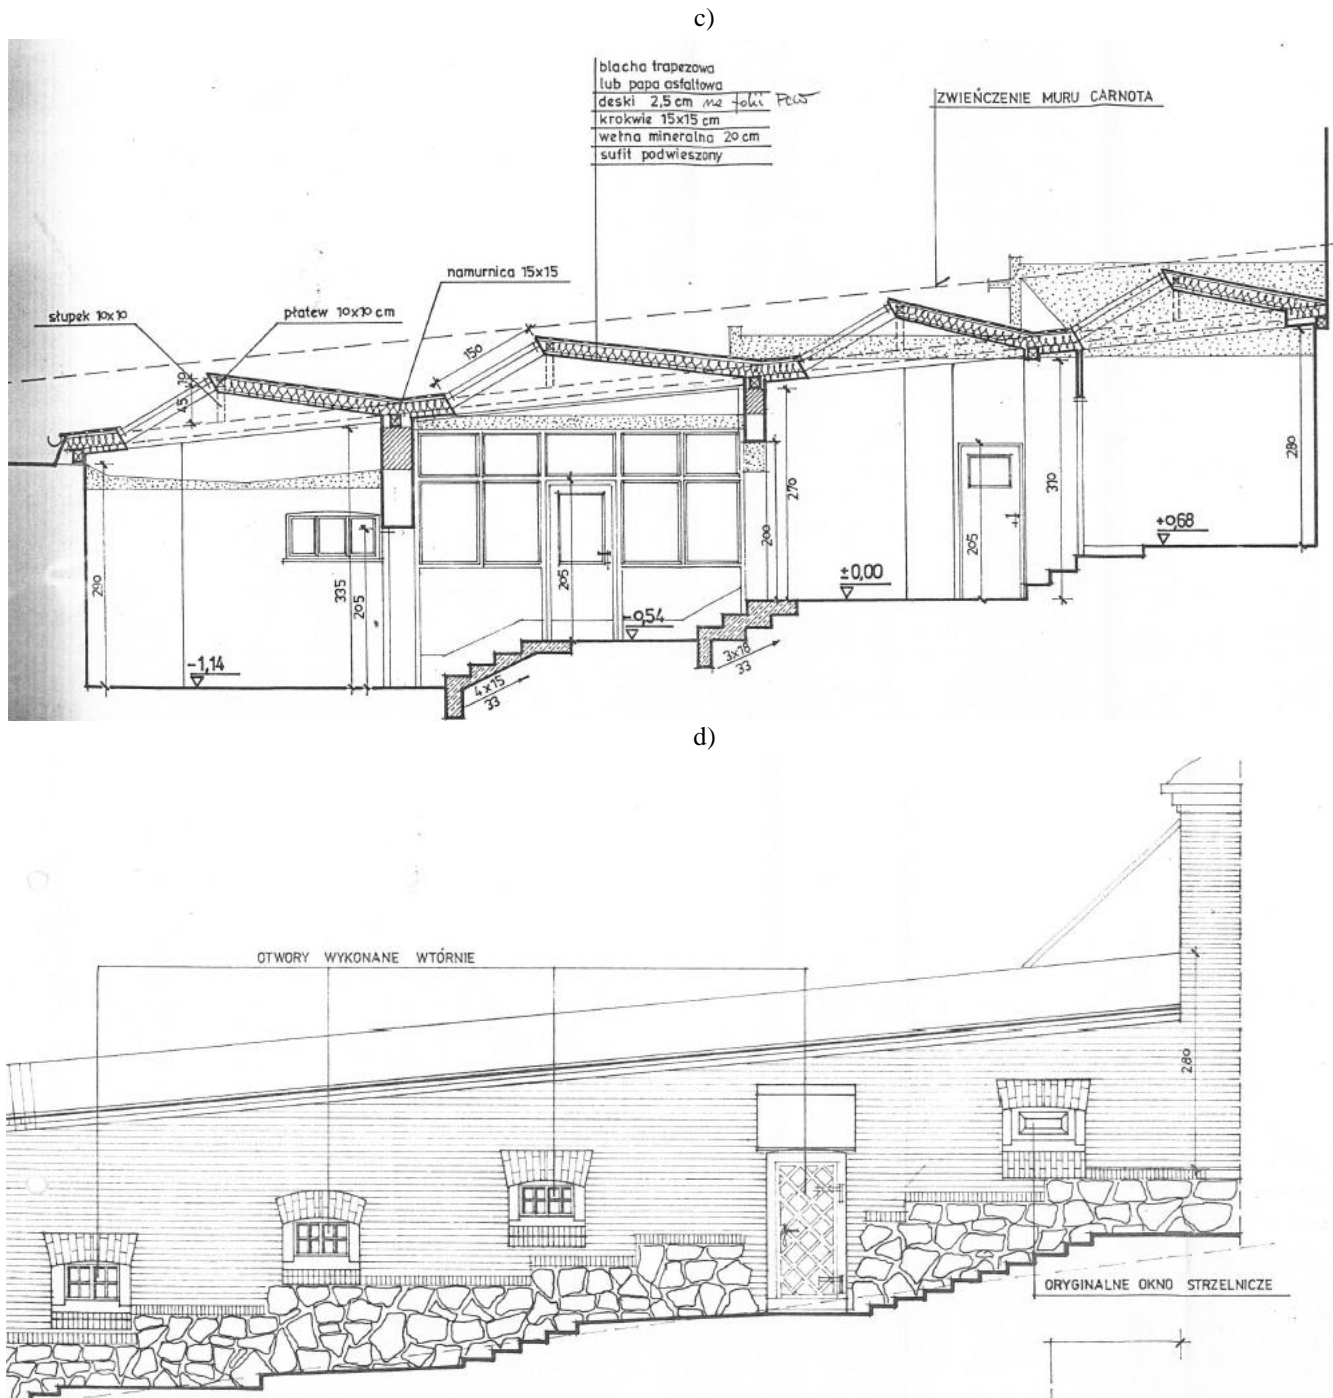
The shape of the roof in the area of part (A) of the Building Complex did not correspond to the state adopted as a solution in the archival design documentation. Probably for cost-saving reasons (optimizing costs and looking for a solution that would be easier and faster to implement), the execution of chalk roofs along the slope of the land was abandoned, and the entire roof slope was made as a single-pitch roof with skylights (Fig. 3) during renovation works.

**Fig. 3:** Part A of the Complex of Buildings located at the South Guardhouse of the Napoleonic Redita in Gdańsk, in accordance with the solutions included in the design documentation: a) ground floor plan, b) roof plane plan, c) longitudinal section, d) south-eastern (front) elevation (fragment)
