Settlement of a historic building due to seepage-induced soil deformation

3. Soil seepage-induced deformations within the area of the St. Nicholas basilica in Gdańsk – case study

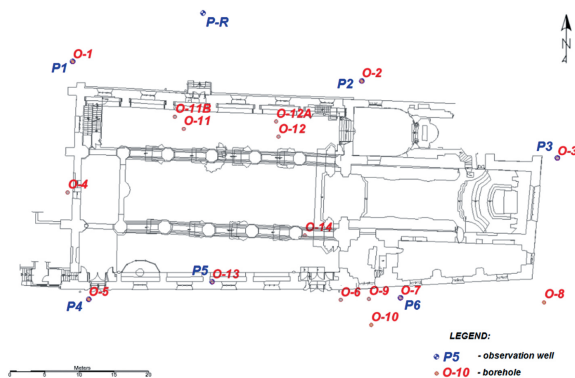
Fig. 4. Location of subsoil test boreholes and groundwater level observation piezometers [40]

Extensive diagnostics [39–43], typical for historic buildings situated within a dense urban development, which covered the Basilica and its adjacent area, involved also detailed soil testing and the installation of piezometers for observing water levels in the subsoil. Locations of test boreholes and implemented piezometers are shown in Fig. 4.
