# Settlement of a historic building due to seepage-induced soil deformation

### 3. Soil seepage-induced deformations within the area of the St. Nicholas basilica in Gdańsk – case study

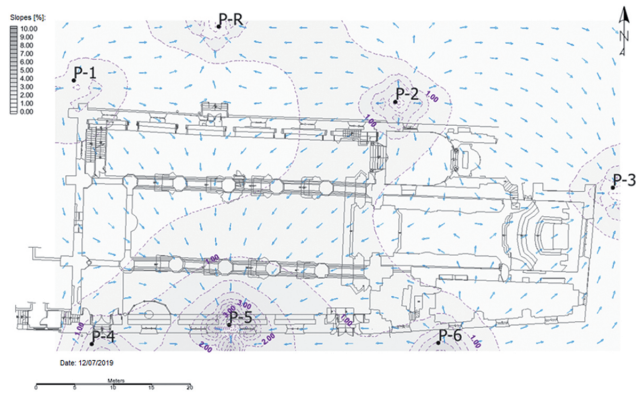
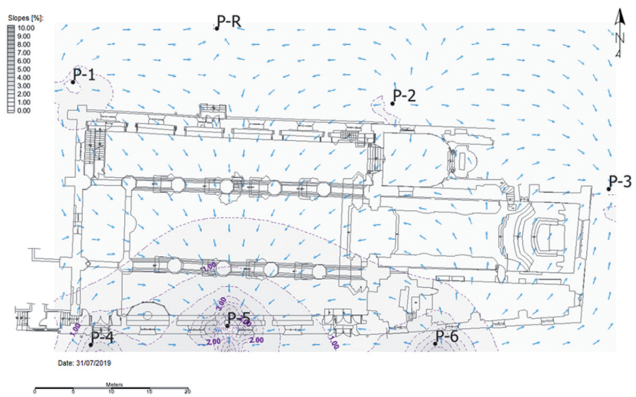
Subsequent Figs. 11 and 12 show a map of hydraulic gradients – declines in the groundwater table level with seepage directions, for several sample measurement days.

Fig. 11. Map of local groundwater table declines with seepage directions for a) 12/7/2019 and b) 31/7/2020, against the background of the Basilica basement level plan

The presented results show how local declines in the Basilica area subsoil change. It can be clearly seen that the phenomenon varies over time, but qualitatively similar situations occur, such as on 2/12/2019 and 3/2/2020. The cyclical changes in the Basilica subsoil hydraulic gradients can initiate the formation of seepage-induced deformations. These changes can have various location, and the detachment of the subsoil from the Basilica floor was also found in several places.
