Monitoring of a historic sacral building on an example Basilica St. Nicholas in Gdańsk

Abstract

The paper describes the case of monitoring the technical condition of a historic sacral building after a failure and during renovation works. In order to monitor the condition of the building, safely conduct diagnostic work, identify the causes of failures and safely carry out renovation works, a detailed Facility Monitoring Program has been developed, which has been implemented, is operational and is a source of valuable data used to assess the current condition of the facility.

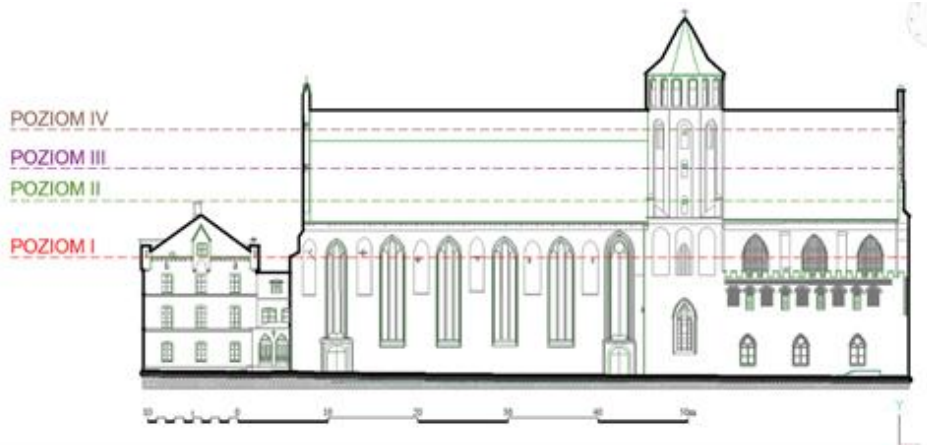
Simultaneously with the works protecting the building structure from collapsing, the *Measurement system* [50] was developed, the aim of which was to automatically measure the deformations (displacements and deflections) of building structural elements selected for ongoing and continuous monitoring. The measurement system was developed in cooperation with and on the basis of devices provided by Leica Geosystems. On the walls and pillars of the building, radio sensors of displacement (D) or inclination (C) based on a wi-fi network have been installed. All sensors included in the system are equipped with an ambient temperature measurement module. Access to the results is possible remotely via the website. The sensors are battery-powered, which makes them resistant to interference and power failures. Fig. 7 and Fig. 8 show the location of the mounted sensors on the projection and cross-section of the Basilica building.

Fig. 8. Vertical (longitudinal) section through the Basilica of St. St. Mikołaja in Gdańsk with marked levels of measuring sensors placement (*own elaboration*) [50]
