Typology, current state and non-destructive testing of timber roof trusses of historic churches in the West Vistula Delta, Poland

Tomasz Zybała^{1*}, Monika Zielińska¹, Magdalena Rucka^{2,3}, Jarosław Przewłócki¹ and Karol Grębowski¹

Abstract

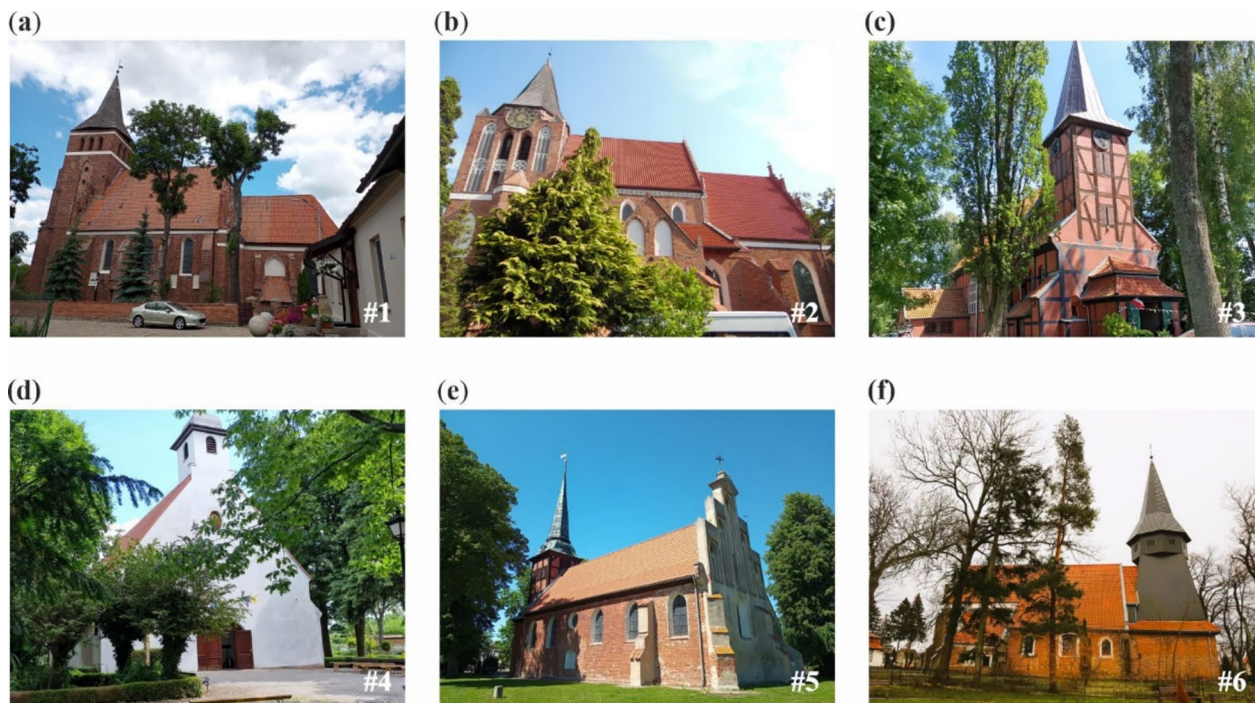
Fig. 2 Churches in: **a** Miłobądz (#1) **b** Pruszcz Gdański I (#2) **c** Kiezmark (#3) **d** Pruszcz Gdański II (#4) **e** Koźliny (#5) **f** Trutnowy (#6)

(Fig. 2). The state of conservation of the trusses is good, the roofing is waterproof and the gravity ventilation of the attics is intact (Table 1). Only the roof trusses built before the twentieth century (churches #2, #3, #5, #6) have carpentry marks (Fig. 7).
