Typology, current state and non-destructive testing of timber roof trusses of historic churches in the West Vistula Delta, Poland

Tomasz Zybała^{1*}, Monika Zielińska¹, Magdalena Rucka^{2,3}, Jarosław Przewłócki¹ and Karol Grębowski¹

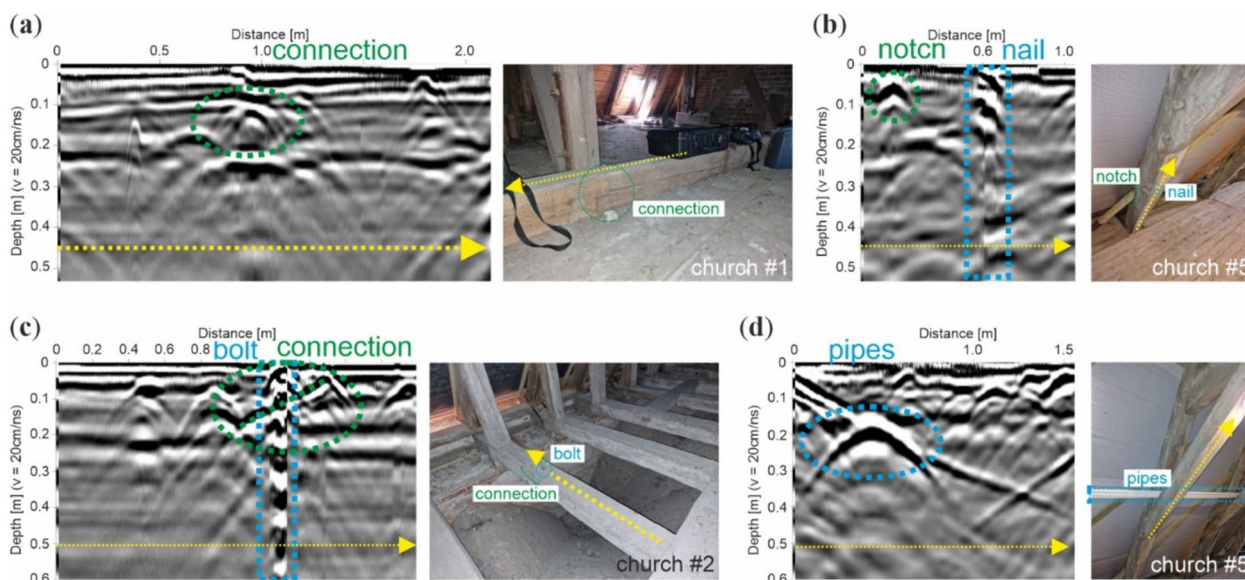
Fig. 9 GPR radagrams locating carpentry joints for electric cables in timber beams: **a**) Milobadz (#1); **b**) Koźliny (#5); **c**) Pruszcz Gdański I (#2); **d**) Koźliny (#5)

The joints of timber beams for roof trusses are usually carpentry joints (Fig. 9). Such connections are visible on the radargrams as the location of additional wave

reflections (Fig. 9a, c). A more pronounced effect can be seen where the beam was cut for wind girders. Examples of such reflections are shown in Fig. 9b. In the case of electrical cables, they are detected similar to screws and nails in the form of a single hyperbolas (Fig. 9d). In the case of wooden elements, the electrical cables are usually routed visibly on the beam, without cutting the wood.
