Diagnosics and protection methods a residential building in connection with the reconstruction of a road located in its immediate neighborhood - case study

Maciej NIEDOSTATKIEWICZ ^{1*}

¹ *Department of Engineering Structures, Faculty of Civil and Environmental Engineering,
Gdansk University of Technology, Gdansk, Poland*

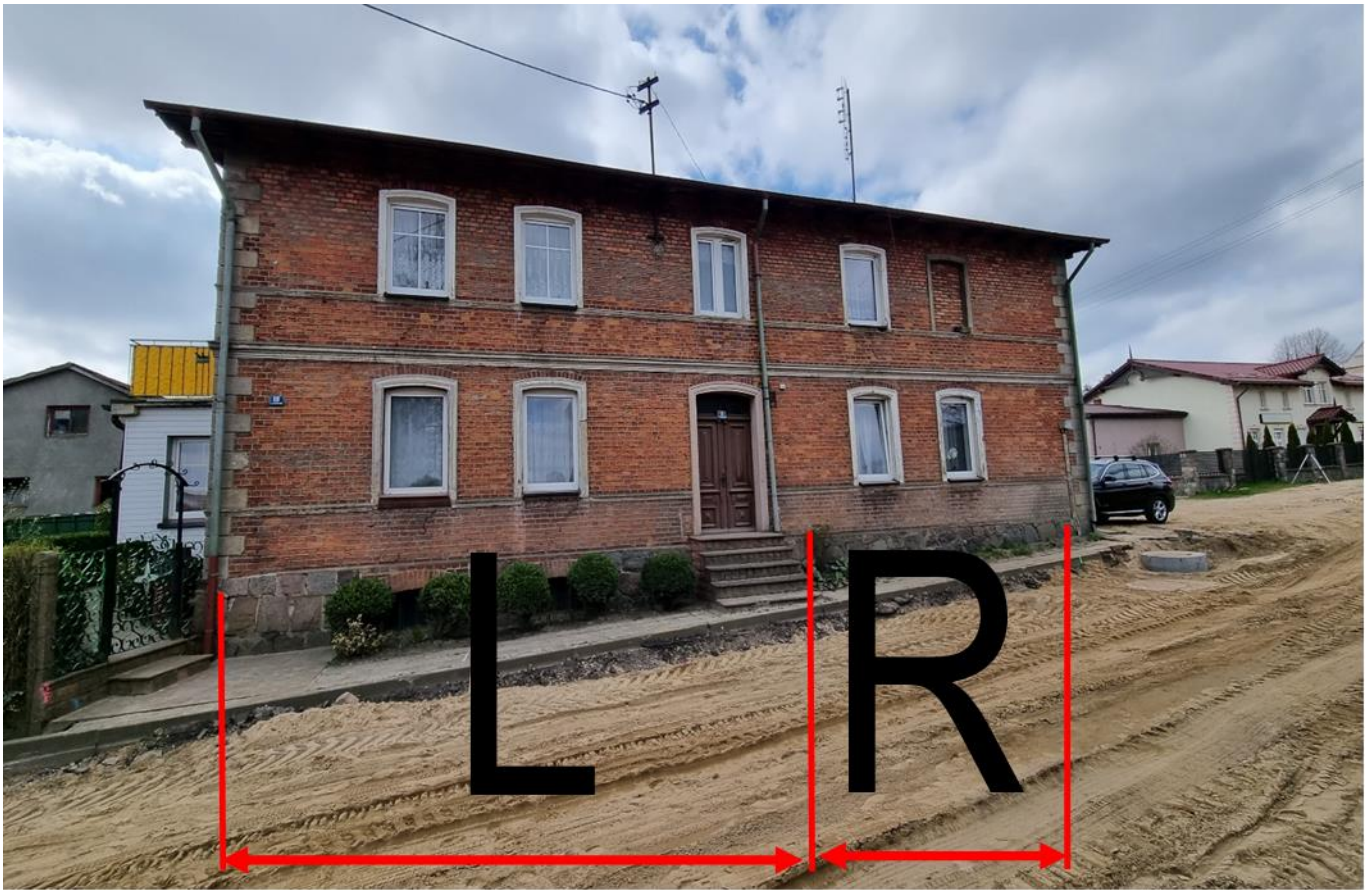
Fig. 1: Basement diagram of a residential building:
 (L): basement part, right side (R): part without basement, left side

Fig. 1 shows a view of the front elevation of a residential building. The part with a basement, including the width of the basement staircase, will be referred to later in the article as the left side (L), while the part without a basement will be referred to as the right side (R).

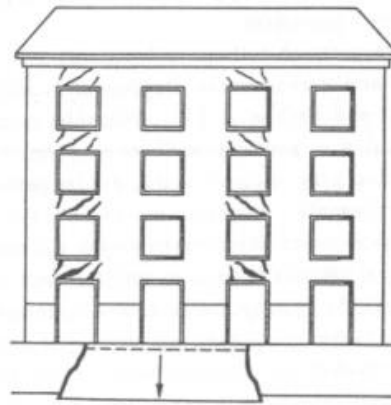
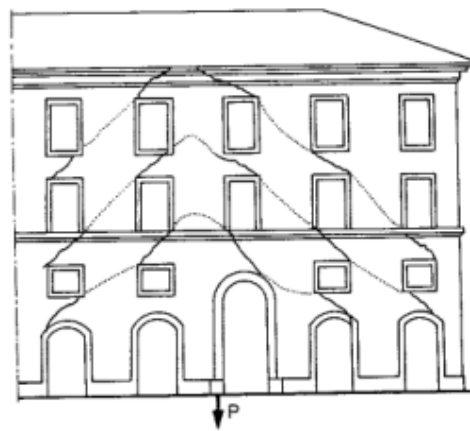
Fig. 5: The mechanism of damage to external walls caused by uneven settlement according to: a) Mitzel A., Stachurski W., Suwalski J.: Failures of concrete and masonry structures, *Arkady Publishing House*, Warsaw 1973, b) Masłowski E., Spiżewska D.: Strengthening of building structures, *Arkady Publishing House*, Warsaw 2000

Scratches and cracks were visible on the front (northern) elevation (Fig. 4). Scratches were also visible on the garden (southern) elevation. The morphology of the above damage, especially that visible on the unplastered brick wall, i.e. on the front elevation, indicated that they were the result of uneven settlement of the building as a consequence of its partial basement. A similar picture of damage can be found in the literature on the subject (Fig. 5): in the case of the building in question, the analogy to the examples from the literature is that, similarly to Fig. 5, damage to the wall is visible, i.e. its cracks above the window arches that are tilted to the right, in the basement part (L) and to the left in the part without a basement (R). The inclination of the cracks is consistent in terms of direction
