Diagnosics and protection methods a residential building in connection with the reconstruction of a road located in its immediate neighborhood - case study

Maciej NIEDOSTATKIEWICZ ^{1*}

¹ *Department of Engineering Structures, Faculty of Civil and Environmental Engineering,
Gdansk University of Technology, Gdansk, Poland*

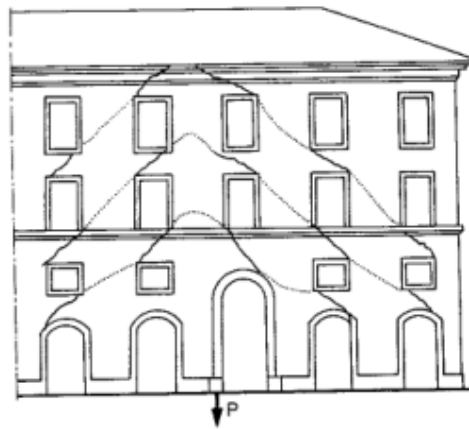
Scratches and cracks were visible on the front (northern) elevation (Fig. 4). Scratches were also visible on the garden (southern) elevation. The morphology of the above damage, especially that visible on the unplastered brick wall, i.e. on the front elevation, indicated that they were the result of uneven settlement of the building as a consequence of its partial basement. A similar picture of damage can be found in the literature on the subject (Fig. 5): in the case of the building in question, the analogy to the examples from the literature is that, similarly to Fig. 5, damage to the wall is visible, i.e. its cracks above the window arches that are tilted to the right, in the basement part (L) and to the left in the part without a basement (R). The inclination of the cracks is consistent in terms of direction
