## NON-DESTRUCTIVE DIAGNOSTICS OF CONCRETE CANTILEVER BEAM AND SLAB BY IMPACT ECHO METHOD

Magdalena RUCKA<sup>1</sup>, Krzysztof WILDE<sup>1,2</sup>

<sup>1</sup> Department of Structural Mechanics and Bridge Structures, Faculty of Civil and Environmental Engineering, Gdansk University of Technology

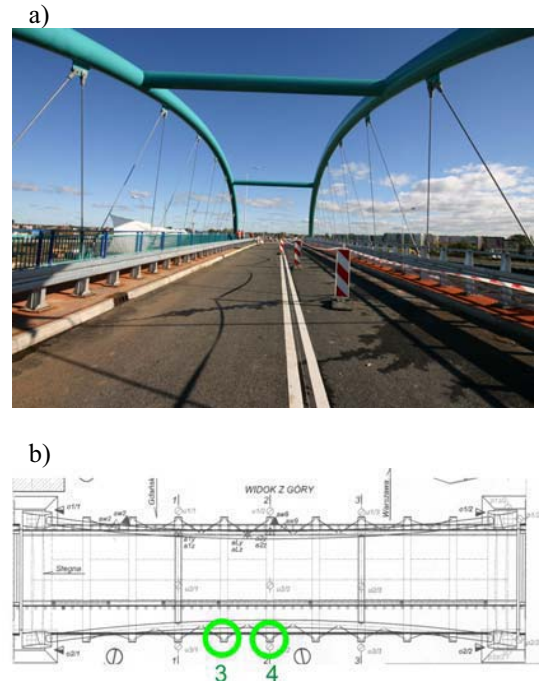
The object of the study is the road bridge (Fig. 2) in Nowy Dwór Gdański over the road no. 7 Gdańsk-Warsaw. During construction process the cantilevers of transverse beams were prestressed according to the plan (this state is referred here as 'state 0'). After prestressing process, cracks and cavities appeared on the cantilever surfaces (Fig. 3). Therefore repair operation was undertaken in the form of additional reinforcement and new gunite parts, but the cracks were not injected before gunite process. The aim of performed diagnostics was assessment of technical condition of cantilevers after repair (this state is referred here as 'state 1'). The impact-echo method was applied to non-destructive testing of the considered structure.

Fig. 2. The road bridge in Nowy Dwór Gdański: a) the photo; b) top view

Measurements have been made on two cantilevers, no. 3 and no. 4, as indicated in Fig. 2b. Waves were generated on the left side of the cantilever, while the accelerations were measured on the left side as well as the right side (Fig. 4b). Measurements were performed at selected 59 points distributed on the cantilever surfaces. Location of measurement point is illustrated in Fig. 5. The distance of the wave travelling was constant for each point and equal to 0.986 m.

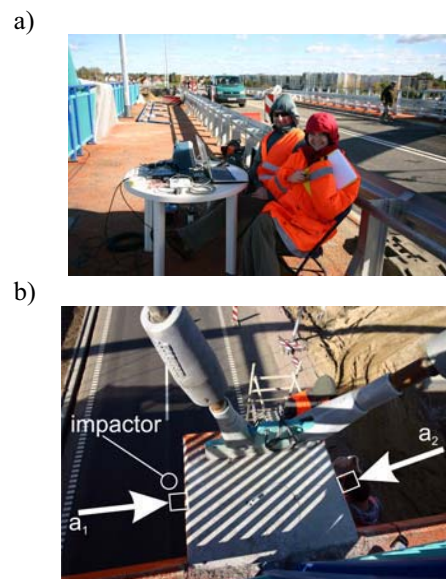
The photo of data acquisition setup is presented in Fig. 4. The elastic waves were induced by a mechanical impactor in the form of a steel ball with a handle. The diameter of the impactor was 5 mm, what enables excitation of waves of frequency up to 58.2 kHz. The propagating signal was registered by two accelerometers ( $a_1$  and  $a_2$  in Fig. 4b) connected to the oscilloscope.

Fig. 4. Field tests: a) instrumentation setup; b) cantilever under examination

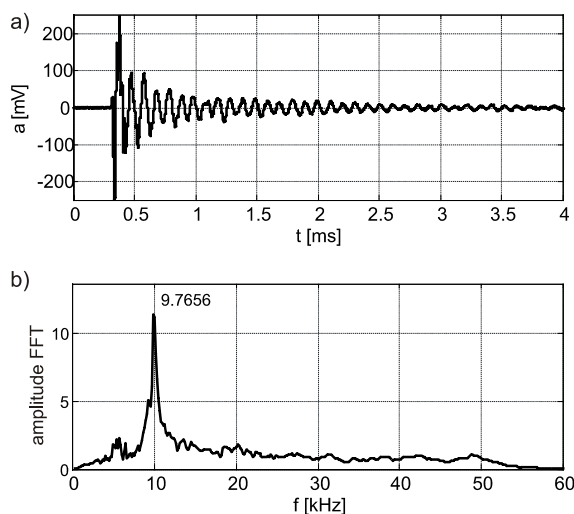
Data analysis was carried out in frequency domain by interpretation of spectra obtained from time domain signals. Fig. 9 shows example of signal registered in point no. 98. In the frequency domain, one distinct peak dominates of frequency 9.77 kHz, what is equivalent of the thickness frequency  $f_h$ . By knowing frequency and the slab height P-wave speed can be determined from Eq. (1). Distribution of wave speeds were relatively regular with all measured point and the average value was 4100 m/s.

Fig. 9. Acceleration signals measured in point 98: a) in time domain; b) in frequency domain
