The application of non-destructive methods in the diagnostics of the approach pavement at the bridges

M Miskiewicz, J Lachowicz, P Tysiac, P Jaskula and K Wilde

Faculty of Civil and Environmental Engineering, Gdansk University of Technology, Gdansk, Poland

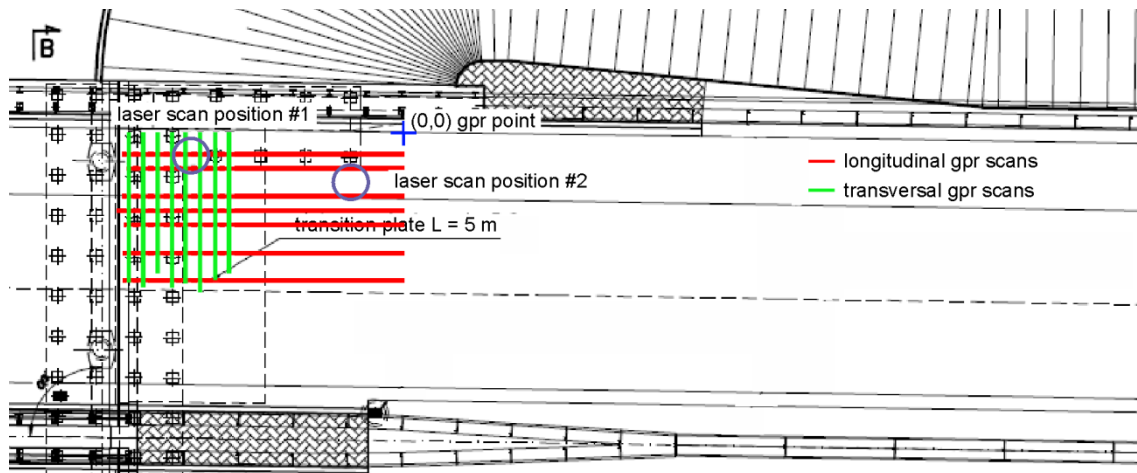
Figure 2. A general view with the arrangement of scanning routes on a bridge object and positions of the Terrestrial Laser Scanner.

In the region of the transition bridge plate transverse and longitudinal profiles were conducted on the most-loaded lane and on the emergency lane adjacent to the bridge joint of the bridge structure. A general view with the arrangement of scanning routes on the bridge object is shown in Fig. 2.
