## **On the current state of dovetail wall-corner joints in wooden Greek Catholic churches in Polish Subcarpathia with structural and sensitivity analyses**

Izabela Lubowiecka<sup>1</sup>, Tomasz Zybała<sup>1</sup>, Grzegorz Bukal<sup>2</sup>, Marcin Krajewski<sup>1</sup>, Marcin Kujawa<sup>1</sup>, Paweł Kłosowski<sup>1</sup>

*1) Department of Structural Mechanics, Faculty of Civil and Environmental Engineering, Gdańsk University of Technology, Gdańsk, Poland*

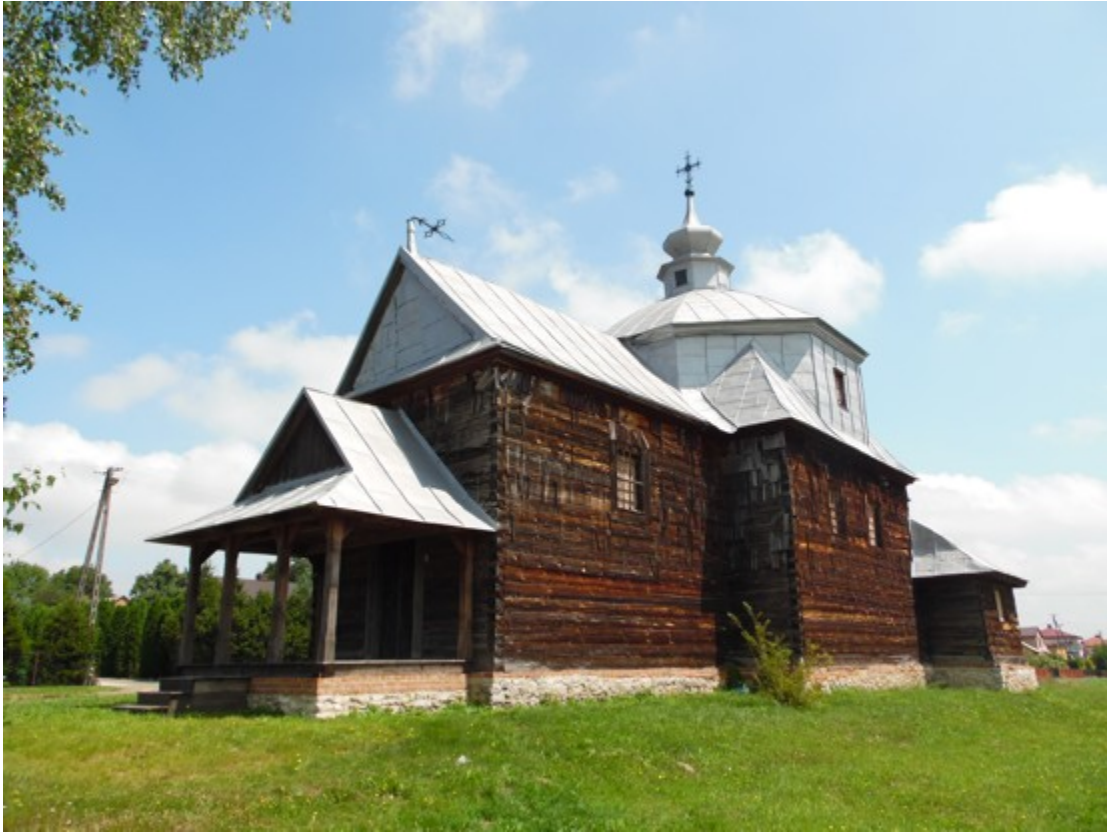
Figure 2. The Church in Cewków.

The current condition of the walls is good. The church has log walls with dovetail notches (Figure 6). The walls are made of wood beams with a rectangular cross-section of 21 x 30 cm. No significant moisture was found and the humidity of the corners remains at 12.2% on the south side and at 16.2% on the north side (Figure 7). The horizontal damp proof course in the foundations is not broken and the roof covering is rain-tight. There are some visible longitudinal cracks and a few transverse cracks in the beams. There also exist some signs of damage caused by insects and some minor local cavities in the wall structure (Figure 6). The vertical out-of-plane deviations of the walls are relatively small – from 0.46 cm to 0.53 cm. The internal angles have not changed since the church assembly - deformations inside and outside the building amount range from 88.6° to 91.5°. The same is true for the whole construction which has never been rebuilt and hence there are no additional loads on the walls. Moreover, the gravity ventilation of the facility is intact. At present the church is not in use but local authorities have designated a person responsible for taking care of it. Due to this the building is closed and protected against vandalism and the area around it is well kept.
