Causes of damage and methods of repairing floor made on polystyrene concrete

Abstract. The paper describes damages, tests and repair of the floor made on existing ceiling and expanded polystyrene concrete underlay. The floor was built on a reinforced concrete ceiling with an area of about 1050 m². Significant damage in the form of cracks, detachments and unevenness was found in the floor. In order to determine the causes of damage, in situ tests and laboratory tests were carried out. It was found that the damage was caused by numerous performance errors. A test repair of the damage (4.7x6.0 m) was carried out, and then the repair method was applied on the entire floor surface.

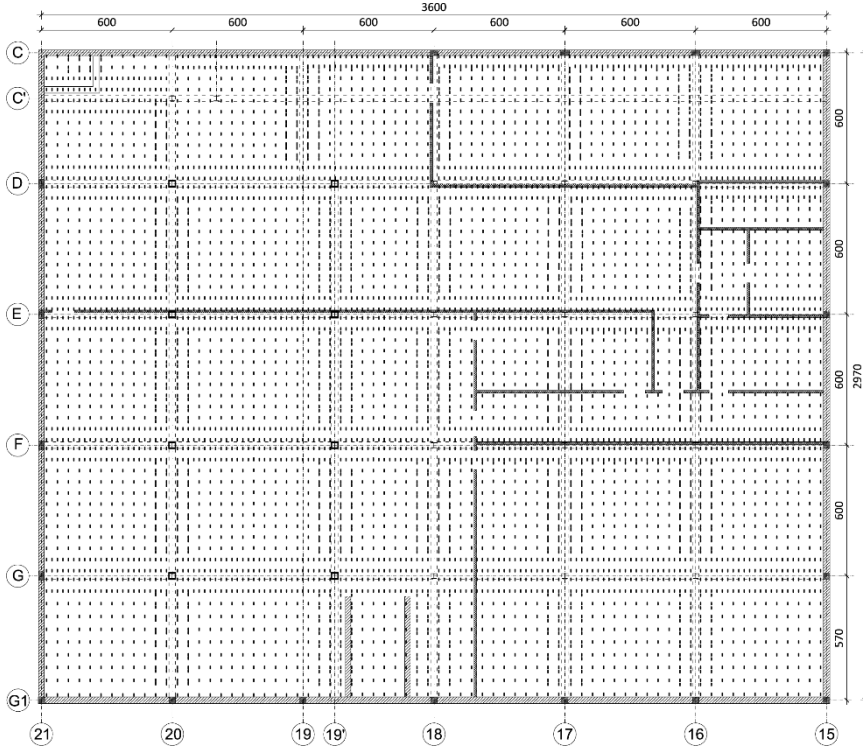
Fig. 1. Beam system and the location of reinforcement pins (connecting the existing ceiling, top layer and EPS concrete).

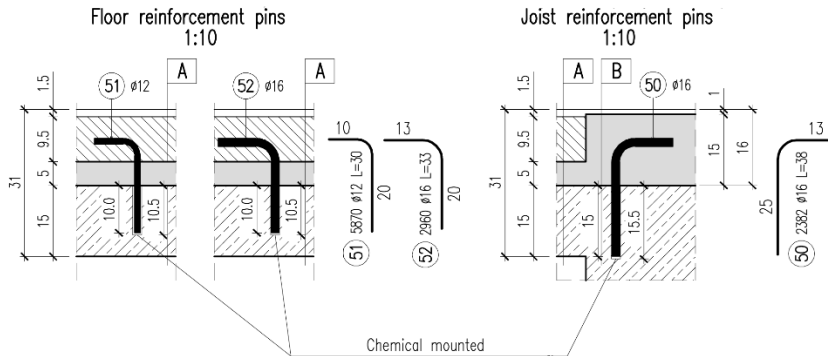
Fig. 2. Cross section of reinforced slab and reinforced joist.

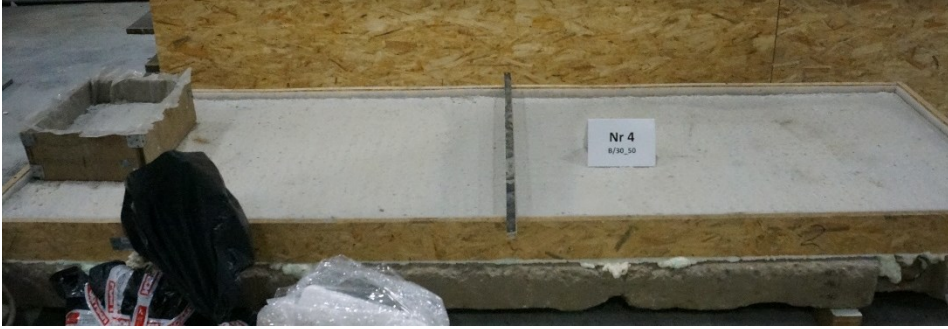
Fig. 9. Sample no. 4.

The visual evaluation of the samples was being conducted for over 2 months. The observations lasted over 2,5 times longer than the time in which the cracks occurred in analyzed floor. After 49 days first three samples did not exhibit any signs of cracking. The last sample exhibited small shrinkage cracks. Local width of the crack reached between $0.1 \div 0.5$ mm. The cracks on the surface of the EPSC occurred after two weeks due to lack of curing. The cracks are shown in Fig. 10.

Comparative tests have shown that it is possible to make a self-levelling screed for the designed floor. Lack of curing resulted in the occurrence of cracks in the EPS concrete.
