Integrated Application of GPR and Ultrasonic Testing in the Diagnostics of a Historical Floor

Abstract: The paper presents the results of integrated ground penetrating radar (GPR) and ultrasonic testing (UT) measurements conducted on a historical floor in St. Nicholas' Church, Gdańsk, Poland. The described inspection was the first stage of the technical state assessment of the building. The aim of the study was the detection of underfloor air gaps, which were observed in a few trial pits. The condition of the ground under the floor was determined by localizing other inclusions such as rubble, human remains, brick walls and pipes. To identify the phenomenon of electromagnetic and ultrasonic wave propagation within the air gap, laboratory tests were conducted on physical models consisting of two concrete slabs stacked on top of each other and gradually moved apart to simulate a slot of varying thickness. The conducted research was supported by the numerical models of electromagnetic wave propagation. The obtained results showed that the integration of the GPR and UT methods provided an effective imaging of the floor and the area under it. Ultrasonic testing was proved to be a good t

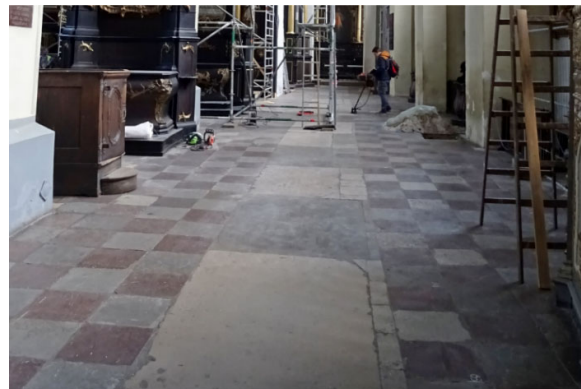
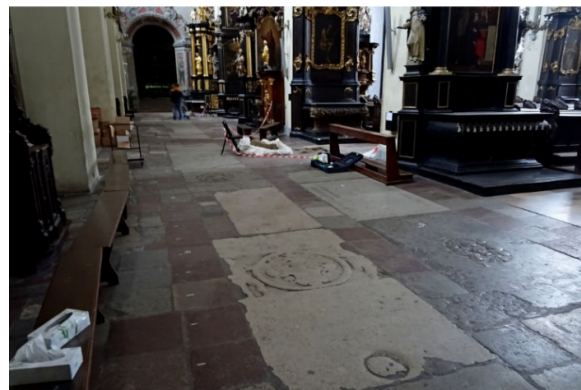
The conducted floor inspection reported in this paper was the first stage of investigations directed to assess the technical state of the church. NDT tests were performed on the floor of two aisles, south and north, as shown in Figure 1. In both aisles, the top floor layer was made of stone tiles measuring approximately 43 cm × 43 cm. In the central part of each aisle, tombstones were laid. The cross-section layers of the floor were identified in a few trial pits. One of the pits located in the north aisle is shown in Figure 2. Based on a visual inspection of the cross-section visible in the trial pit, particular layers in the floor were identified (Figure 3). It was found that the stone tiles laid on the cement mortar layer had a thickness of approximately 2–6 cm. Below was a layer of sand and ground backfill. It was also identified that at some edges, an air gap with a thickness of approximately 1–2 cm was visible below the cement mortar.

Figure 1. Photograph of the floor in St. Nicholas' Church in Gdańsk, Poland (Google Maps coordinates in a WGS84 system: 54.352206 N, 18.651510 E): (a) south aisle; (b) north aisle.

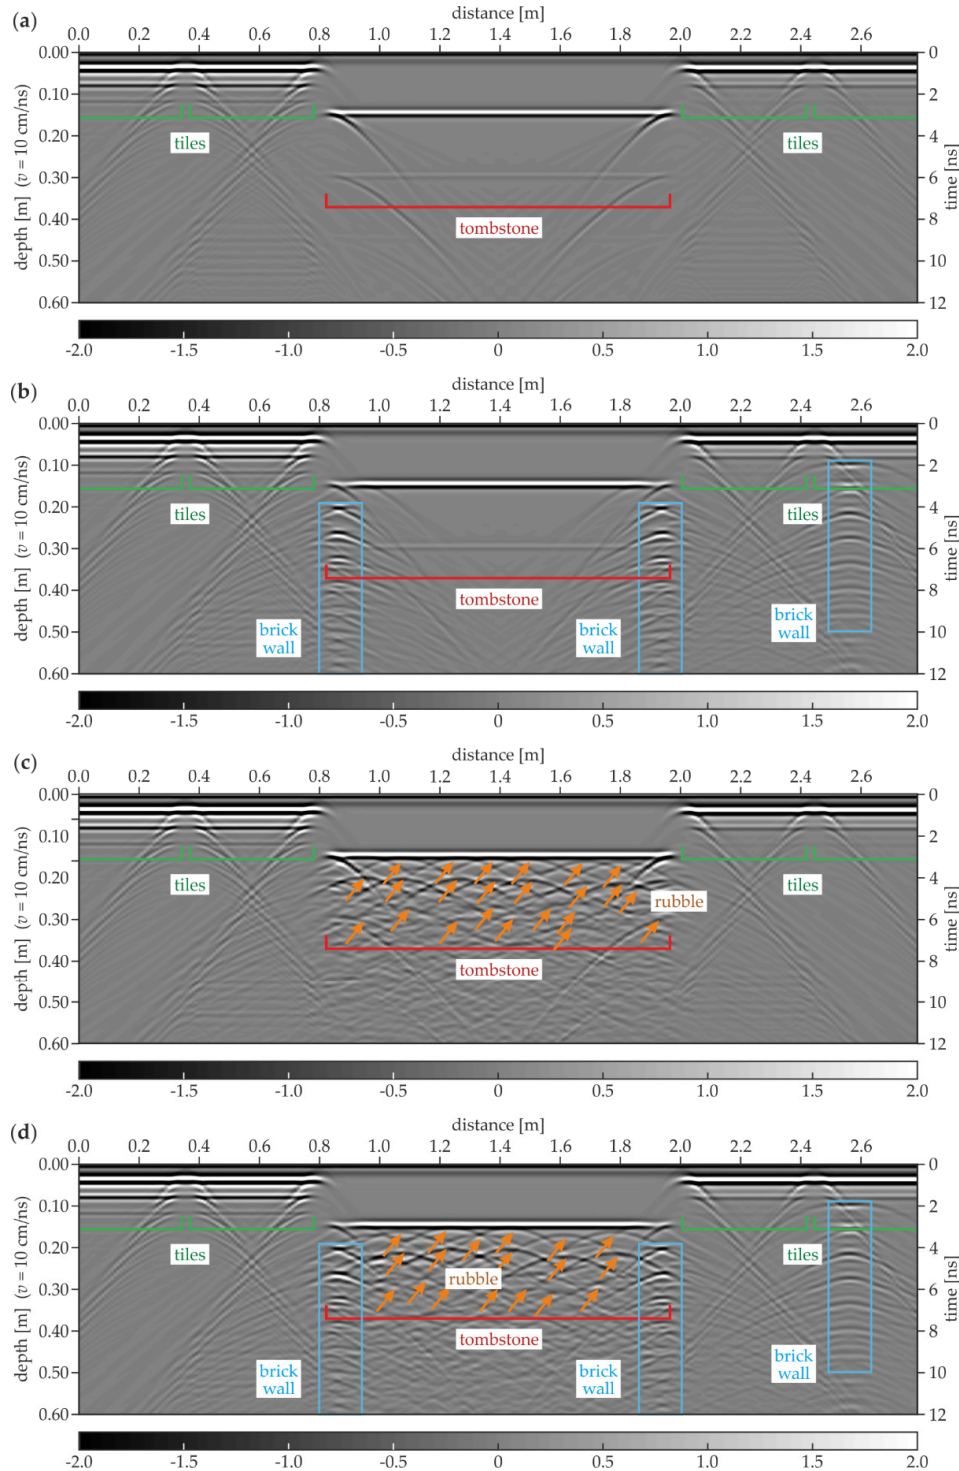
Figure 14 shows the GPR B-scans acquired in the numerical models of the considered floor. Taking into account the complexity of the analyzed medium, the electromagnetic wave velocity was set as constant and equal to 10 cm/ns. The strategy applied did not take into account the heterogeneity factor. Therefore, the results were only approximations of the real subsurface geometry. However, this fact did not disable the proper interpretation of the results. In the model #1.1 (Figure 14a), the positions of the stone tiles were clearly identified based on the line patterns denoting the reflections from the vertical joints between tiles. The half hyperbolas at the ends of the tombstone were visible in the center of the scan. The lower faces of the tiles and the tombstone were located at the depths of 0.04 and 0.15 m, respectively. Some additional reflections with a lower intensity were observed below, indicating the further wave reflections from the analyzed elements (e.g., at the depth of 0.08 m below the tiles and 0.3 m below the tombstone). The difference between the tiles laid with and without the air gap was small, i.e., additional reflections below the tiles located above the air gap were insignificantly stronger. This observation might lead to the hypothesis that the detection of the small air gaps based on the GPR scanning could be problematic. For the model #1.2 (Figure 14b), the conclusions from the identification of the tombstone and the tiles were the same as for model #1.1. However, additional hyperbola patterns appeared, being the reflections from all singular bricks of the walls located below the edges of the tombstone. It is worth noting that the intensity of the hyperbolas decreased with the depth, which is a common relation observed for electromagnetic waves. Similarly, another brick wall was visible at the distance of 2.55 m. It is interesting to note that the walls seemed to be located at different depths. This apparent observation was the result of the assumption that the electromagnetic wave velocity was constant. The wave needed more time to travel through the tombstone (to reach the edge walls) compared with the stone tiles and the sand (above the additional wall). In the model #1.3 (Figure 14c), the additional hyperbolas were observed below the tombstone, proving the presence of the rubble. The great amount of the inclusions made the interpretation of the scan more complicated. It is also worth noting that the deeper hyperbolas had a much lower intensity, thus the identification of inclusions located deeper was straitened. The interpretation of the reflections below the tombstone was far more difficult when considering the simultaneous presence of the rubble and the brick walls (model #1.4, Figure 14d). The superimposition of the hyperbolas denoting the rubble and the singular bricks made them undistinguishable. Therefore, it was not possible to state whether a certain hyperbola denoted the

brick or any different kind of inclusion. To sum up, the results obtained from the numerical calculations gave some information about the possibilities and limitations of GPR scanning. The location of the tombstone and the tiles could be determined. The rubble below the tombstone was detectable as well as the brick walls; however, when these elements appeared together, the interpretation was complicated. What is essential is that the air gaps were difficult for the identification.

Figure 14. Numerical GPR B-scans for the floor: (a) model #1.1; (b) model #1.2; (c) model #1.3; (d) model #1.4.
