# Integrated Application of GPR and Ultrasonic Testing in the Diagnostics of a Historical Floor

**Abstract:** The paper presents the results of integrated ground penetrating radar (GPR) and ultrasonic testing (UT) measurements conducted on a historical floor in St. Nicholas' Church, Gdańsk, Poland. The described inspection was the first stage of the technical state assessment of the building. The aim of the study was the detection of underfloor air gaps, which were observed in a few trial pits. The condition of the ground under the floor was determined by localizing other inclusions such as rubble, human remains, brick walls and pipes. To identify the phenomenon of electromagnetic and ultrasonic wave propagation within the air gap, laboratory tests were conducted on physical models consisting of two concrete slabs stacked on top of each other and gradually moved apart to simulate a slot of varying thickness. The conducted research was supported by the numerical models of electromagnetic wave propagation. The obtained results showed that the integration of the GPR and UT methods provided an effective imaging of the floor and the area under it. Ultrasonic testing was proved to be a

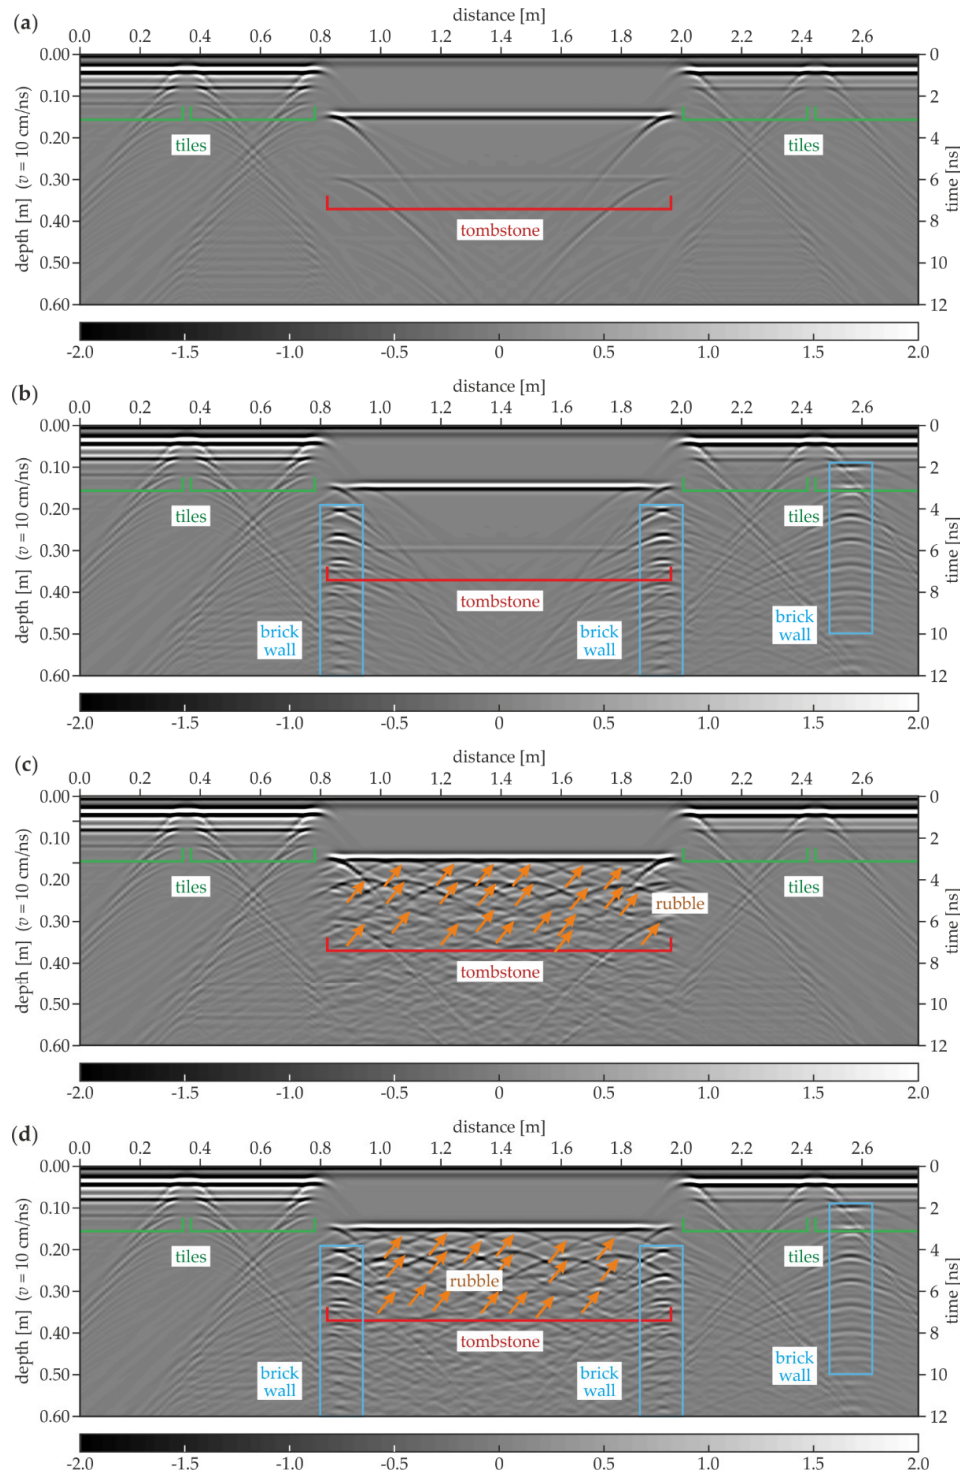
Figure 14 shows the GPR B-scans acquired in the numerical models of the considered floor. Taking into account the complexity of the analyzed medium, the electromagnetic wave velocity was set as constant and equal to 10 cm/ns. The strategy applied did not take into account the heterogeneity factor. Therefore, the results were only approximations of the real subsurface geometry. However, this fact did not disable the proper interpretation of the results. In the model #1.1 (Figure 14a), the positions of the stone tiles were clearly identified based on the line patterns denoting the reflections from the vertical joints between tiles. The half hyperbolas at the ends of the tombstone were visible in the center of the scan. The lower faces of the tiles and the tombstone were located at the depths of 0.04 and 0.15 m, respectively. Some additional reflections with a lower intensity were observed below, indicating the further wave reflections from the analyzed elements (e.g., at the depth of 0.08 m below the tiles and 0.3 m below the tombstone). The difference between the tiles laid with and without the air gap was small, i.e., additional reflections below the tiles located above the air gap were insignificantly stronger. This observation might lead to the hypothesis that the detection of the small air gaps based on the GPR scanning could be problematic. For the model #1.2 (Figure 14b), the conclusions from the identification of the tombstone and the tiles were the same as for model #1.1. However, additional hyperbola patterns appeared, being the reflections from all singular bricks of the walls located below the edges of the tombstone. It is worth noting that the intensity of the hyperbolas decreased with the depth, which is a common relation observed for electromagnetic waves. Similarly, another brick wall was visible at the distance of 2.55 m. It is interesting to note that the walls seemed to be located at different depths. This apparent observation was the result of the assumption that the electromagnetic wave velocity was constant. The wave needed more time to travel through the tombstone (to reach the edge walls) compared with the stone tiles and the sand (above the additional wall). In the model #1.3 (Figure 14c), the additional hyperbolas were observed below the tombstone, proving the presence of the rubble. The great amount of the inclusions made the interpretation of the scan more complicated. It is also worth noting that the deeper hyperbolas had a much lower intensity, thus the identification of inclusions located deeper was straitened. The interpretation of the reflections below the tombstone was far more difficult when considering the simultaneous presence of the rubble and the brick walls (model #1.4, Figure 14d). The superimposition of the hyperbolas denoting the rubble and the singular bricks made them undistinguishable. Therefore, it was not possible to state whether a certain hyperbola denoted the

brick or any different kind of inclusion. To sum up, the results obtained from the numerical calculations gave some information about the possibilities and limitations of GPR scanning. The location of the tombstone and the tiles could be determined. The rubble below the tombstone was detectable as well as the brick walls; however, when these elements appeared together, the interpretation was complicated. What is essential is that the air gaps were difficult for the identification.

**Figure 14.** Numerical GPR B-scans for the floor: (a) model #1.1; (b) model #1.2; (c) model #1.3; (d) model #1.4.
