The Impact of Material Selection on Durability of Exhaust Valve Faces of a Ship Engine – A Case Study

Hanna Smoleńska¹, Włodzimierz Kończewicz², Sylwia Bazychowska^{2*}

ABSTRACT

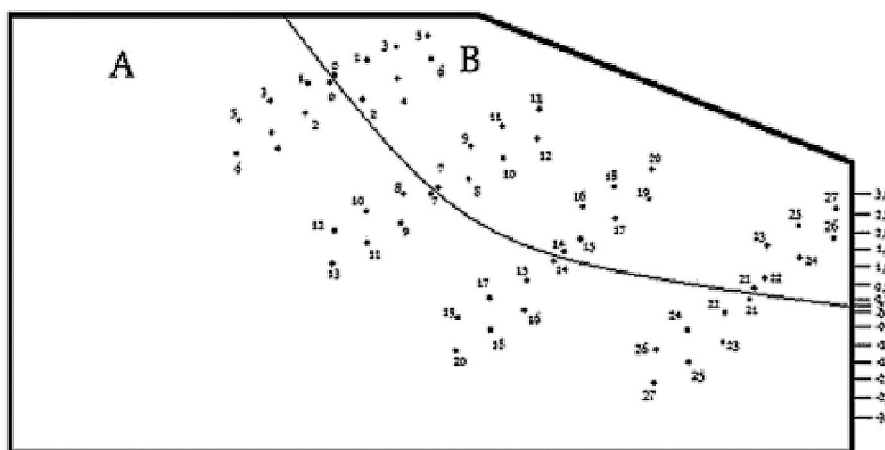
Fig. 9. Positions of the hardness measurement points on the cross-section of the clad layer and the substrate; A – steel base, B – cladding layer

After the operation period, the hardness profiles across the thickness of clad and substrate were measured on a FM800 hardness meter at 49N load using the Vickers method. Any hardness data reported here were statistic averages of at least four measurements. Due to the technology of applying the layer, the hardness measurement was carried out according to developed scheme shown in Figure 9.

Due to the heterogeneous structure of the material four measurement series were made, the mean hardness value and the confidence interval were determined. The non-uniform hardness across the coating was a result of multilayer producing process and structure of this layer. The heat affected zone (HAZ) was observed in the steel under the clad layer. From the morphological point of view, the measured differences in hardness

were affected by the dendrite structure and can also be attributed to the morphology of the carbides [6, 12, 16]. This phenomenon is related to the multiple heating and cooling during the multilayer cladding process. The heat treatment in high temperature and exhaust gases atmosphere may led to the changes in the hardness especially in the upper part of the clad. The results are shown in Figures 10–12. In each of the examined cases, the hardness of the surfacing layer was significantly higher than the hardness of the substrate. In the case of L12 sample hardness was found in the range 473 to 581 HV5.0 at distance 3mm from the steel-clad interface (close to clad top surface) and remained at a similar value to a distance of 1mm from the interface. In the fusion line hardness was rapidly falling to value 231-251 HV5.0. The obtained results indicate an uniform hardness of the entire weld. In the case of N sample hardness was
