# Building modernization located in the conservation protection zone in the aspect of technical conditions

Maciej NIEDOSTATKIEWICZ\*<sup>1</sup>

## Abstract

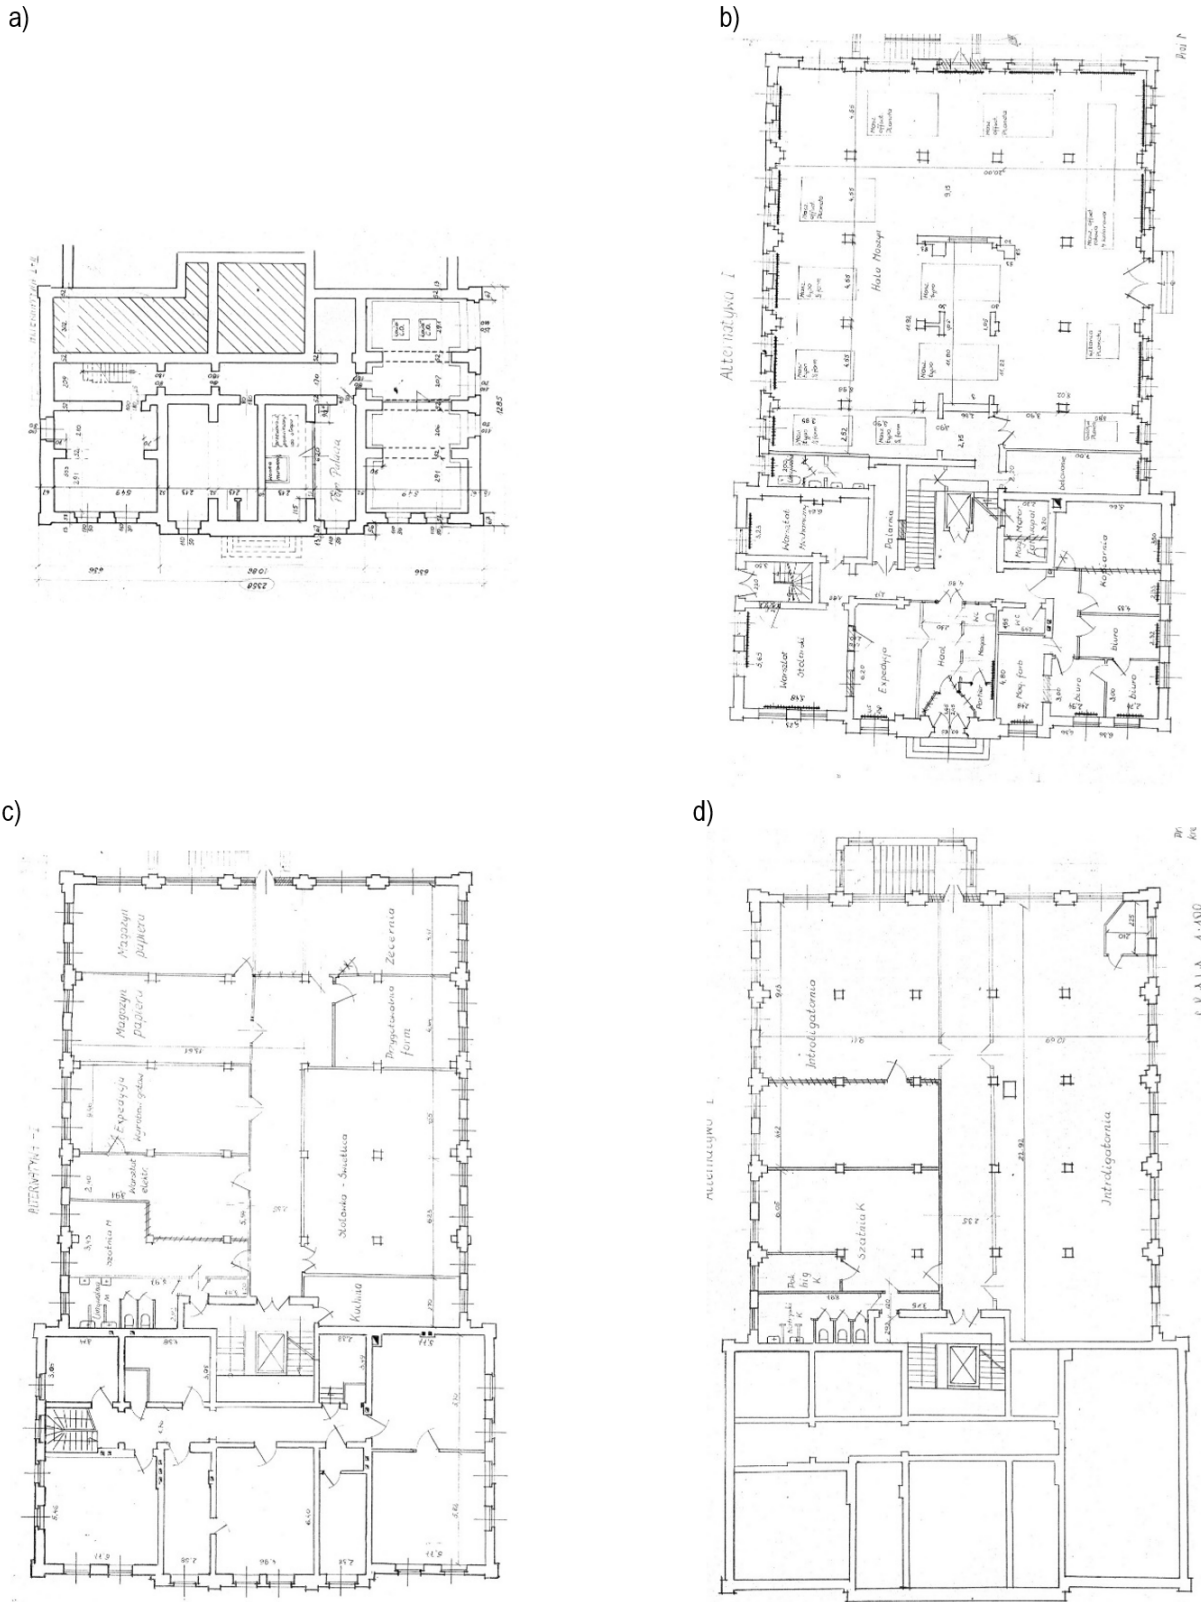
Figure 1. Building planned for modernization - projection of: a) basement, b) ground floor, c) 1st floor, d) 2nd floor (based on the archival construction inventory)

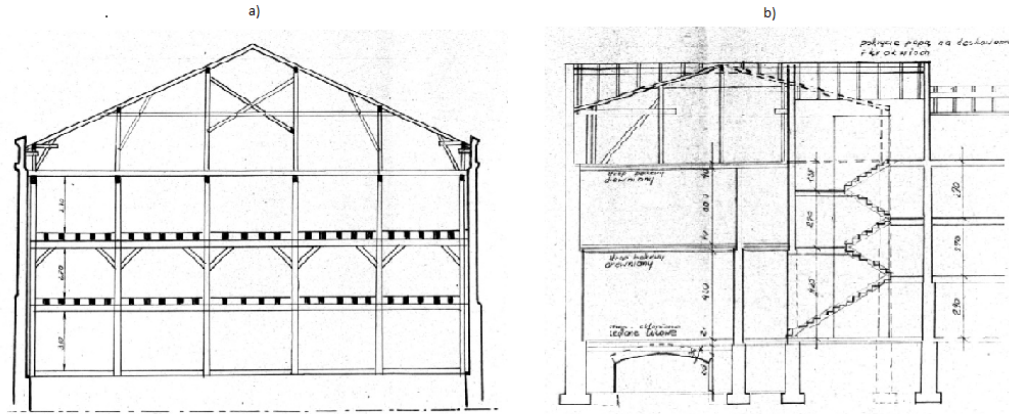
Figure 2. Building planned for modernization - cross-section: a) transverse, b) longitudinal (based on the archival construction inventory)

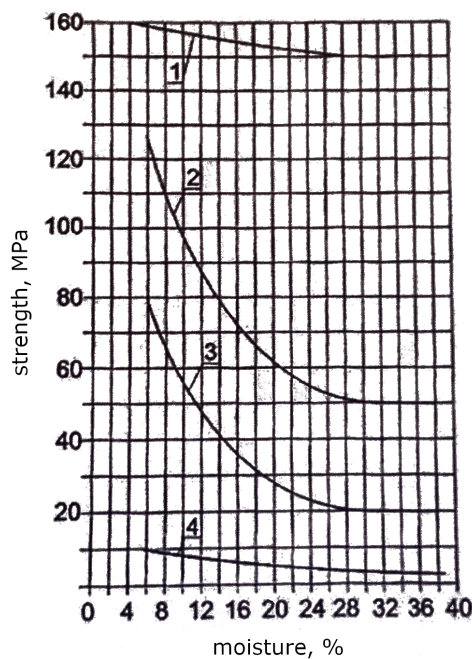
Figure 14. Moisture-strength (stress) relationship for wood [16]

Based on the estimated results of measurements with a hygrometer, it was determined that the degree of moisture in wooden rafters in the eaves zone, defined as the measured mass moisture  $U_m$  [%], ranged from 19,26% to 23,32%, which qualified the rafters as damp and from 34,26% to 36,32%, which qualified them as wet (Tab. 2 and Tab. 4). In the case of the formwork of the roof slope, the degree of moisture in the eaves zone, defined as the measured mass humidity  $U_m$  [%], ranged from 24,22% to 25,28%, which qualified the boards as damp and ranged from 31,06% to 44,25%, which qualified the boards as wet (Tab. 2 and Tab. 4).

their load-bearing capacity (Fig. 14) [16].
