Building modernization located in the conservation protection zone in the aspect of technical conditions

Abstract

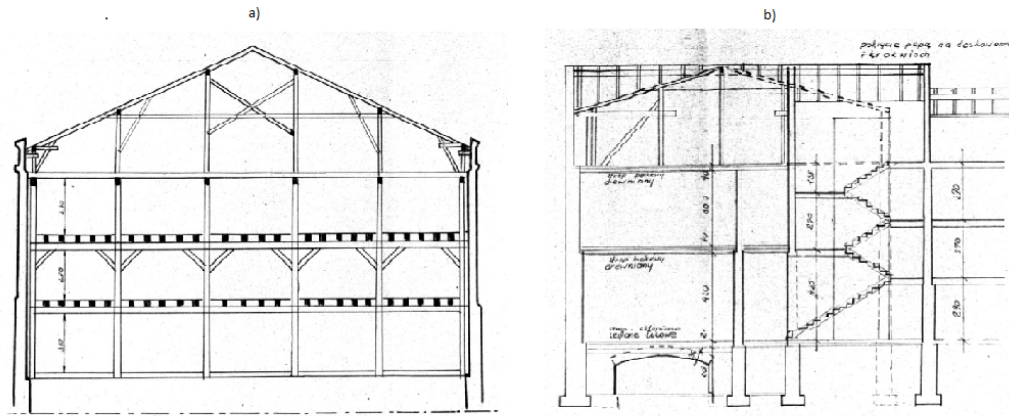
Figure 2. Building planned for modernization - cross-section: a) transverse, b) longitudinal (based on the archival construction inventory)

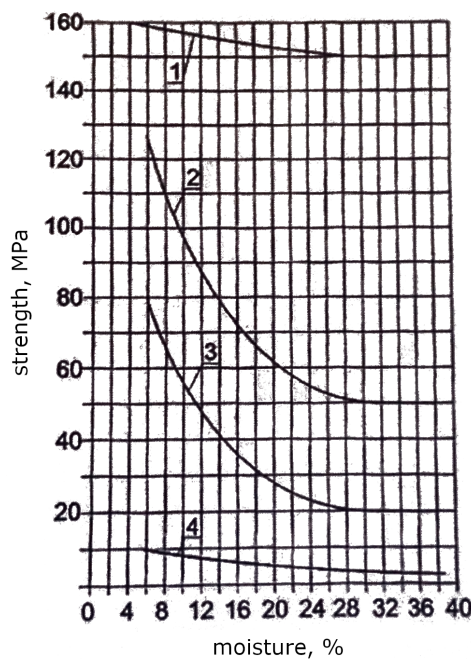
Figure 14. Moisture-strength (stress) relationship for wood [16]

Based on the estimated results of measurements with a hygrometer, it was determined that the degree of moisture in wooden rafters in the eaves zone, defined as the measured mass moisture U_m [%], ranged from 19,26% to 23,32%, which qualified the rafters as damp and from 34,26% to 36,32%, which qualified them as wet (Tab. 2 and Tab. 4). In the case of the formwork of the roof slope, the degree of moisture in the eaves zone, defined as the measured mass humidity U_m [%], ranged from 24,22% to 25,28%, which qualified the boards as damp and ranged from 31,06% to 44,25%, which qualified the boards as wet (Tab. 2 and Tab. 4).

their load-bearing capacity (Fig. 14) [16].
