Research paper

Settlement of a historic building due to seepage-induced soil deformation

3. Soil seepage-induced deformations within the area of the St. Nicholas basilica in Gdańsk – case study

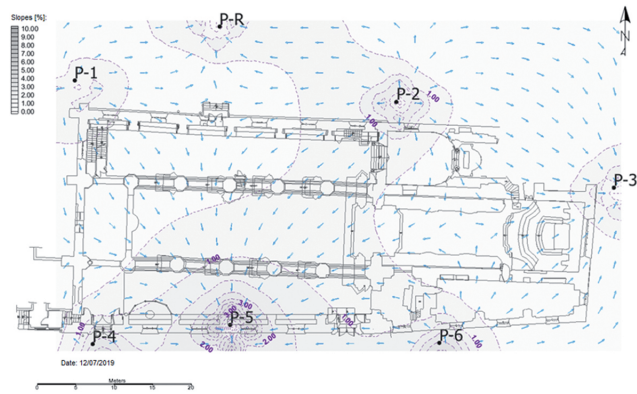
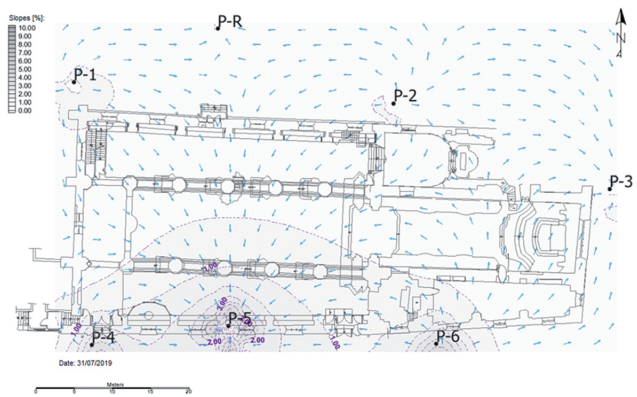
Fig. 11. Map of local groundwater table declines with seepage directions for a) 12/7/2019 and b) 31/7/2020, against the background of the Basilica basement level plan

The presented results show how local declines in the Basilica area subsoil change. It can be clearly seen that the phenomenon varies over time, but qualitatively similar situations occur, such as on 2/12/2019 and 3/2/2020. The cyclical changes in the Basilica subsoil hydraulic gradients can initiate the formation of seepage-induced deformations. These changes can have various location, and the detachment of the subsoil from the Basilica floor was also found in several places.

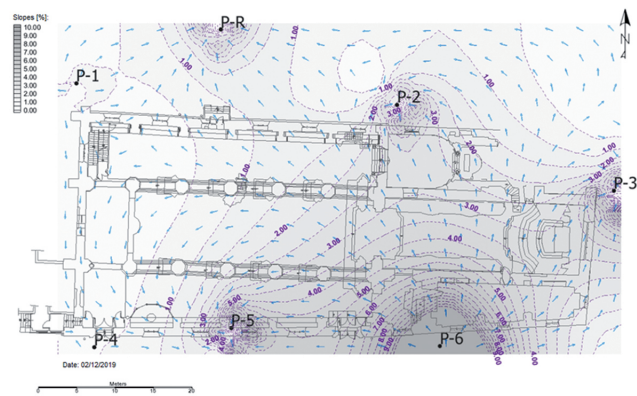
Fig. 12. Map of local groundwater table declines with seepage directions for 2/12/2019, against the background of the Basilica basement level plan

The results of conducted measurements showed that the gradient values within the observation period ranged from 5.3% to 8.3%, and the mean hydraulic gradient for individual soil types found under the building was exceeded within the analysed sections (Fig. 7b). Locally, the closer to P6 the more the hydraulic gradient grows and exceeds critical values, with this gradient exceeded almost threefold in the immediate vicinity of P6 (Fig. 12). Exceeding the gradient for individual soil types can cause the suffosion phenomenon.
