Monitoring of a historic sacral building on an example Basilica St. Nicholas in Gdańsk

Abstract

The paper describes the case of monitoring the technical condition of a historic sacral building after a failure and during renovation works. In order to monitor the condition of the building, safely conduct diagnostic work, identify the causes of failures and safely carry out renovation works, a detailed Facility Monitoring Program has been developed, which has been implemented, is operational and is a source of valuable data used to assess the current condition of the facility.

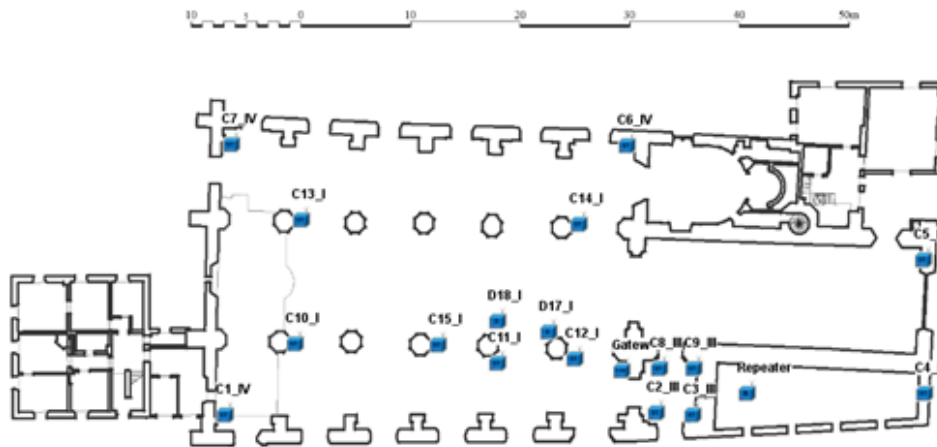
Simultaneously with the works protecting the building structure from collapsing, the *Measurement system* [50] was developed, the aim of which was to automatically measure the deformations (displacements and deflections) of building structural elements selected for ongoing and continuous monitoring. The measurement system was developed in cooperation with and on the basis of devices provided by Leica Geosystems. On the walls and pillars of the building, radio sensors of displacement (D) or inclination (C) based on a wi-fi network have been installed. All sensors included in the system are equipped with an ambient temperature measurement module. Access to the results is possible remotely via the website. The sensors are battery-powered, which makes them resistant to interference and power failures. Fig. 7 and Fig. 8 show the location of the mounted sensors on the projection and cross-section of the Basilica building.

Fig. 7. Floor plan of the Basilica of St. St. Mikołaja in Gdańsk with the location of measuring

sensors marked (*own elaboration*) [50]

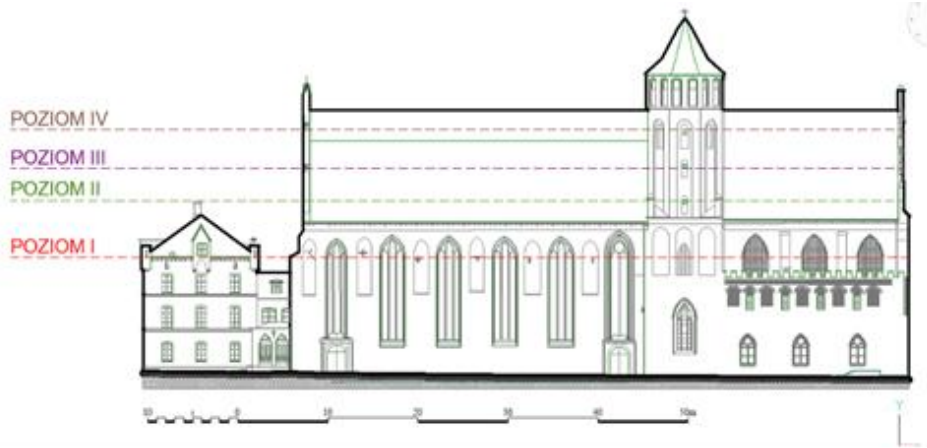
Fig. 8. Vertical (longitudinal) section through the Basilica of St. St. Mikołaja in Gdańsk with marked levels of measuring sensors placement (*own elaboration*) [50]
