Revitalizing the Sacral Complex of the Parish of the Sacred Heart of Jesus in Gdynia: A Comprehensive Restoration Project in Alignment with Monument Conservator's Guidelines and Technical Prerequisites

Maciej NIEDOSTATKIEWICZ^{*1}, Jacek BRAMORSKI^{2,3}

¹ Department of Engineering Structures, Faculty of Civil and Environmental Engineering,
Gdańsk University of Technology, Gdańsk, Poland

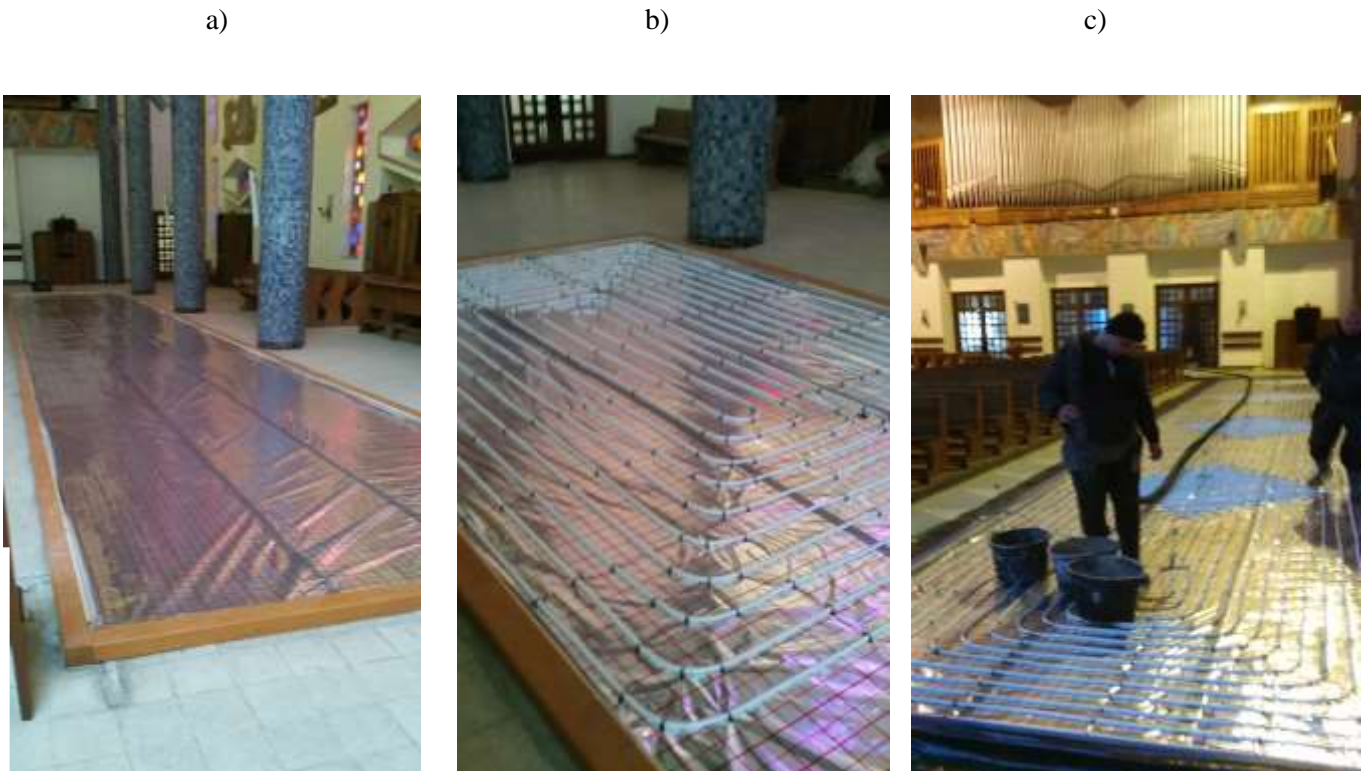
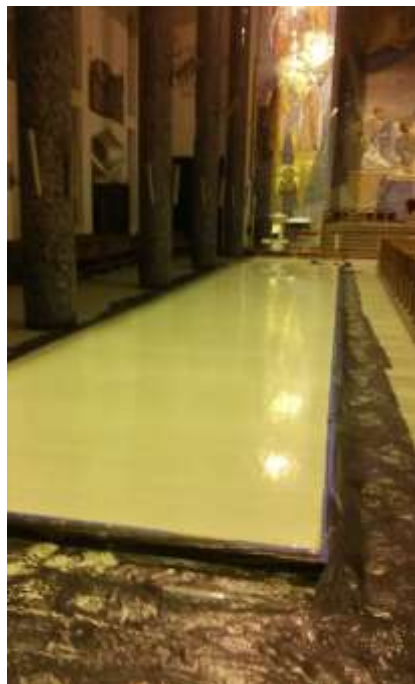
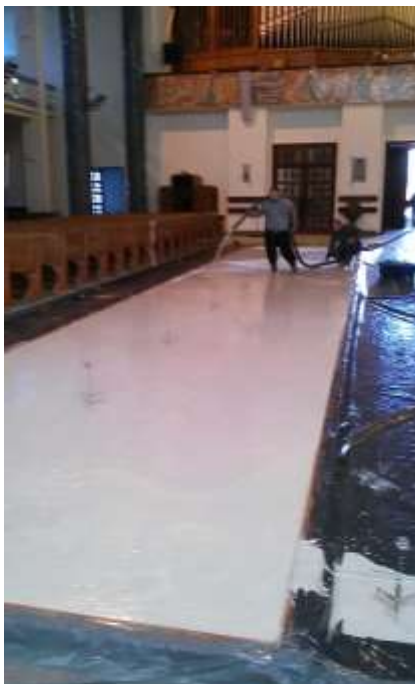
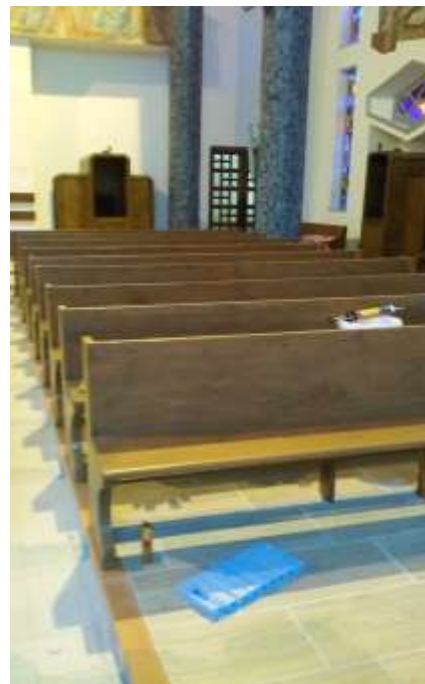
Underfloor heating has been installed in the so-called upper church. Loops with a heating medium were arranged under three rows of benches - the installation of underfloor heating did not require changing the arrangement of the benches, functioning in the so-called the upper church in an unchanged form until it is made available to the faithful. The implementation of the water-type underfloor heating was carried out on the basis of a design study - an executive design. During the works related to the installation of underfloor heating, special attention was paid to the fact that the thickness of the layers of thermal insulation material and the concrete screed was selected in such a way as to protect the heating installation against the possibility of heat loss (thickness of the thermal insulation material) and the possibility of damage to the heating loops (thickness of the concrete screed (anhydrite)), on the other hand, so that the installation of underfloor heating does not make it necessary to rebuild (raise) the existing platforms under the benches. The heating center was installed on the level of the upper church. The individual stages of work related to the installation of underfloor heating in the so-called the upper church is shown in Photo 19.

Photo 19: Installation of underfloor heating in the Church of the SHoJ in Gdynia in the rooms of the so-called of the upper church: a), b), c), d), e), f) stages of work (photo by Jacek Bramorski)
