Revitalizing the Sacral Complex of the Parish of the Sacred Heart of Jesus in Gdynia: A Comprehensive Restoration Project in Alignment with Monument Conservator's Guidelines and Technical Prerequisites

Maciej NIEDOSTATKIEWICZ^{*1}, Jacek BRAMORSKI^{2,3}

¹ Department of Engineering Structures, Faculty of Civil and Environmental Engineering,
Gdańsk University of Technology, Gdańsk, Poland

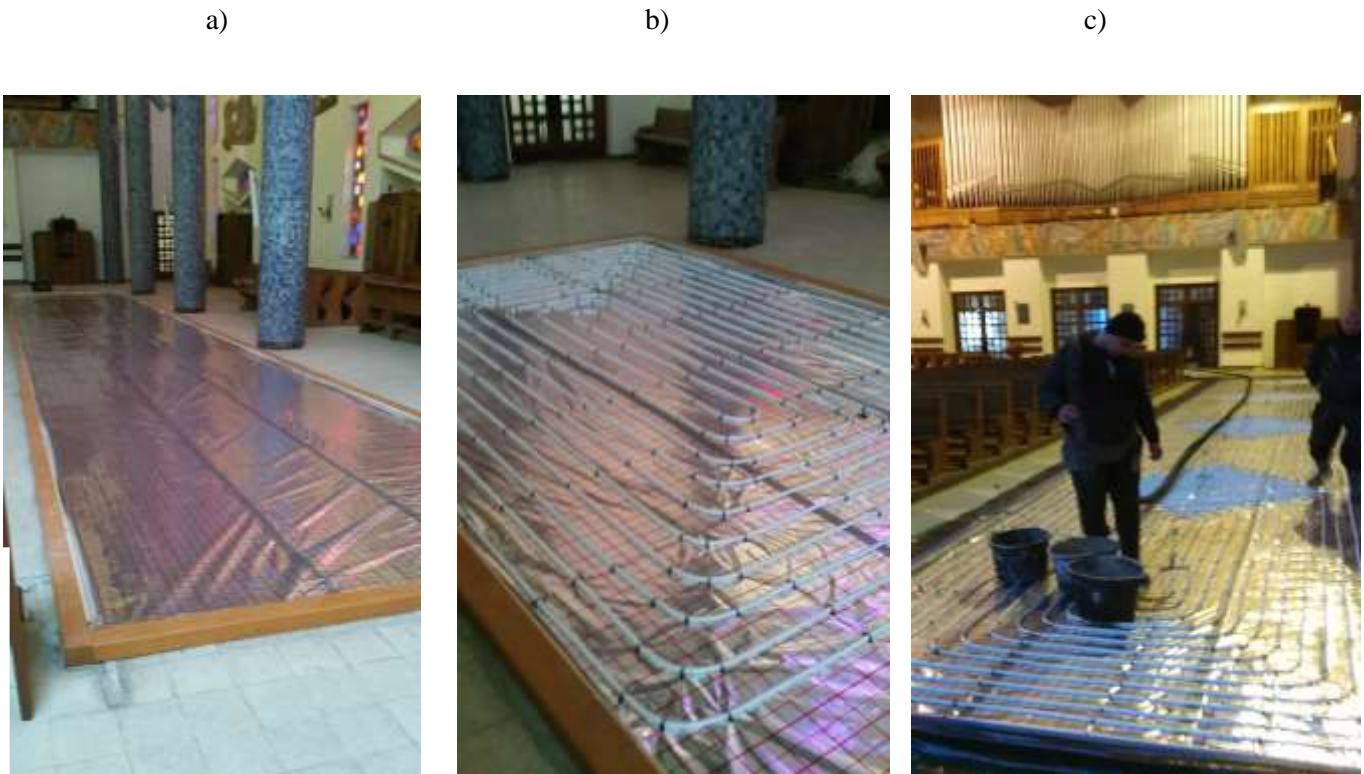
Underfloor heating has been installed in the so-called upper church. Loops with a heating medium were arranged under three rows of benches - the installation of underfloor heating did not require changing the arrangement of the benches, functioning in the so-called the upper church in an unchanged form until it is made available to the faithful. The implementation of the water-type underfloor heating was carried out on the basis of a design study - an executive design. During the works related to the installation of underfloor heating, special attention was paid to the fact that the thickness of the layers of thermal insulation material and the concrete screed was selected in such a way as to protect the heating installation against the possibility of heat loss (thickness of the thermal insulation material) and the possibility of damage to the heating loops (thickness of the concrete screed (anhydrite)), on the other hand, so that the installation of underfloor heating does not make it necessary to rebuild (raise) the existing platforms under the benches. The heating center was installed on the level of the upper church. The individual stages of work related to the installation of underfloor heating in the so-called the upper church is shown in Photo 19.

Photo 19: Installation of underfloor heating in the Church of the SHoJ in Gdynia in the rooms of the so-called of the upper church: a), b), c), d), e), f) stages of work (photo by Jacek Bramorski)
