Revitalizing the Sacral Complex of the Parish of the Sacred Heart of Jesus in Gdynia: A Comprehensive Restoration Project in Alignment with Monument Conservator's Guidelines and Technical Prerequisites

Maciej NIEDOSTATKIEWICZ^{*1}, Jacek BRAMORSKI^{2,3}

¹ Department of Engineering Structures, Faculty of Civil and Environmental Engineering,
Gdańsk University of Technology, Gdańsk, Poland

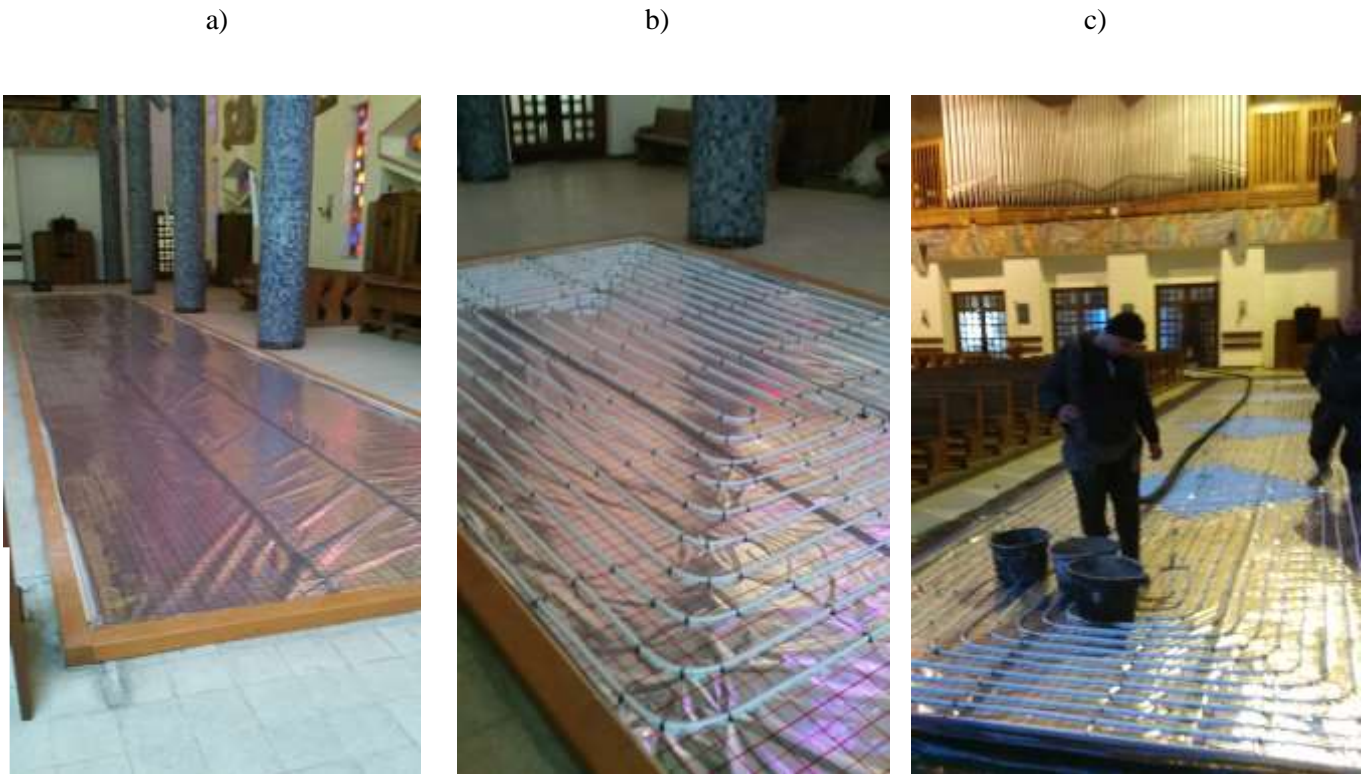
Photo 19: Installation of underfloor heating in the Church of the SHoJ in Gdynia in the rooms of the so-called of the upper church: a), b), c), d), e), f) stages of work (photo by Jacek Bramorski)

Underfloor heating has been installed in the so-called upper church. Loops with a heating medium were arranged under three rows of benches - the installation of underfloor heating did not require changing the arrangement of the benches, functioning in the so-called the upper church in an unchanged form until it is made available to the faithful. The implementation of the water-type underfloor heating was carried out on the basis of a design study - an executive design. During the works related to the installation of underfloor heating, special attention was paid to the fact that the thickness of the layers of thermal insulation material and the concrete screed was selected in such a way as to protect the heating installation against the possibility of heat loss (thickness of the thermal insulation material) and the possibility of damage to the heating loops (thickness of the concrete screed (anhydrite)), on the other hand, so that the installation of underfloor heating does not make it necessary to rebuild (raise) the existing platforms under the benches. The heating center was installed on the level of the upper church. The individual stages of work related to the installation of underfloor heating in the so-called the upper church is shown in Photo 19.
