Typology, current state and non-destructive testing of timber roof trusses of historic churches in the West Vistula Delta, Poland

Tomasz Zybała^{1*}, Monika Zielińska¹, Magdalena Rucka^{2,3}, Jarosław Przewłócki¹ and Karol Grębowski¹

Abstract

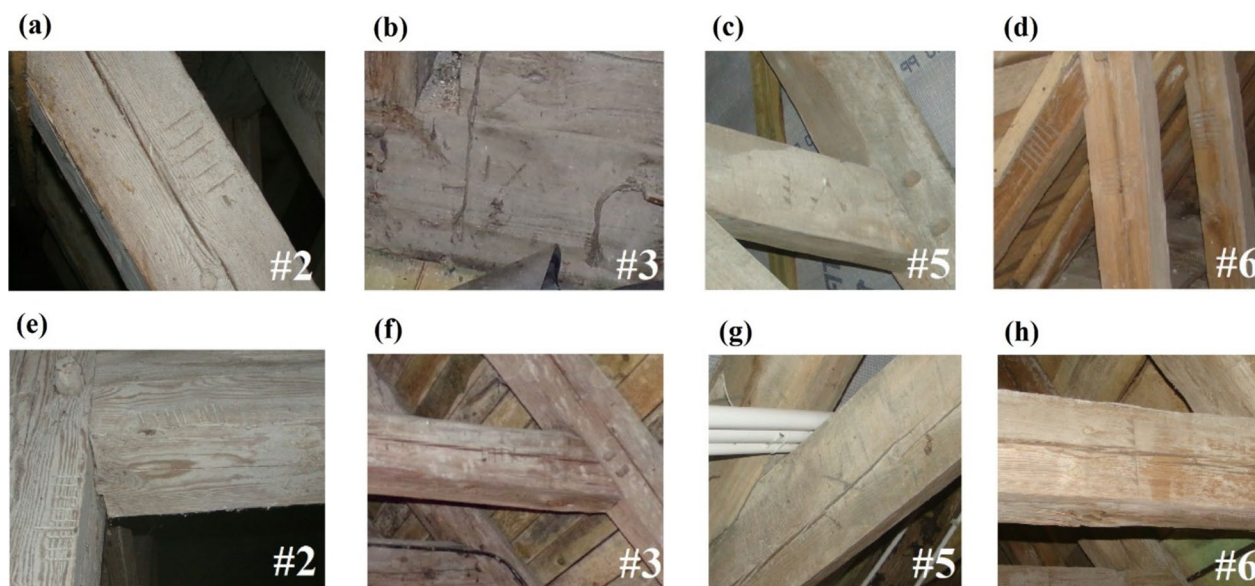
(Fig. 2). The state of conservation of the trusses is good, the roofing is waterproof and the gravity ventilation of the attics is intact (Table 1). Only the roof trusses built before the twentieth century (churches #2, #3, #5, #6) have carpentry marks (Fig. 7).

Fig. 7 Carpenters' marks on roof trusses: **a** and **e** Pruszcz Gdański I (#2), **b** and **f** Kiezmark (#3), **c** and **g** Koźliny (#5), **d** and **h** Trutnowy (#6)
